### Problem Statement

The objective of this research was to document a high-polymer content mixture (HPM) as an inlay material on a heavily cracked pavement at the National Center for Asphalt Technology (NCAT) Pavement Test Track. The results of this research are critical to its adoption as an overlay/inlay material on public roads.

Section N8 on the NCAT Test Track was originally constructed in 2006 as an under-designed perpetual pavement. Its performance history was divided into three main parts for the purposes of this study: original construction, conventional rehabilitation in 2009 and HPM rehabilitation in 2010.

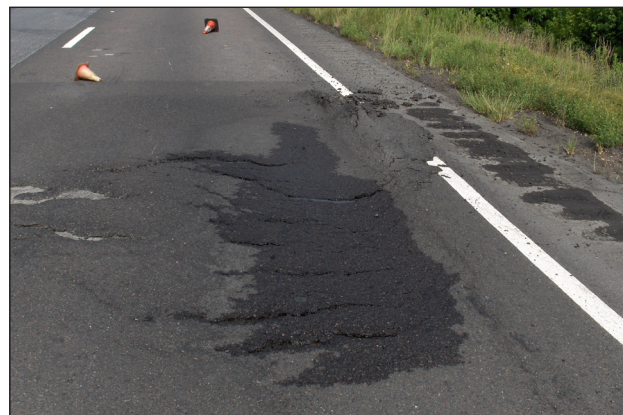
Although cracking did not occur as rapidly in the areas where the fabric interlayer was placed, the pavement condition in these particular areas deteriorated more quickly after cracking was observed. Figure 1 illustrates the most severely distressed area of the failed pavement surface, which was close to the installed paving fabric. This rehabilitated pavement failed completely after about 3.5 million equivalent single-axle loads (ESALs).

Figure 1 Severe pavement distress on Section N8 at the NCAT Pavement Test Track.

The HPM design used for the second rehabilitation consisted of three lifts of hot-mix asphalt (HMA) blended with binder modified with 7.5 percent low-viscosity styrene-butadiene-styrene (SBS) polymers. The surface and base lifts of the inlay were 3/8-inch nominal maximum aggregate size (NMAS) placed 1.25 inches thick. The intermediate lift was 3.25 inches thick with 3/4 inch NMAS. The virgin asphalt combined with 7.5 percent polymer in this formulation resulted in a PG 88-22 binder. The distressed pavement was milled to 5.75 inches to accommodate the HPM inlay, and a crack map was developed on the milled surface. Fabric interlayers were not used in the HPM rehabilitation. After about 5.5 million ESALs on the new HPM surface (2 million more ESALs than the conventional rehabilitation), no changes in surface condition were noted. No cracking was observed, and measured rutting was less than 1/8 inch.

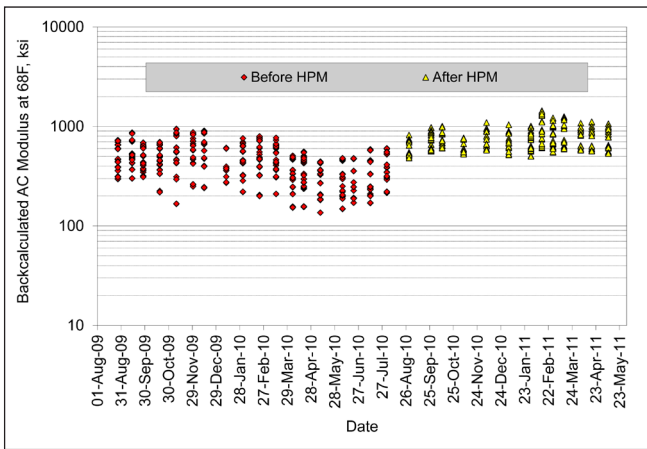
Beginning in the 2009 experiment, falling-weight deflectometer (FWD) tests were conducted every other Monday on Section N8. The deflection data were used to backcalculate asphalt concrete moduli, and relationships between temperature and modulus were established. These relationships were used to normalize the modulus to a reference temperature of 68°F so that modulus versus time could be examined. Figure 2 shows these data split into before and after the HPM inlay. The plot shows that before the HPM rehabilitation, the AC moduli were much more variable and lower.

- 2) The HPM had an immediate and statistically significant impact on the AC modulus of the pavement, with about a 55 percent modulus increase with reduced section-wide variability in the modulus. The coefficient of variation went from 47 percent before the HPM to 26 percent after the HPM was placed.

**Figure 2 Backcalculated AC moduli before and after HPM mill-and-inlay.**

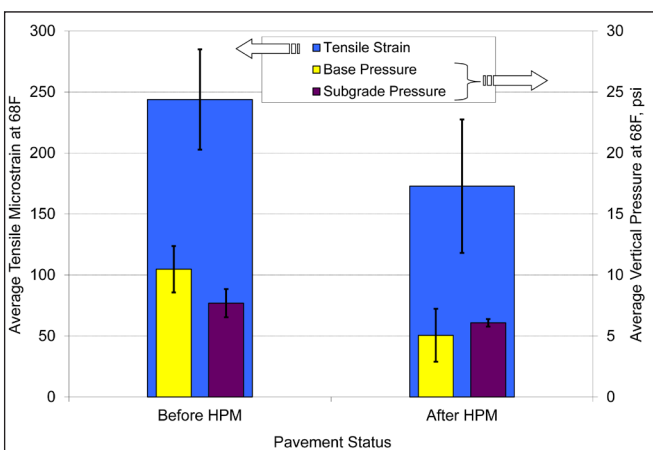
- 4) The HPM had statistically significant impacts on measured AC strain, base pressure and subgrade pressure. Strains normalized to 68°F were reduced by 29 percent, aggregate base pressure was reduced 51 percent and subgrade pressure was reduced 21 percent.

Three sets of measured pavement responses were obtained. Tensile strain at the bottom of the AC served as an indicator of cracking performance, and vertical pressures in the aggregate base and subgrade were considered in the context of rutting. As with the backcalculated AC modulus, comparisons were made before and after the HPM mill-and-inlay. Figure 3 summarizes the data from the pavement responses normalized to a 68°F reference temperature. In each case, pavement responses were reduced, a sign of improved structural integrity, after the HPM rehabilitation.

**Figure 3 Pavement response at 68°F.**
