Research Report No. 2F for ALDOT Project 930-601

**REPAIR OF CRACKED PRESTRESSED  
CONCRETE GIRDERS, I-565,  
HUNTSVILLE, ALABAMA**

**JULY 2011**

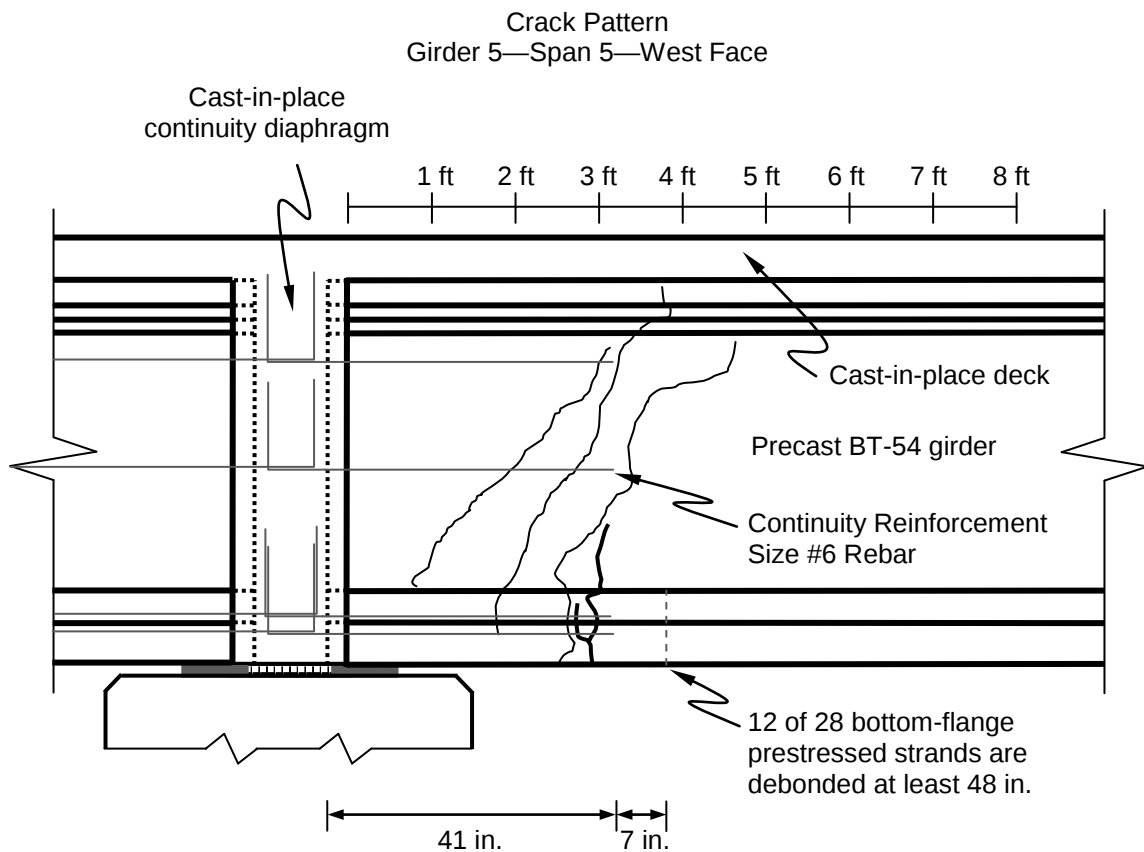
Figure 2.24: Cracked girder with continuity reinforcement details (Barnes et al. 2006)

Prestressing strand debonding and continuity reinforcement details discussed in Sections 2.3.3 and 2.3.5 have an effect on the positive bending moment capacity near the continuity diaphragm. The continuity reinforcement length of 41 in. and the debonded length of 48 in. for more than one-third of the strands have been superimposed with the crack pattern observed at Girder 5 of Span 5, as shown in Figure 2.24.

During a critical thermal event, bottom-flange tensile stresses could be induced near the continuity diaphragm along the girder. The debonded strands result in cross sections with a relatively weak positive moment bending capacity compared to the midspan cross sections. Due to relatively weak cross sections for a distance of 48 in. and local stress concentrations that can occur near the continuity reinforcement termination point at 41 in., cross sections near the continuity reinforcement termination location are likely points of origin for flexural cracking in response to positive moment bending.

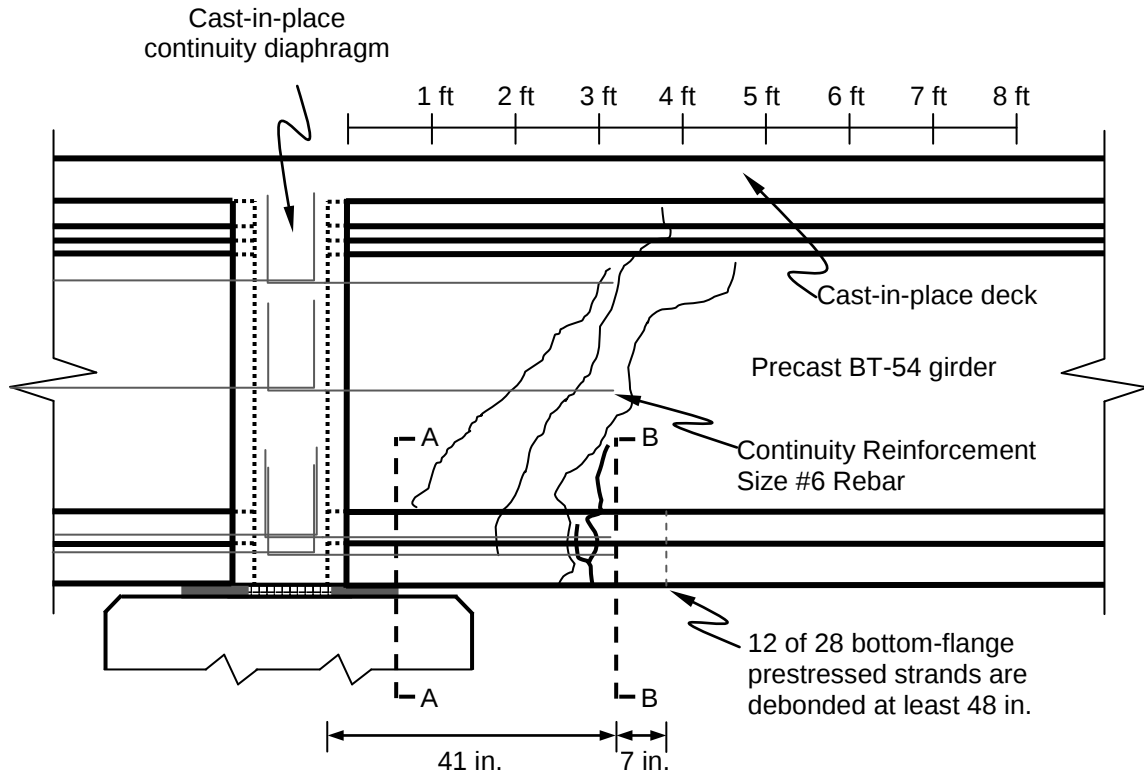
**Figure 2.17: Cracked pre-tensioned bulb-tee girders (Barnes et al. 2006)**

Shear cracks within the web were observed near the interior face of the bearing pad, and flexural cracking was observed near the termination of the continuity reinforcement, as shown in Figure N.1. These critical cross sections have also been noted for a girder with an overlaying illustration of an example FRP reinforcement system with unknown number of layers and length of FRP reinforcement, as shown in Figure N.2.
