**DRAFT FINAL REPORT**

# **Portable T-Section Glulam Timber Bridge Modules: Modeling and Performance**

**Results from Project USFS 96-CA-2824  
Portable Timber Bridge Monitoring and Development of  
Standard Plans**

**June 2001**

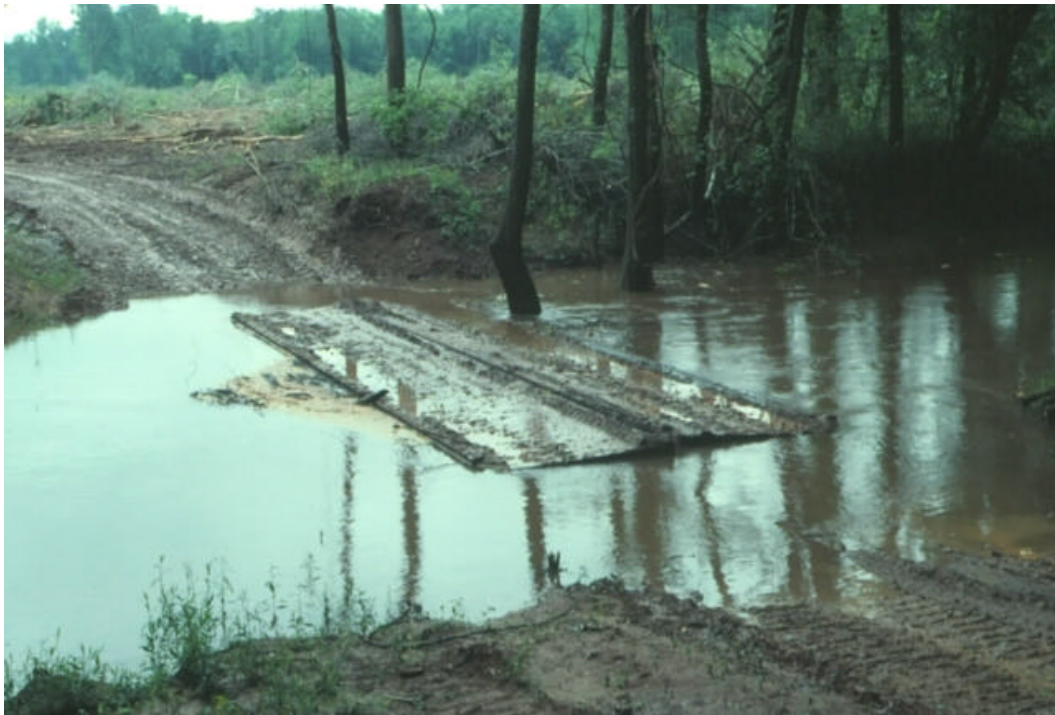
Figure 21. Georgia Pacific bridge in early stages of flood. This photograph illustrates the importance of securing the bridge to nearby trees.

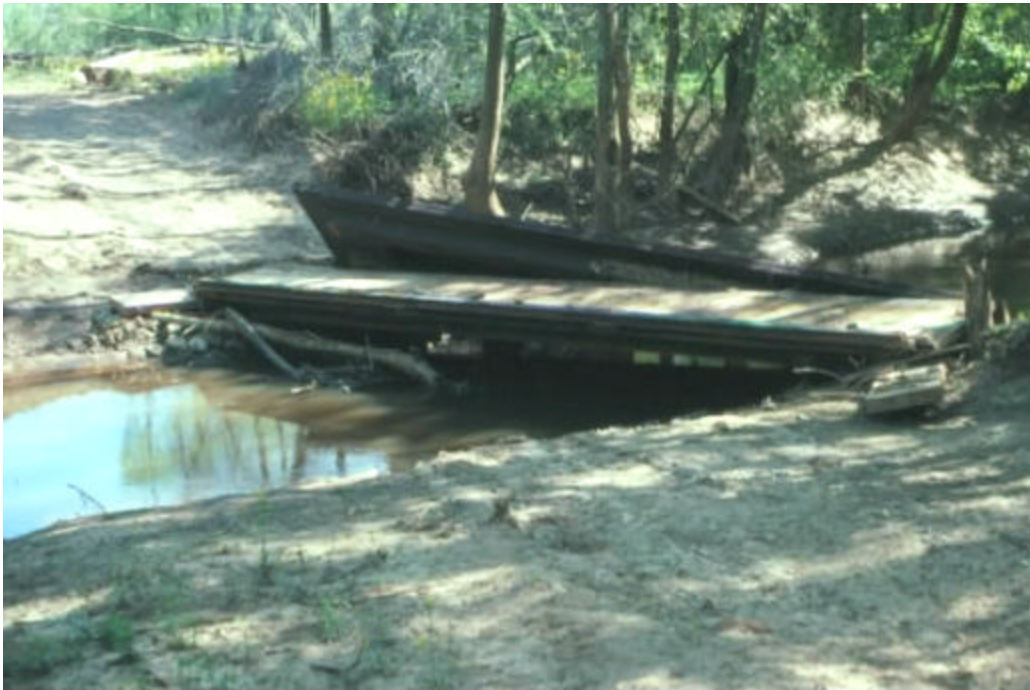
Figure 22. Georgia Pacific bridge after floodwaters had receded. The bridge was subsequently repositioned and the timber harvesting operation was completed.

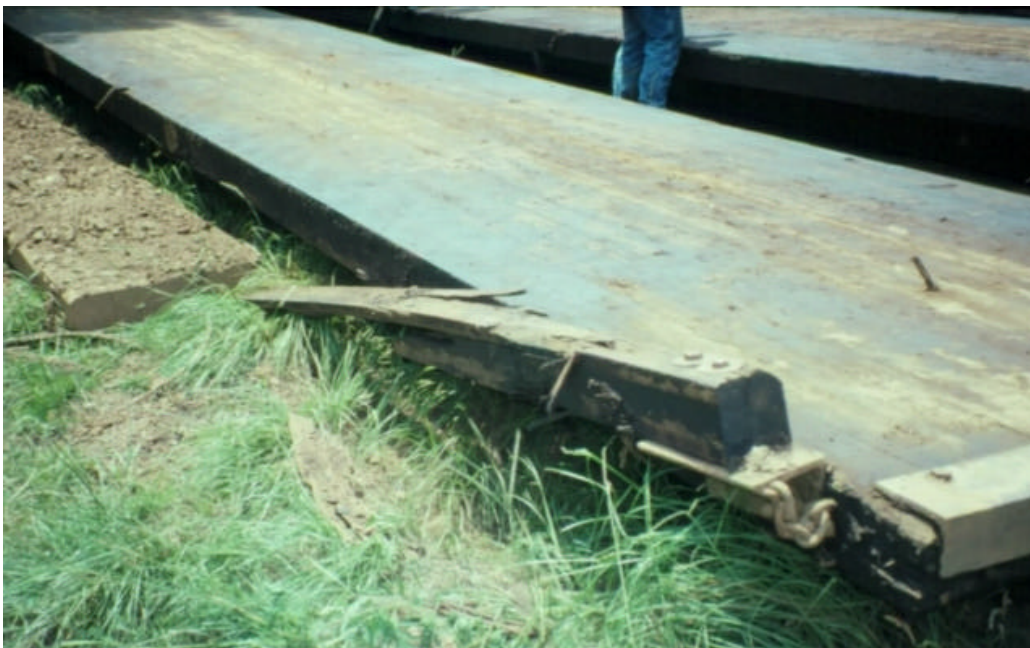
Several areas of damage were noted during this inspection. The most noticeable items apparently resulted from rough handling by the grapple skidder. It should be pointed out that using a skidder to remove the panels and skid them for such distances was not the intended removal method for the bridge. Most of the curb rail for Panel 1 was missing, with only short pieces near the panel ends remaining (Figure 23). It appeared that the skidder had dragged the panel against a tree and pulled the curb off of the flange. The lag screws that held the two steel curb brackets to the flange were pulled out of the flange; however, it appeared that the flange was not significantly damaged. One end of the curb on Panel 2 was also broken and pulled away from the steel bracket at the panel end. This apparently resulted from taking the grapple

of the skidder and clamping the end of the bridge to drag the bridge to the staging area. At the same location where the curb was broken, the edges of the flange were also apparently damaged slightly by the skidder grapple. Also, one of the steel angles attached to the end of Panel 2 was pulled loose from the flange.

Figure 23. Broken curb rail on the Georgia Pacific bridge after a removal by a grapple skidder.

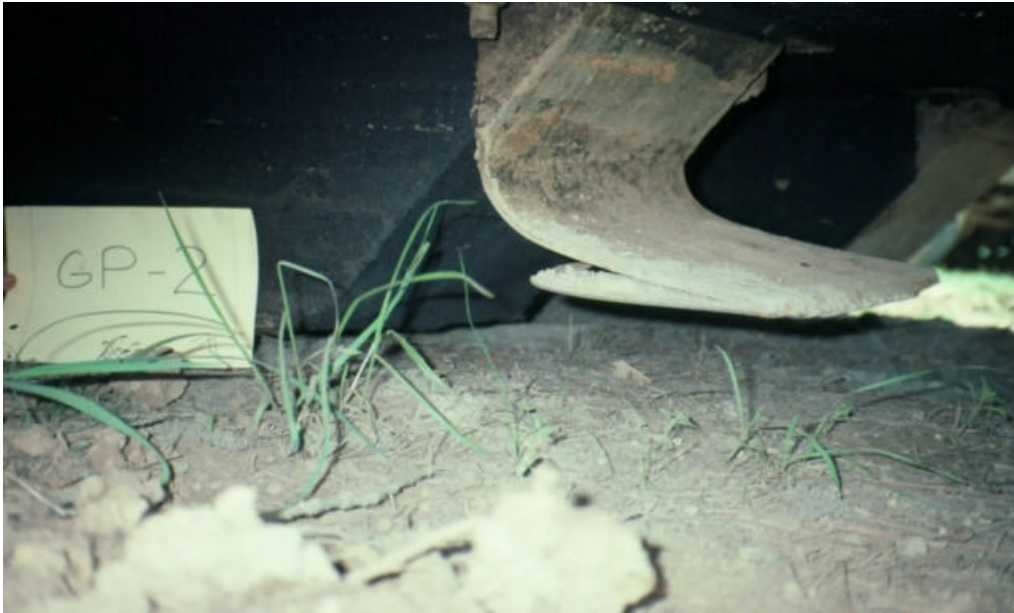
Another feature damaged during this removal was the steel protector plates fastened to the ends of the webs. On the ends of the panels that were dragged on the ground, the steel plates were peeled back away from the wood as shown in Figure 24. This was the result of dragging the panels such a long distance over a rough gravel road. Because the panels were sitting on the ground during the inspection, there was no way to determine if the webs were damaged.

Figure 24. Bent steel protector plates on the webs of the Georgia Pacific bridge after skidding a long distance over a gravel road.

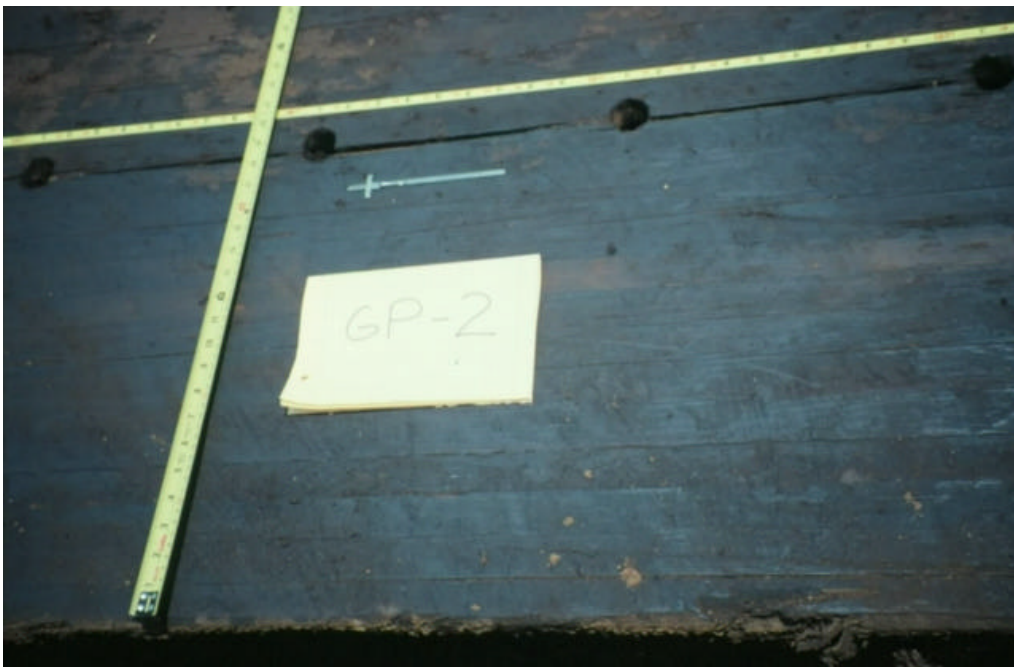
Since the bottom surface of the webs could not be inspected, no information could be obtained on the condition of the checks in the webs. However, at this point, several checks on the top surface of the flanges were observed. The majority of the checks were found on Panel 2. The checks ran longitudinally along the flange surface with the largest checks near the holes drilled in the flanges as shown in Figure 25. The largest checks were 24 mm (0.95 in.) deep and 5 mm (0.19 in.) wide. It is possible that these checks were present during the earlier visits, but were not observed due to the mud and gravel that was on the surface of the bridge. It was only during this visit that it was possible to clean the bridge surface without interfering with traffic using the bridge. The checks also could have been the result of the extended time that the bridge was partially submerged in the water.

Figure 25. Checks in the top surface of the flange of the Georgia Pacific bridge.

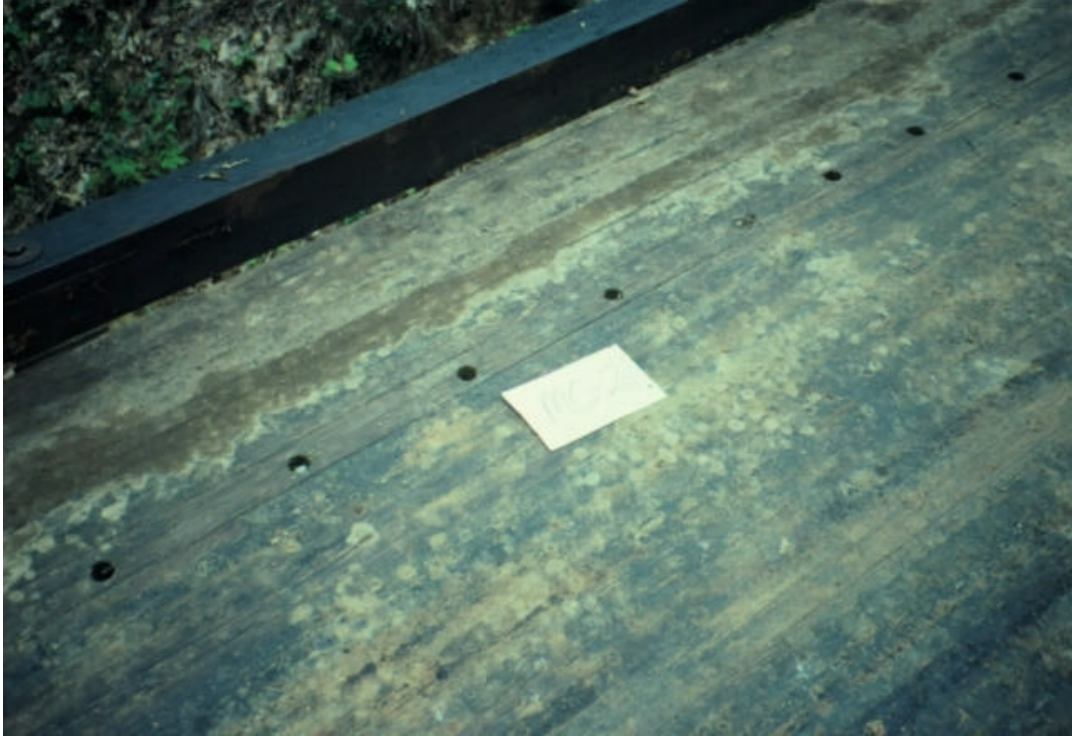
Minor surface checking was observed on the surface of Panel 2. The largest check on the surface of the flange of Panel 2 was 10 mm (0.38 in.) deep, 2 mm (0.10 in.) wide, and 1.7 m (66 in.) long. These checks did not appear to be associated with the holes drilled through the flanges. No checks were observed on the surface of the flange of Panel 1. Several large checks, similar to those on the Georgia Pacific bridge, were observed on the bottom surfaces of the webs of both panels. Again, the checks appear to propagate

Surface checks on the flange of Panel 2, which were observed in the first visit, did not appear to have changed in length or width since the first visit, although the maximum depth of the check was measured at 12 mm (0.5 in.). As in the first visit, no checks were observed on the surface of Panel 1. The checks observed on the webs of Panel 1 do not appear to have increased in their depth; however, the maximum width has increased to 10 mm (0.38 in.). Checks observed on the webs of Panel 2 do not appear to have changed in length or depth; however, the maximum width has increased to 8 mm (0.31 in.). Figure 26 is a photograph of these checks. Moisture contents in the webs ranged generally from 17.3% to 28.7% with one outlier value of 41.9%. The slight camber observed in the flange was still evident during this second inspection.

Figure 26. Checks in the top surface of the flange of the Morgan County bridge.
