# Corrosion Test Stand Army – Corp 1

U.S. ARMY AVIATION AND MISSILE COMMAND

Final Report

Dr. Beale – Comprehensive Design Two – MECH 4250 – Spring 2009

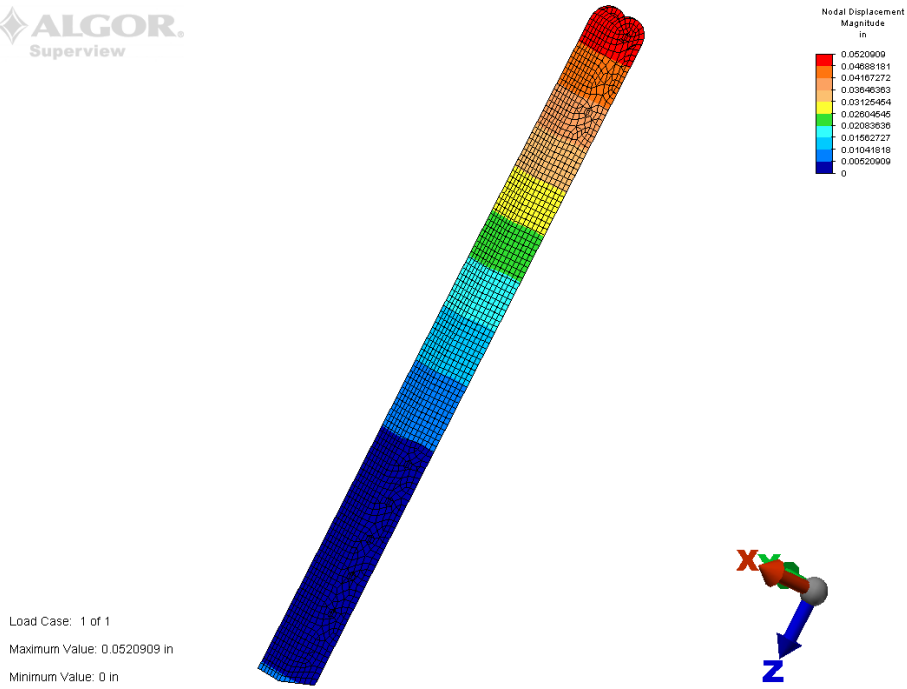
**Figure 13: Displacement of front leg under normal load**

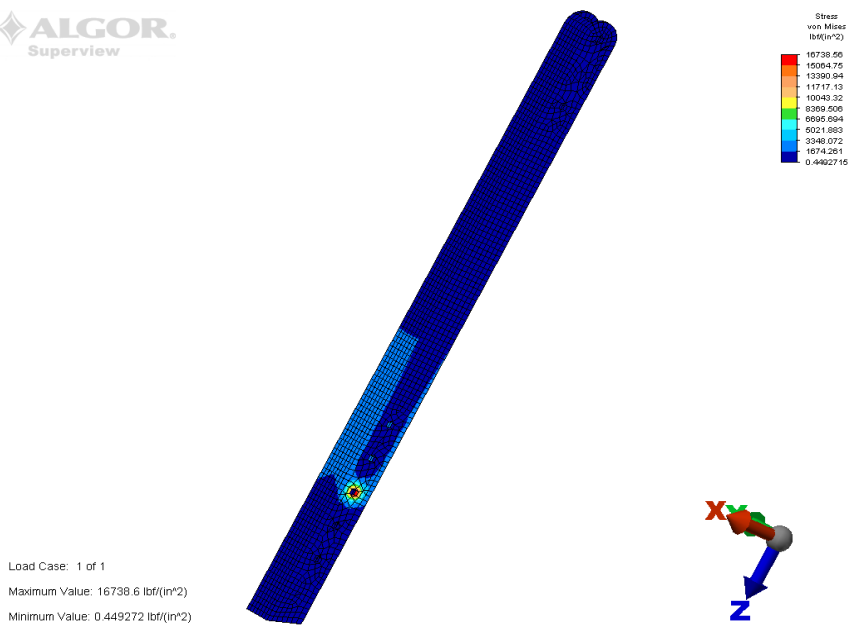
**Figure 14: Stress of front leg under normal load**

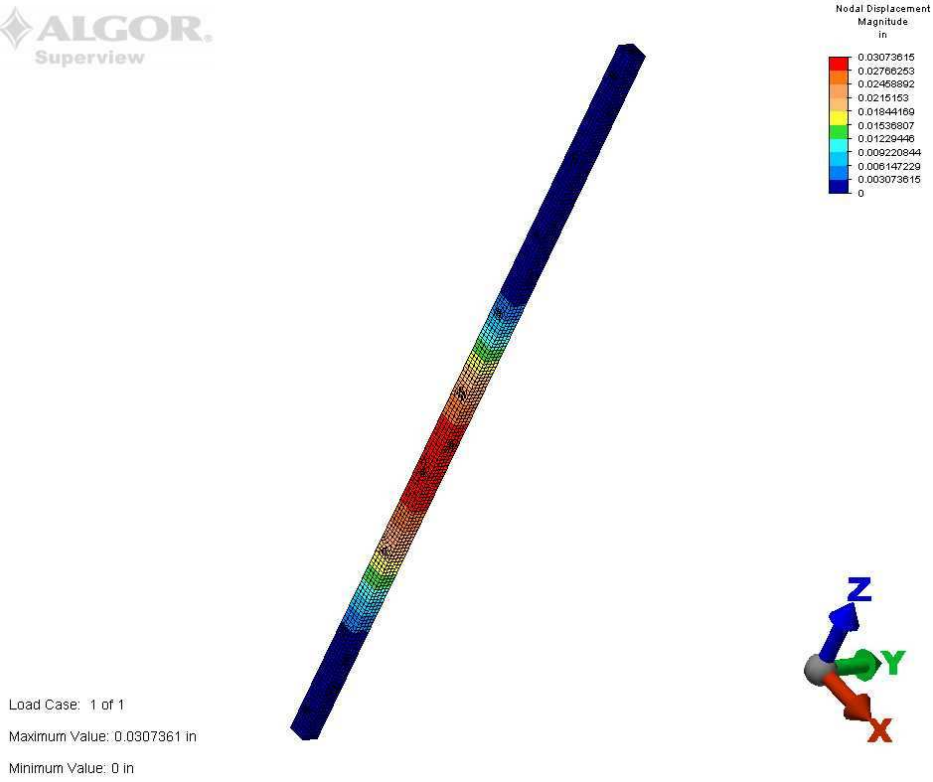
**Figure 19: Displacement of side bar given worst case scenario**

FEA was also performed with the new forces on each of the members of the assembly. Please review Figures 17- 30 for all the FEA results. The results of the FEA show that there will be now permanent yielding in the parts of the assembly. The rear leg analysis was supported in two places to prevent permanent yielding. This can be done since the actual leg will be supported by a brace between the leg and the side bar. The greatest displacement was found in the front leg at a distance of 0.8 inches.

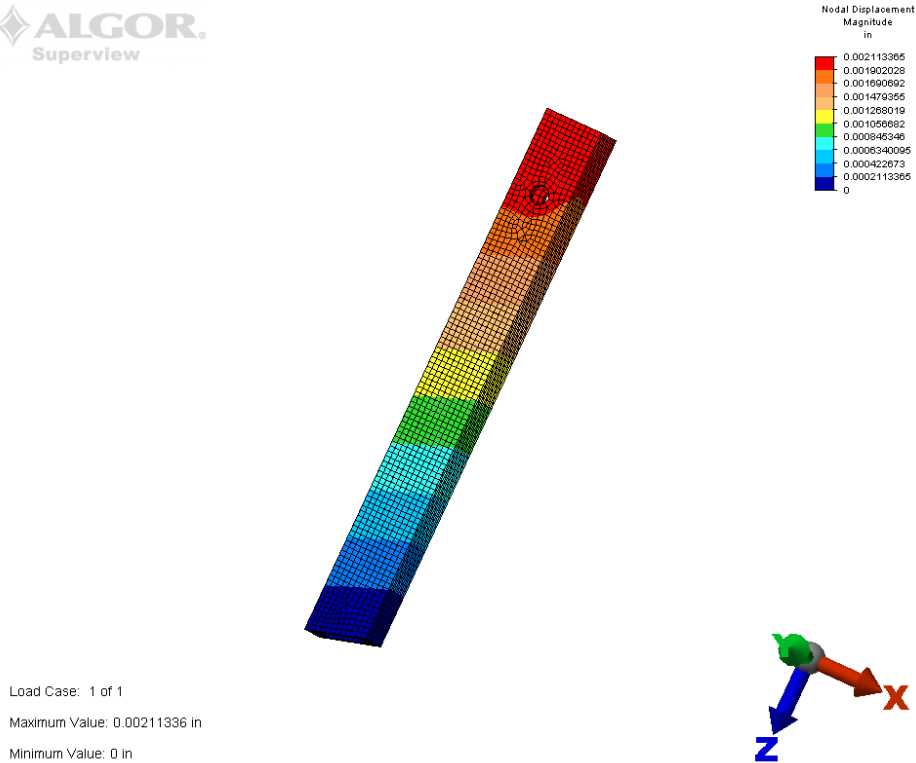
**Figure 21: Displacement of front leg insert given worst case scenario**

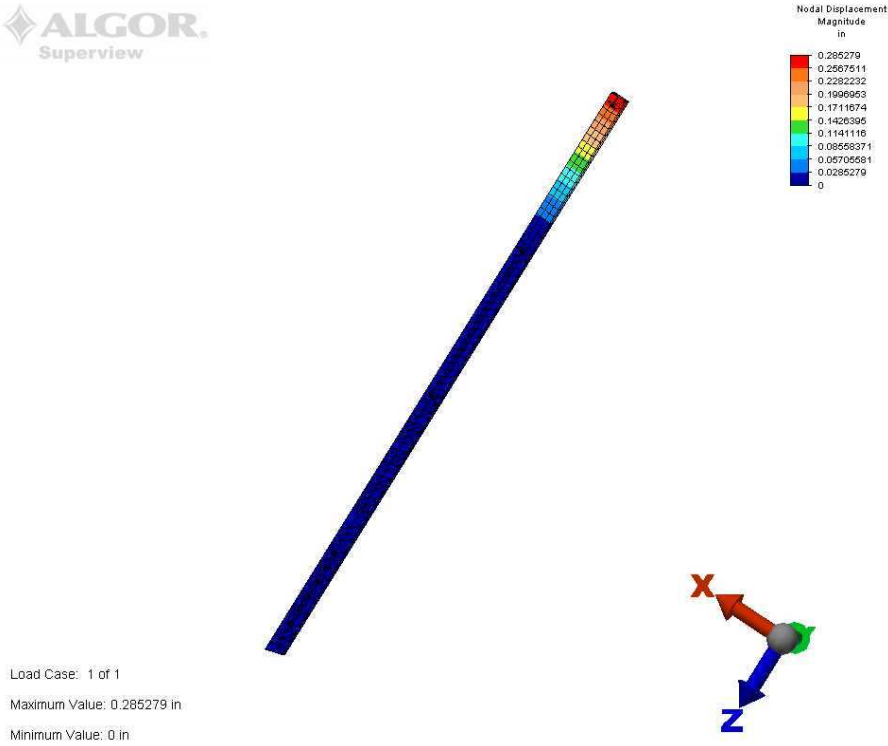
**Figure 27: Displacement of rear leg given worst case scenario**

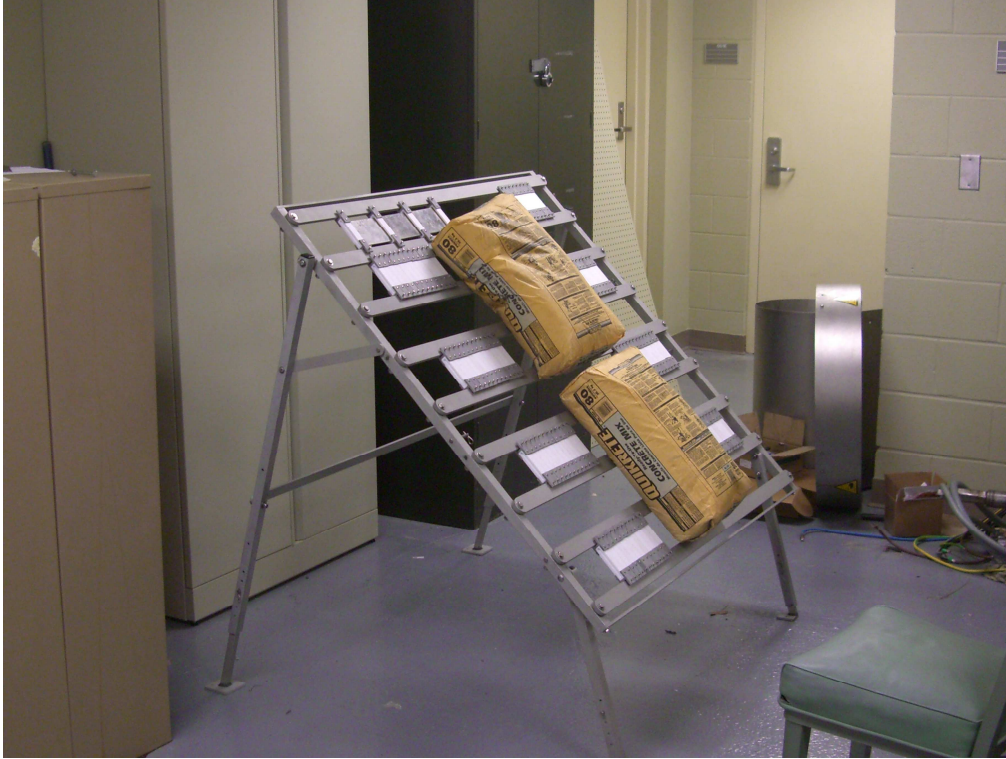
After assembling the corrosion rack, it was necessary to test the structural integrity of the rack. We initially tested the rack by placing 160 lbs on the stand. There was no deformation from this load. Two people then placed all their weight on the stand to increase the load on the stand. Once again, there was no deformation or instability in the stand. This equaled a combined weight of 560 pounds on the corrosion rack, which showed no visible deformation throughout the test. Finally, four concrete bags were placed on the stand and four people placed their weight on the stand and there was no deformation. This combined to a total of 1120 lbs of force on the corrosion stand. It was concluded after this structural test that the stand will easily withstand normal loads and loads during a hurricane. Please refer to Figures 33 and 34.

**Figure 33: Structural Integrity Testing of Corrosion Stand using Concrete Bags**

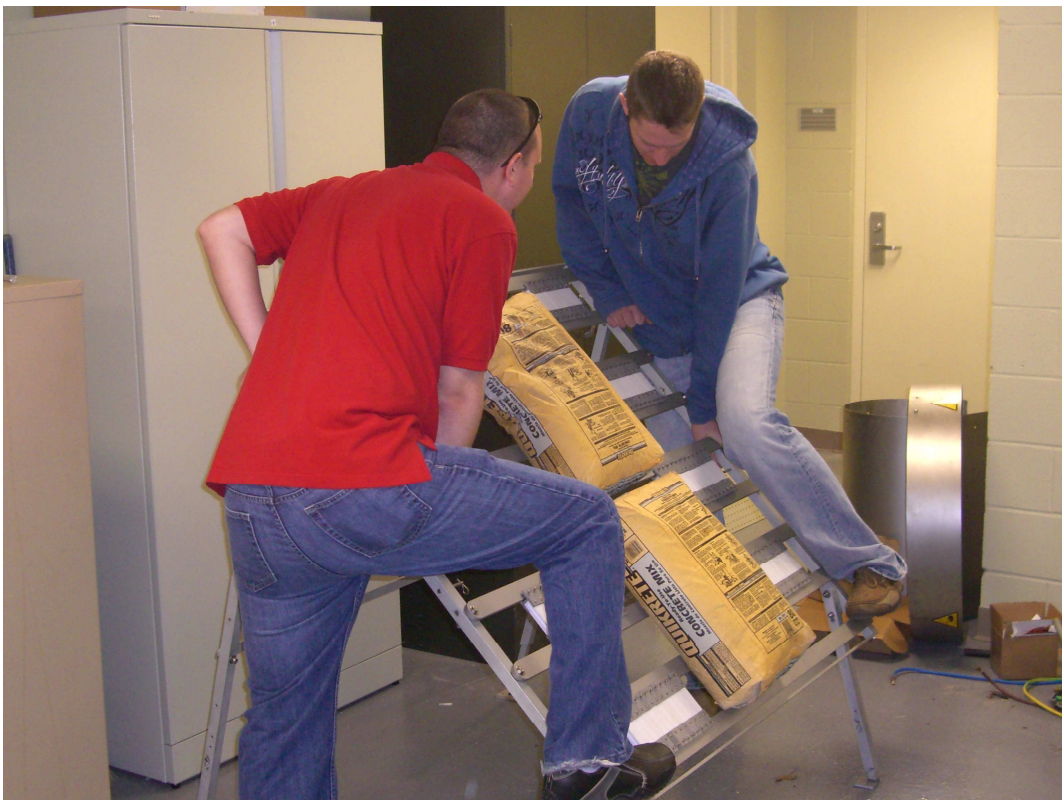
**Figure 34: Structural Integrity Testing of Corrosion Stand using Concrete Bags and Personnel**

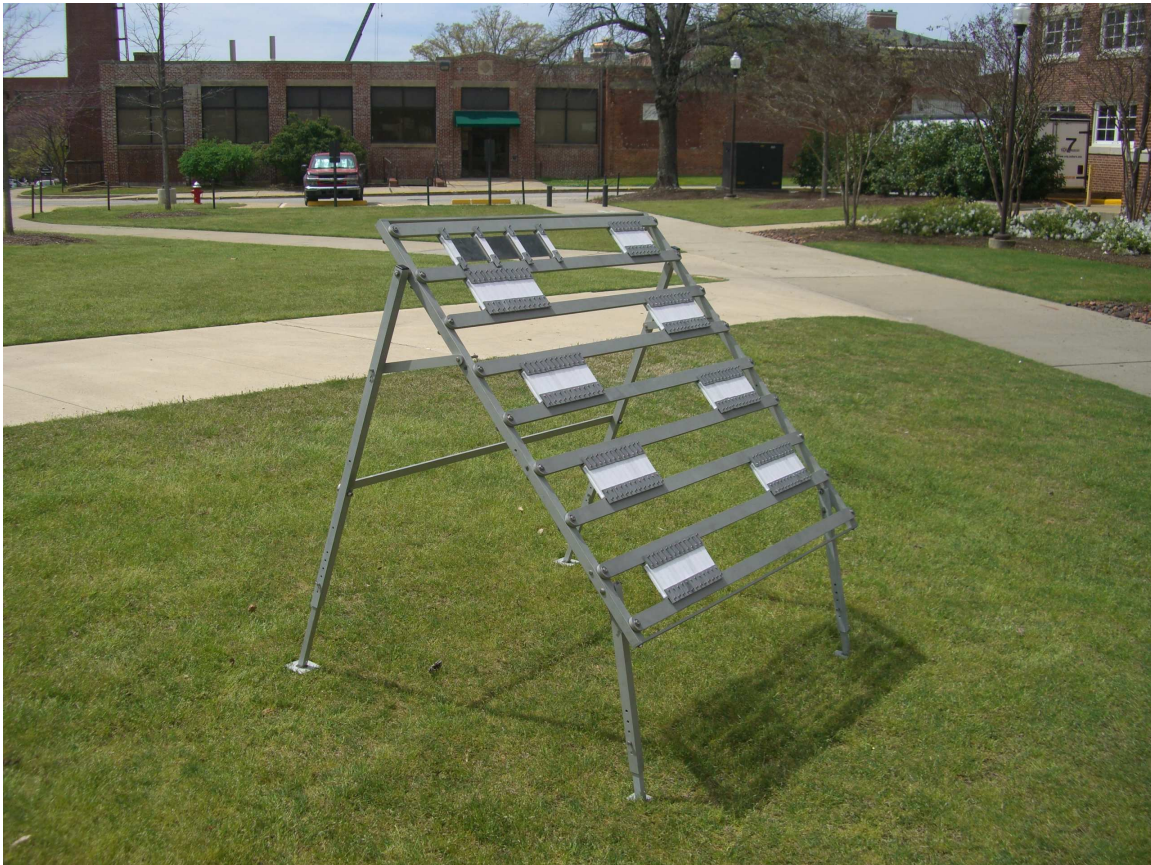
**Figure 35: Completed Corrosion Test Stand**

During the manufacturing process, the H-bar received were not the size that we had dimensioned. The H-bar was assumed to have an inside dimension of  $3/8$ ", but the H-bar we received was actually  $1/2$ ". We searched for  $3/8$ " H-bars, but found that we could locate any vendors with our desired product. We then made the necessary adjustments to the corrosion rack to accommodate the larger H-bars. The changes included purchasing larger crossbars. The thicknesses of the crossbars were increased from  $1/4$ " to  $3/8$ " and the width was increased to  $1-1/2$ ". This adjustment actually increased the stability of the corrosion test stand substantially. Please refer to Figures 35 and 36 for pictures of the completed test stand.

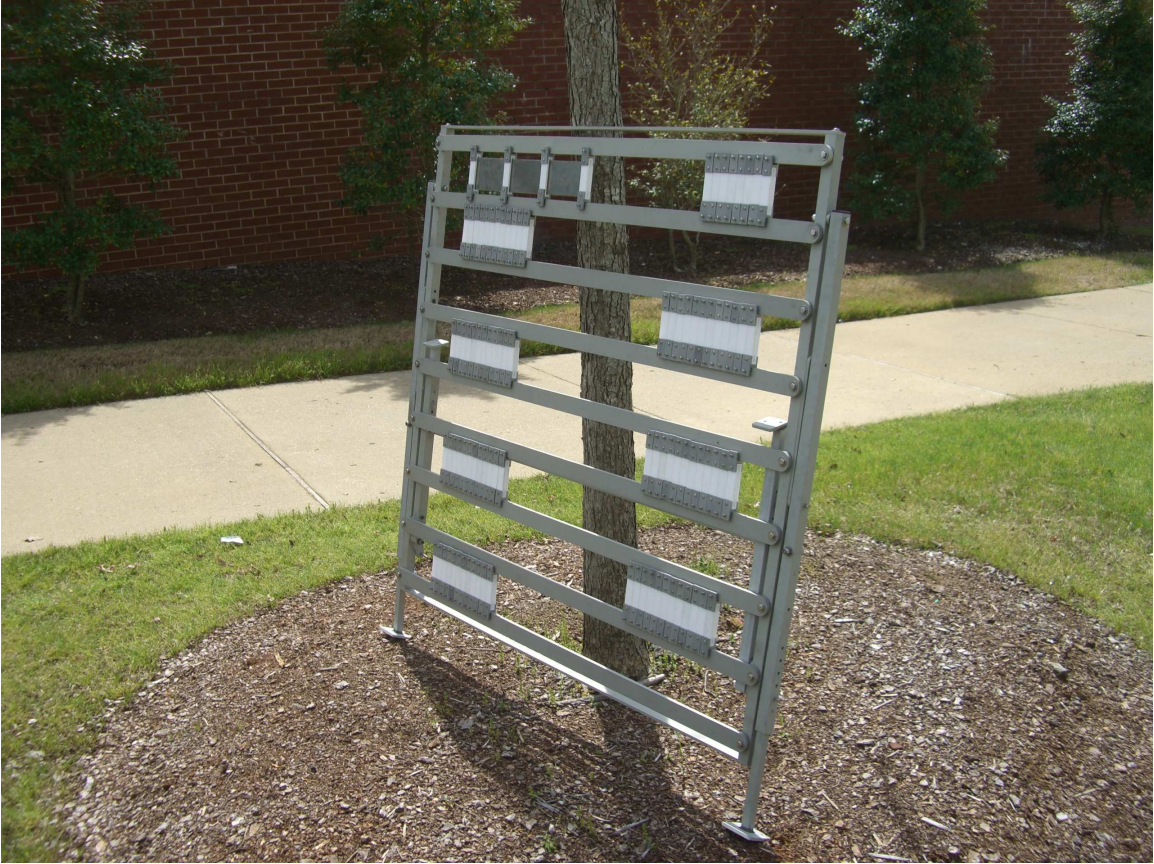
**Figure 36: Completed Corrosion Test Stand Compacted**
