PATCHING OF PCC PAVEMENTS
FIELD EVALUATION OF MATERIALS & CONSTRUCTION TECHNIQUES

Project Number ST-2019-2

Final Report

Frazier Parker and Lee Shoemaker
Highway Research Center
Auburn University

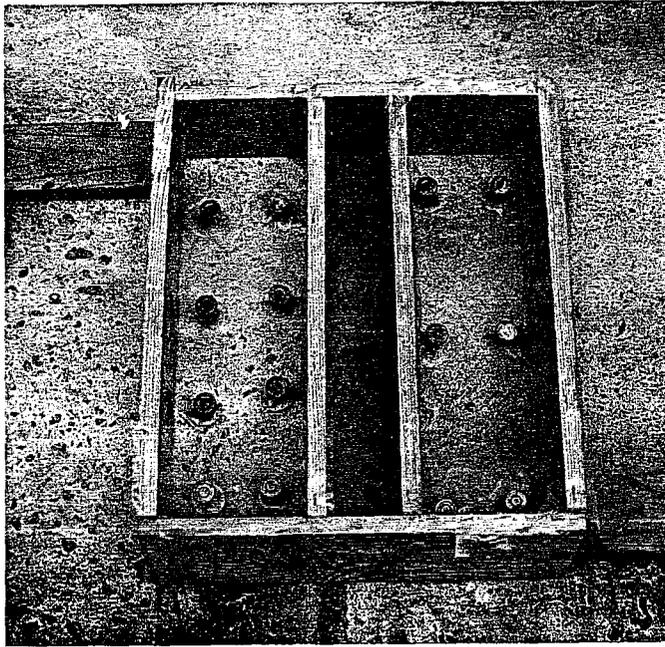
a. Forms and Shear Connectors In-Place

Figure 3a shows forms and shear connectors in-place and ready for concrete placement. Figure 3b shows test specimens cast around a reaction pedestal. Figure 3c illustrates the set up for loading and measuring deflection. Figure 3d illustrates several failed specimens that

A series of tests were conducted to extend the earlier study, and to develop rudimentary data that could be used to select the amount, size and type anchor steel for inclusion in field patches. Blocks of concrete (18" x 6-1/2" x 5-1/2") with various anchor configurations, were cast on the surface of an old concrete pavement slab and loaded horizontally as described in reference 2. Reinforcing bars (#3, #4, and #6) bent into a "U" shape and shear connectors (1/2" and 3/4" diameter), as used in composite design, were used as anchors. Holes were drilled in the pavement slab and anchors attached with quick-setting polyester grout. The surface of the pavement slab was cleaned and lightly scarified prior to placing concrete.

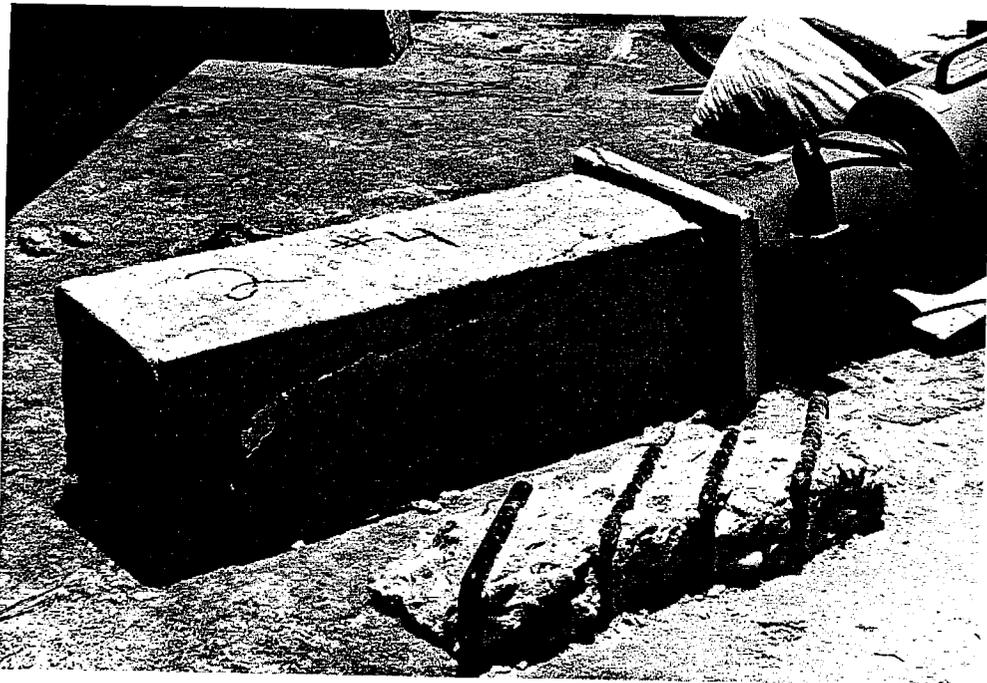
d. Failed Specimen

contained reinforcing bar anchors. The specimen in the background illustrates the cracking that develops at complete failure and the specimen in the foreground shows the reinforcing bars after the outer cracked concrete was removed.

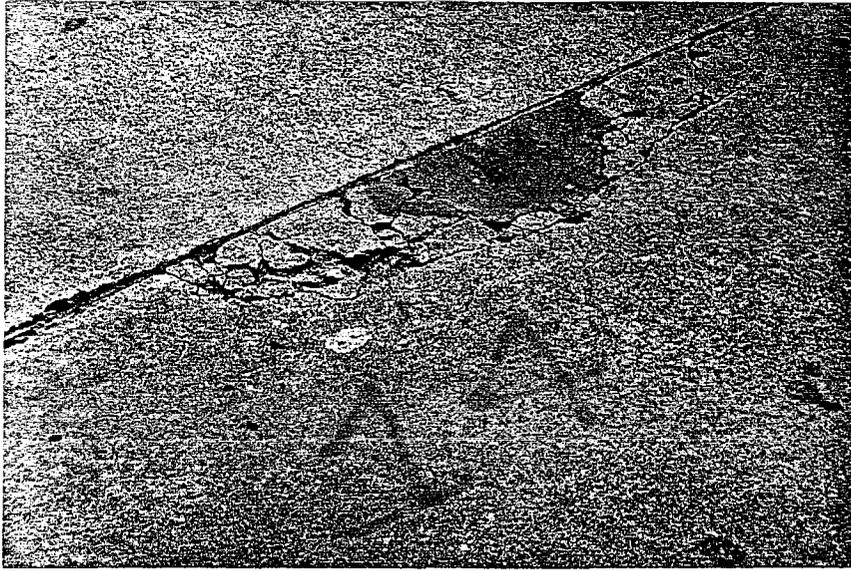
a. Cracked Area Along a Joint

The multiple photographs in Figure 7 illustrate the construction process. Figure 7a illustrates a typical cracked area along a transverse contraction joint. As mentioned earlier, the deteriorated areas on I-59 in Gadsden were larger than those on I-85 in Montgomery. At both locations deteriorated areas were adjacent to a transverse joints. Some were along the interior of transverse joints, as shown in Figure 7a, while others were at corners along the pavement edge or along longitudinal centerline contraction joints. In most cases the deterioration was only on one side of a transverse joint, but occasionally was on both sides.

On I-59, the deterioration was concentrated on the upstream side of transverse joints, while on I-85 it was more uniformly distributed on both sides. On I-59, there were several deteriorated areas completely across a lane. On I-85, quite a few of the deteriorated areas were adjacent to previously placed patches or replaced slabs. A few completely replaced old deteriorated patches. Along I-85 there were several locations where

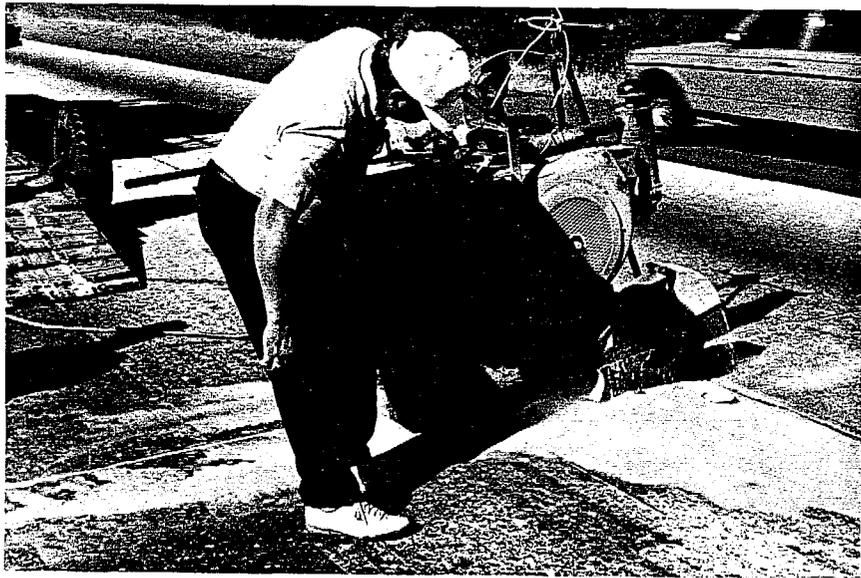
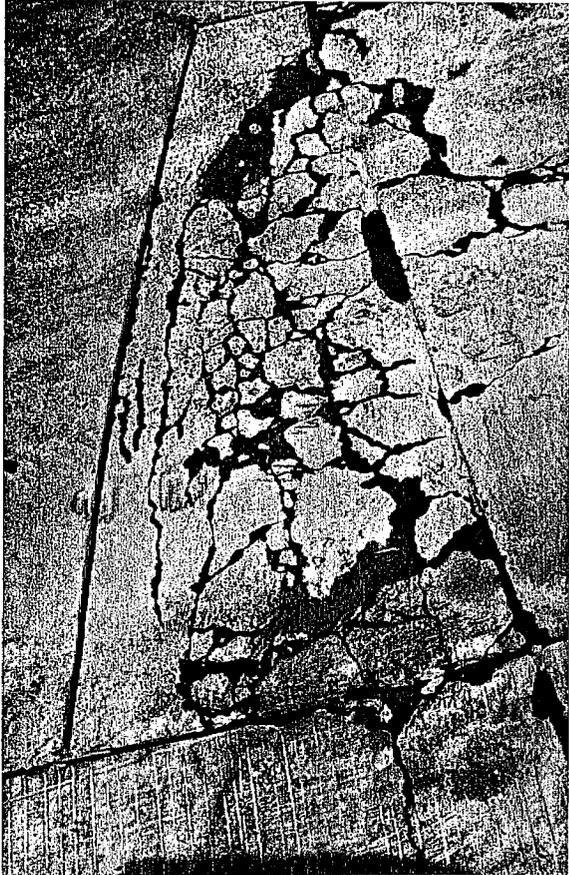
b. Sawcut (1-2" Deep) Around Failed Area

The first step in the patch construction process was to identify the area of deteriorated concrete to be removed. In a portion of the patches a sawcut, 1-2" deep, was made around the area as illustrated in Figure 7b and c. The sawcut made removal of the deteriorated concrete easier and gave a more uniform edge patch depth. As will be discussed later, removal of all damaged concrete is critical to patch performance. Sawing seems to increase the likelihood of complete removal.

During patch construction areas of deteriorated concrete should be identified and outlined with a sawcut 1 to 2 in. deep. The area outlined with the sawcut should be about 1 ft. larger on all sides than the deteriorated area. The smallest jackhammer possible should be used to remove damaged concrete; if possible 30 lb. or less. Patch material should be consolidated with vibration.

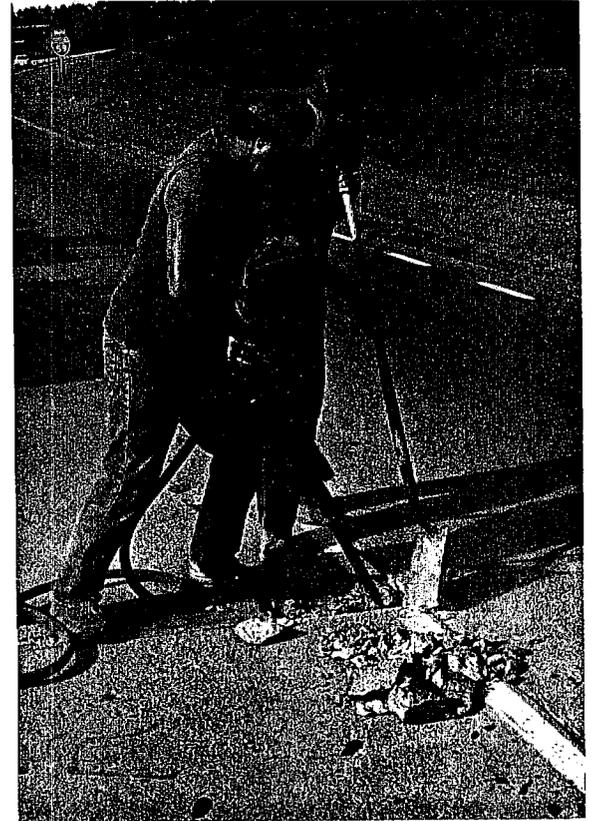
d. Jackhammer Removing Damaged Concrete

The next step is the removal of damaged concrete with a jack hammer as illustrated in Figure 7d. The size jackhammer should be kept as small as possible to prevent cracking of the concrete around the patch area. A 30 lb. maximum size is recommended.

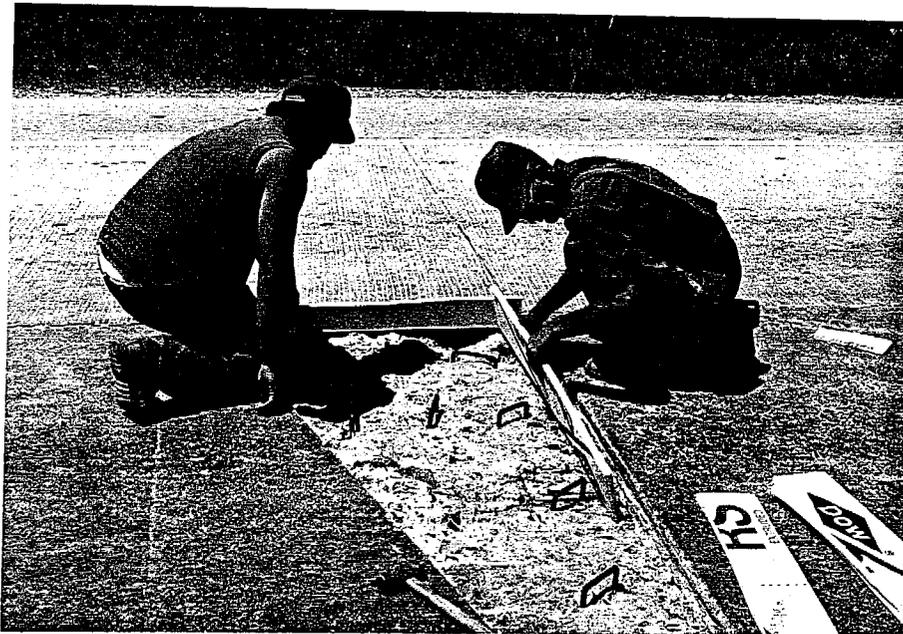
f. Joint Filler Installation

Expanded polystyrene insulation board, 3/4 in. thick, was shaped and placed along joints as shown in Figure 7f. The soft polystyrene protects the patch against expansion forces from adjacent slabs and provides a reservoir for sealant. In several patches where deterioration was on both sides of a joint no joint was formed in the patch; and, as expected, a crack matching the joint formed.

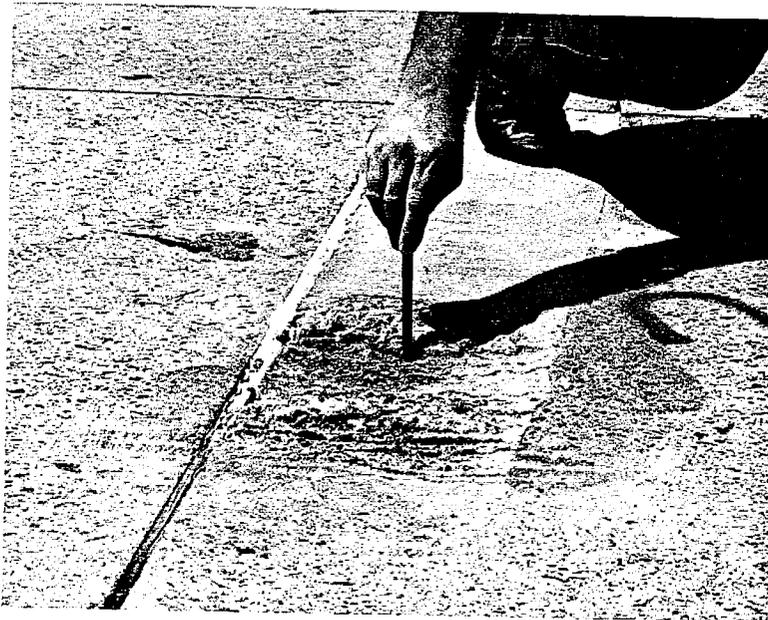
l. Tire Damage to Unset Patch

A patch that develops early strength sufficient to resist damage when opened to traffic is the first priority of patch construction. Certainly, long term performance is the ultimate goal, but getting and keeping the patch in place allowing strength to develop is critical. Only two cool weather patches were damaged immediately after opening to traffic as illustrated in Figure 71. There was some surface deformation and abrasion in these patches which were replaced during the next work day.

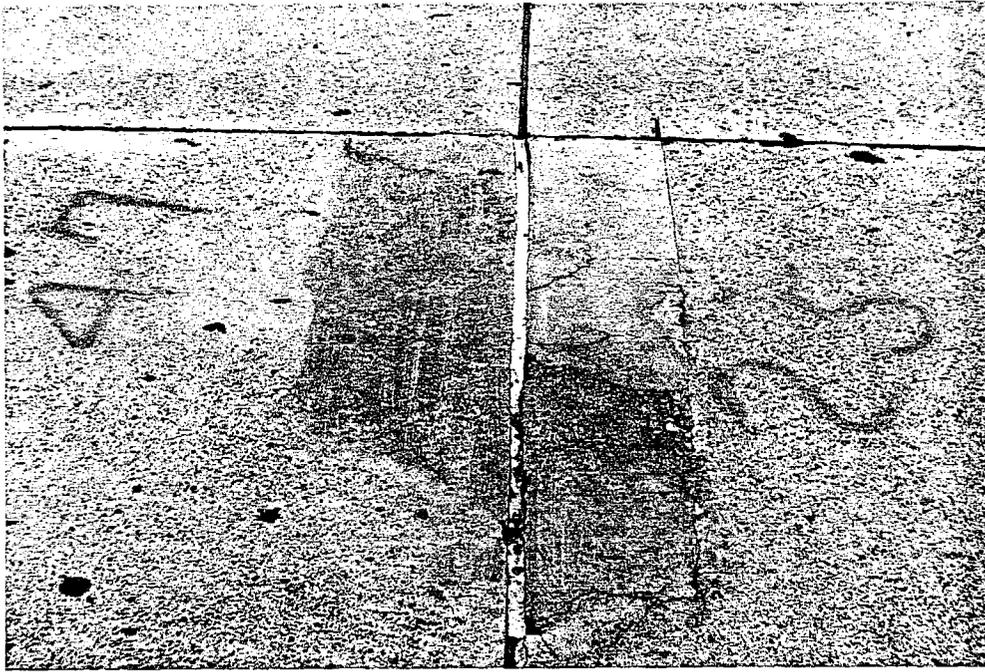
a. Initial Cracking and Spalling

localized cracking as illustrated in Figure 12a. In two patches on I-59 joints were not placed in patches and working cracks, as illustrated in Figure 12b, developed. In neither case have these working cracks contributed to further deterioration. Localized cracking progressed until large spalls began to break loose, as shown in Figure 12c filled with asphalt mix. In some, this progressed until it became necessary to completely remove the remaining patch material and replace with asphalt mix as illustrated in the patch (*27) in the background of Figure 12d.

In a few patches shallow spalling developed along joints and around the patch-slab boundary, as illustrated in Figure 12a. In no cases has this been a serious failure mode unless accompanied by cracking.

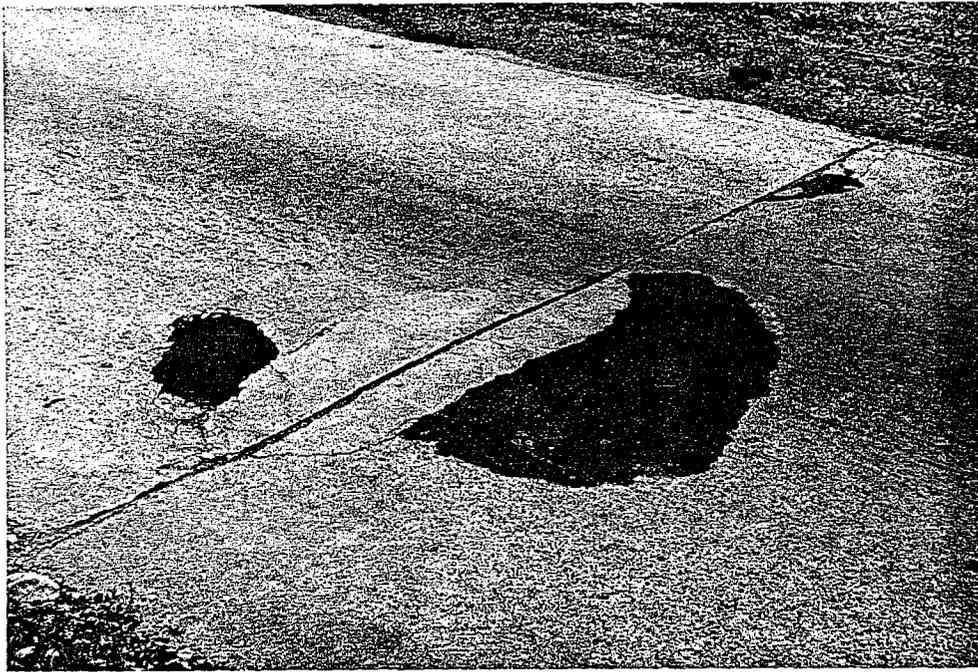
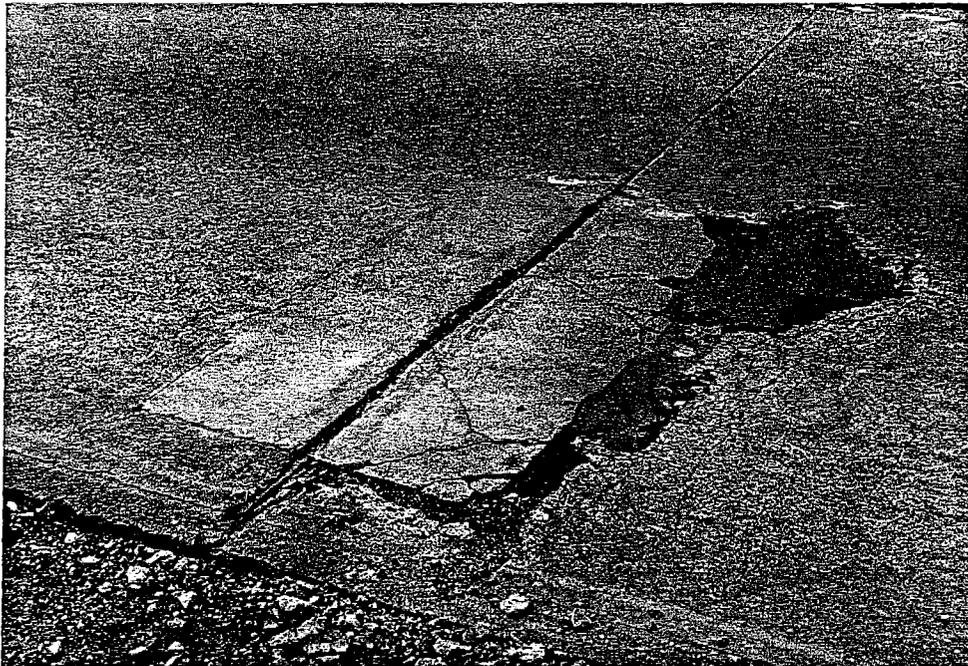
Figure 12. Patch Deterioration

Figure 12e and f show patches which are still intact, but where the slab adjacent to the patches has continued to deteriorate. In both cases the slabs have been patched with asphalt mix. This behavior may be caused by one or a combination of two factors. All damaged concrete may not have been removed when the patch was placed. The subsequent deterioration may only have been the worsening of an existing condition. When outlining the area to be removed for patching a good practice to follow is to be conservative and then to add one foot to all sides.

The second factor is that the patching is not correcting the condition that initially caused the deterioration. The deterioration around the patch may be only a manifestation of these continuing conditions. The response

of five cold weather I-59 patches further reinforces this notion. All five patches (#26-#30) were placed sequentially on the outside lane just upstream of the intersection with the US 431 entrance ramp. They were placed in December 1986, were in good condition in April 1987 (4 months) and completely failed (removed and filled with asphalt mix) during the summer of 1987. Patch 27 is shown in the background of Figure 12d. A possible explanation for this behavior is that the ramp entrance may restrict the cyclic movement of the slabs which may have been the cause of the initial deterioration along the joints. As summer temperature increased, the same restraint and resulting compressive forces may have caused failure in the patches.
