Final Report RP-930-466-2

**REPAIR OF THE UPHAPEE CREEK BRIDGE WITH FRP
LAMINATES**

Alabama Department of Transportation
Research Project 930-466
Montgomery, Alabama

November 2005

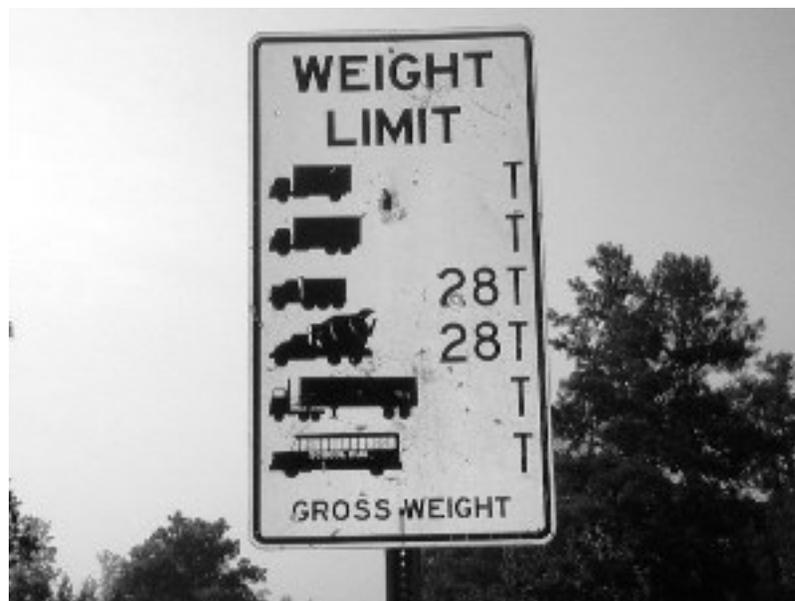
Figure 1.2 Load Posting Sign for War Memorial Bridge

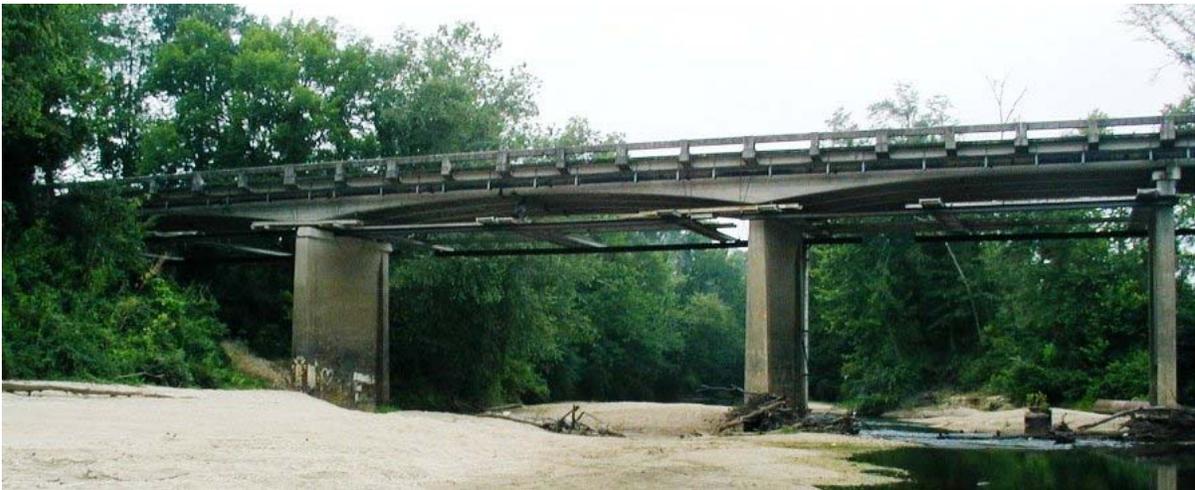
The War Memorial Bridge is of north-south orientation and consists of eighteen, 38-ft simple spans and a three-span continuous section of 161-ft length. Figure 3.1 shows the continuous span portion of the War Memorial Bridge, the section of concern to this report. The roadway is 26 ft wide. Spans are numbered incrementally from south to north, and girders are numbered incrementally from west to east. Bents, or piers, are numbered incrementally from south to north.

Figure 3.1 Three-Span Continuous Portion of War Memorial Bridge

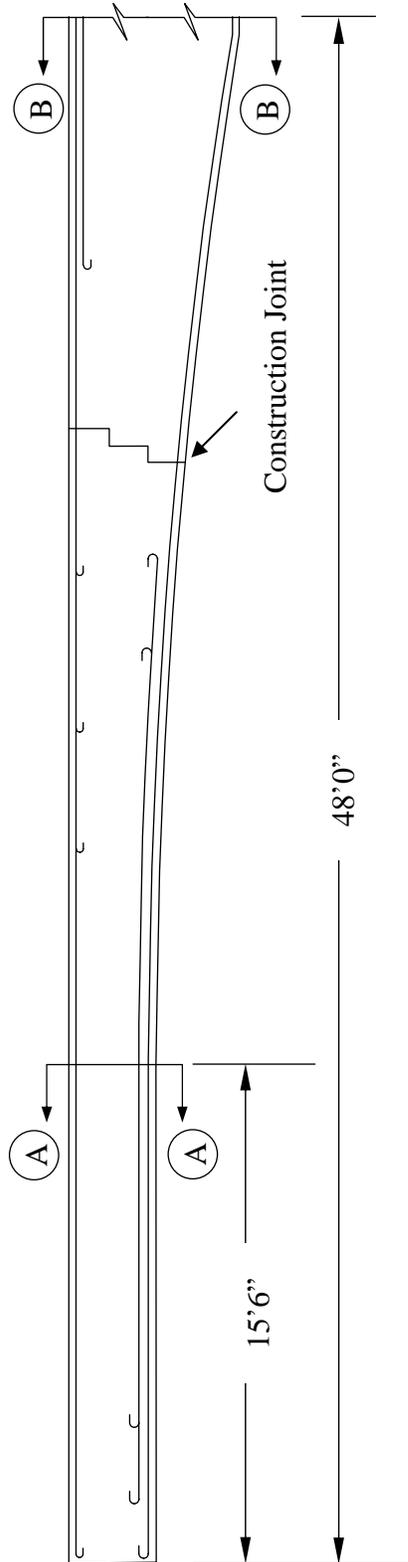
Figure 3.2 Typical End Span

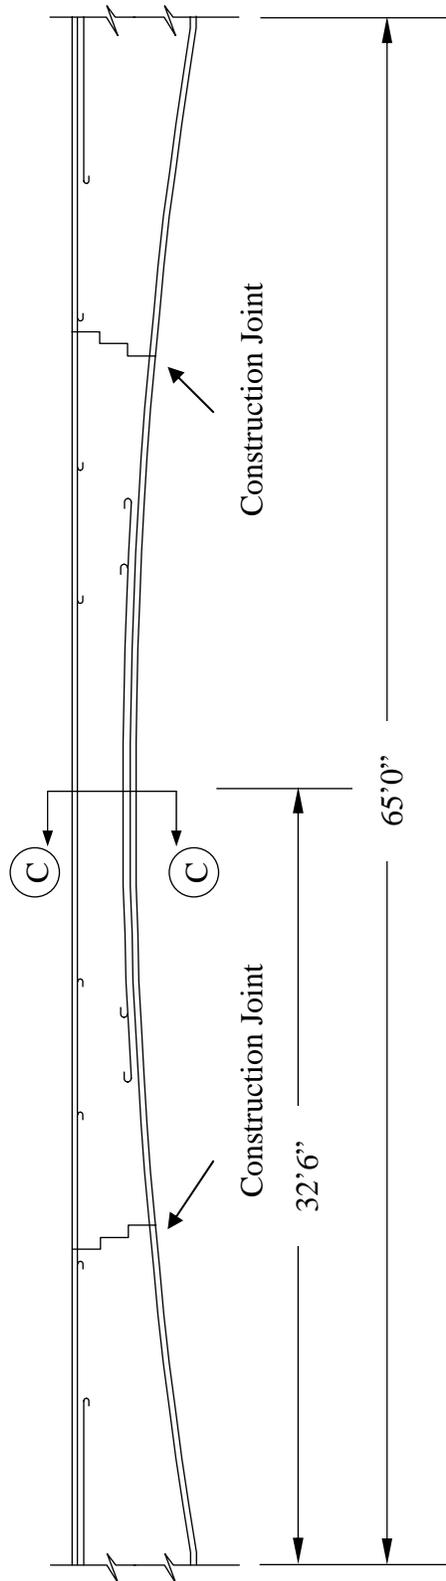
Figure 3.3 Typical Center Span

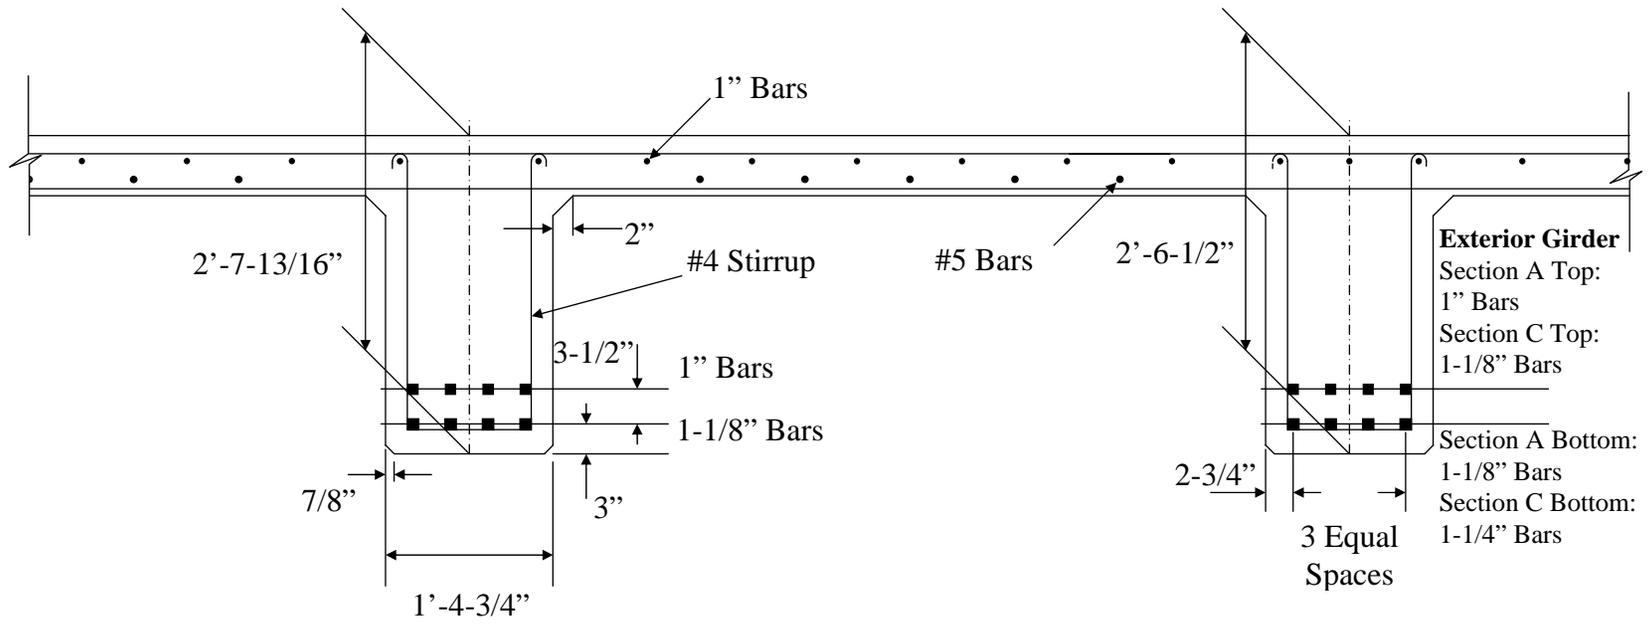
The four variable-depth T-beams are spaced at 88 in. center-to-center and support a 6-in. thick bridge deck. Positive moment reinforcement consists of one to two layers of deformed steel bars. For a typical exterior girder, the bottom layer consists of four 1-1/8 in. or 1-1/4 in. square bars depending on location. For a typical interior girder, the bottom layer consists of four 1-1/8 in. square bars. For both exterior and interior girders, the top layer of steel consists of up to four 1 in. or 1-1/8 in. square bars, depending on location within the span. Half cross sections for Sections A, B, and C (as located in Figure 3.2 and Figure 3.3) are shown in Figure 3.4 and Figure 3.5. All reinforcing steel bars are deformed bars. The yield stress, f_y , of the steel was taken from the Manual for Condition Evaluation of Bridges (AASHTO 1994) as 33,000 psi for bridges built prior to 1954.

Figure 3.4 Cross Sections A and C
 (Refer to Figures 3.2 and 3.3 for Cross Section Locations)

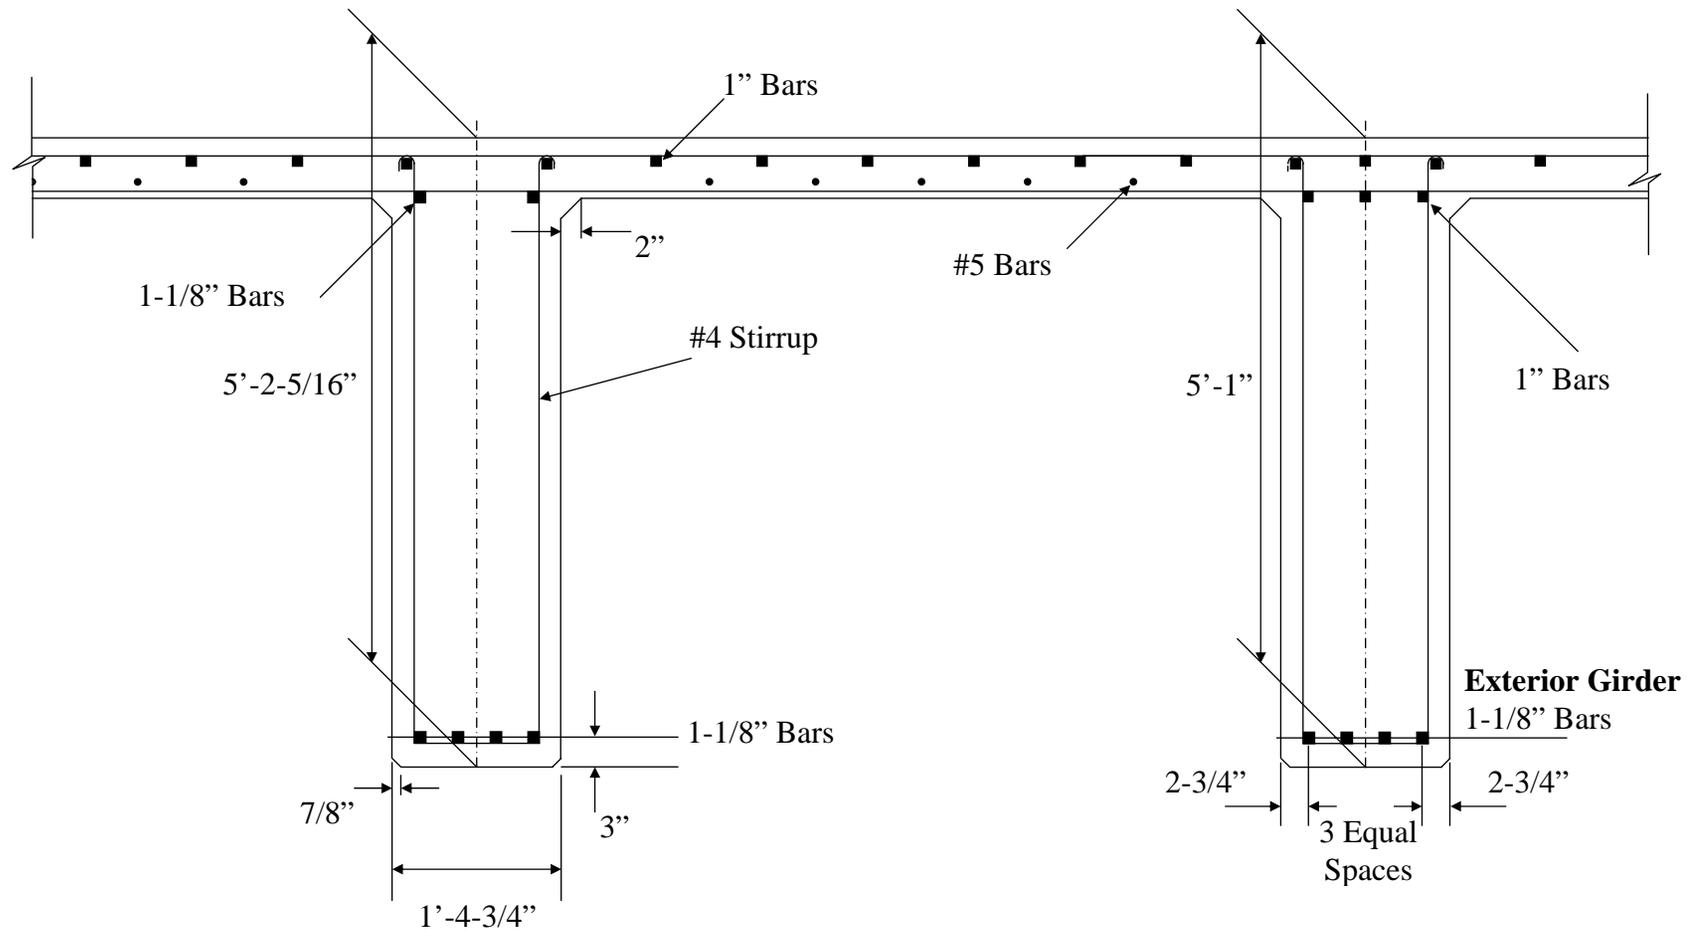
Figure 3.5 Cross Section B
 (Refer to Figures 3.2 and 3.3 for Cross Section Locations)

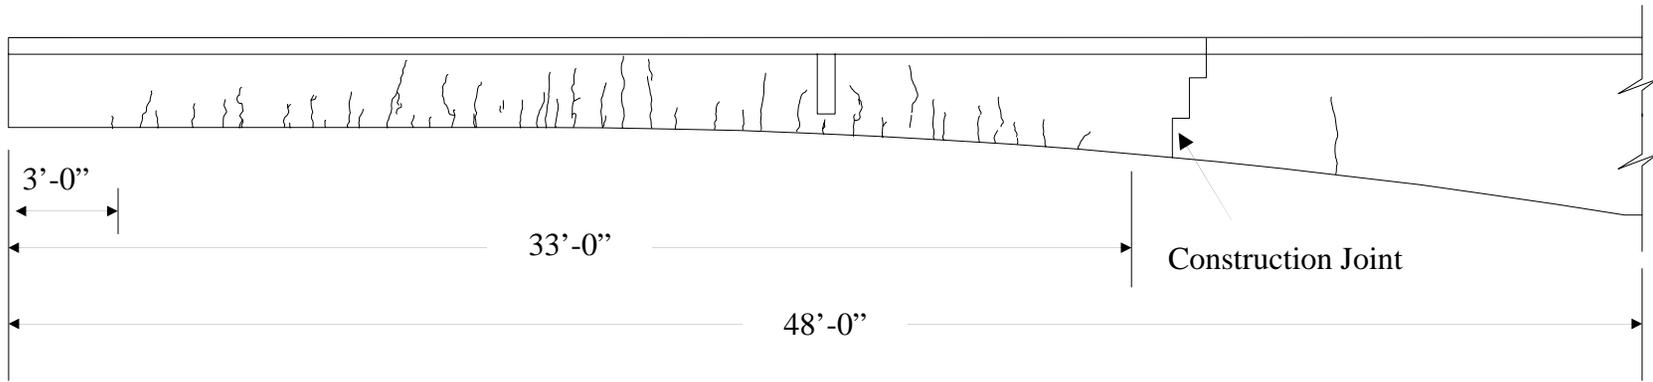
Cracks in the end spans exhibited similar patterns on both exterior and interior girders. Cracks in these spans are located within a region of approximately 3 ft to 33 ft from the simply supported end of the girders (Figure 3.6). In these regions, the average horizontal spacing between cracks on each girder ranges from roughly 9 in. to 12 in.

Figure 3.6 Crack Pattern for Typical End Girder

Typical construction joints can be seen in the girders in Figure 3.6 and Figure 3.7. Cracking was present at the construction joints, and they were epoxy injected in order to prevent further introduction of contaminants through those cracks.

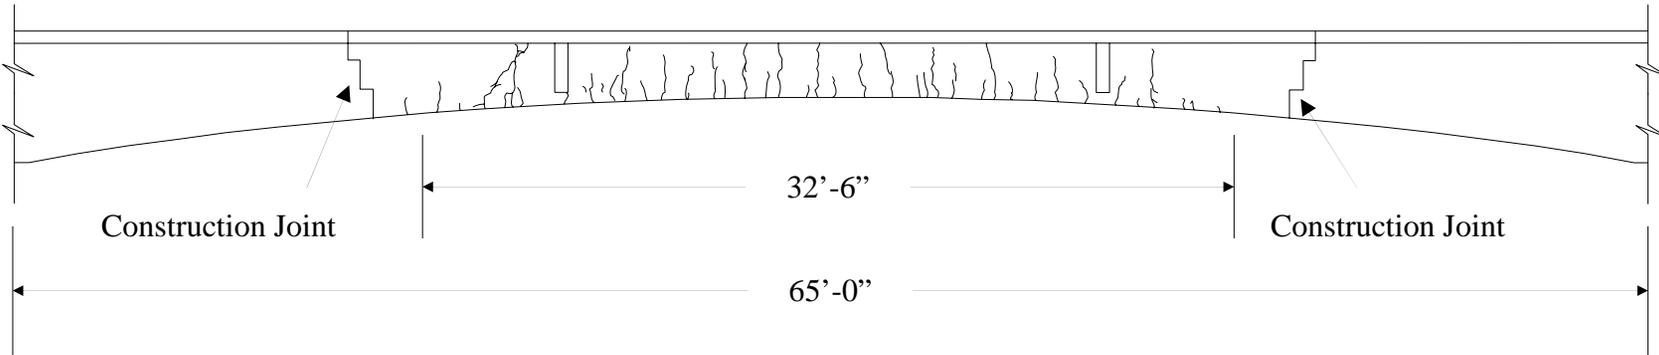
Cracks in the center span exhibited similar patterns on both exterior and interior girders. Cracks in this span are primarily located in the middle 50 percent of the span with the average distance between horizontal cracks ranging from approximately 8 in. to 10 in. (Figure 3.7).

Figure 3.7 Crack Pattern for Typical Center Girder

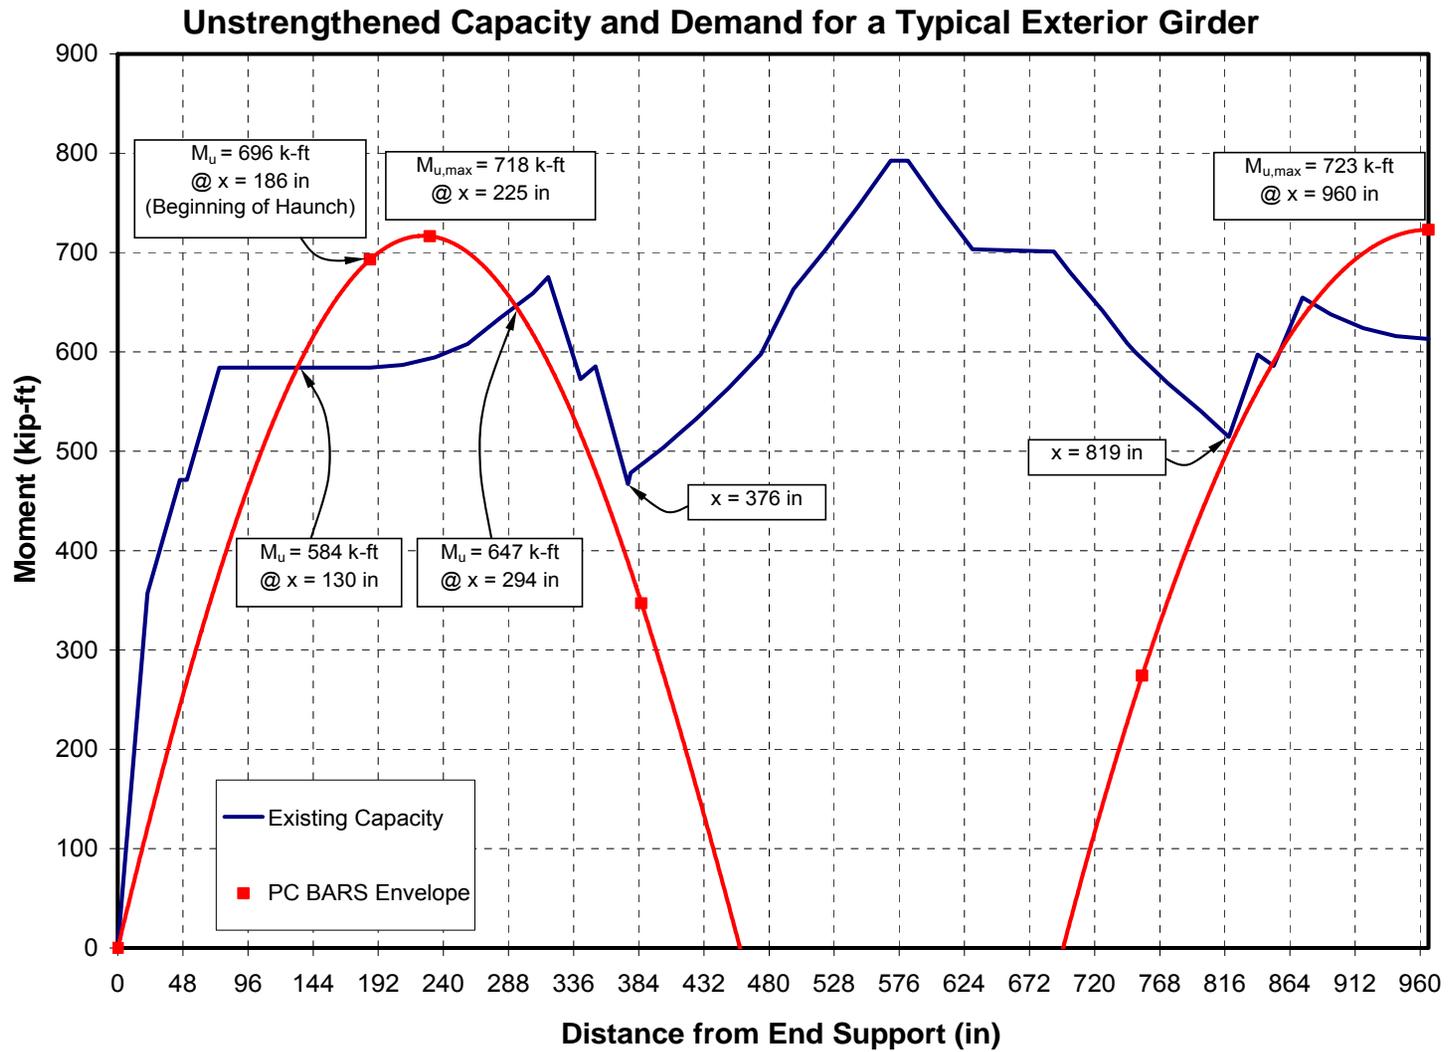
The locations at which load effects exceed the capacity in Figure 3.8 and Figure 3.9 indicate deficient regions. Thus, these regions require positive moment strengthening. The design and application of the FRP composite to the deficient regions is presented in Chapter Four.

Figure 3.8 Unstrengthened Capacity and Demand for a Typical Exterior Girder

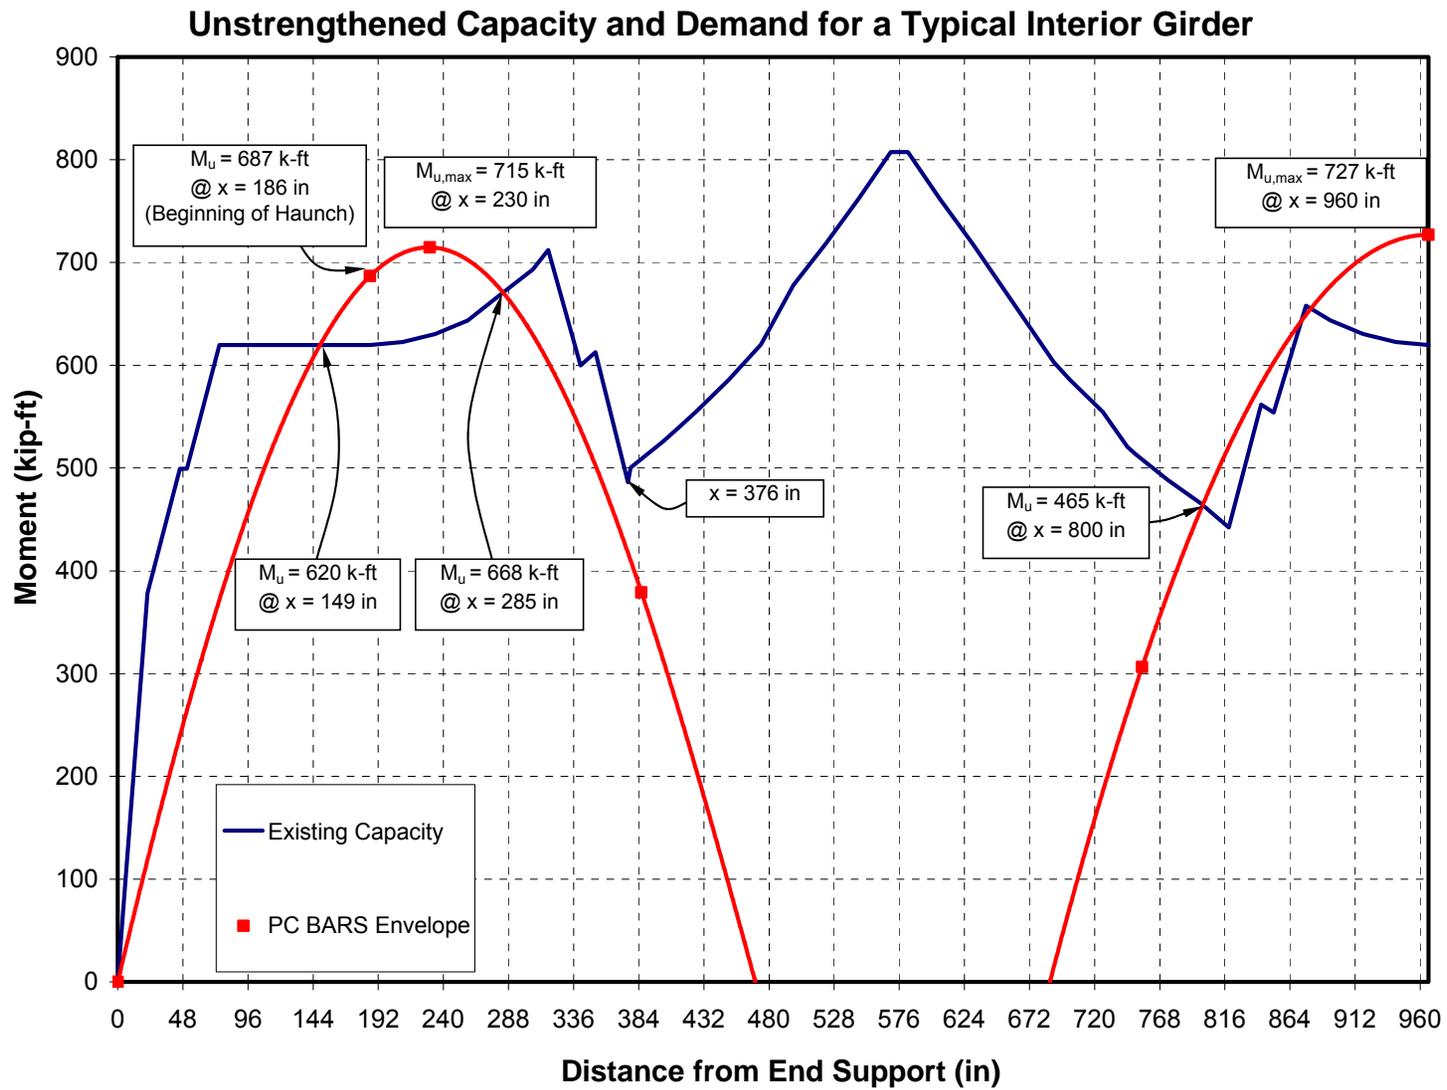
Figure 3.9 Unstrengthened Capacity and Demand for a Typical Interior Girder

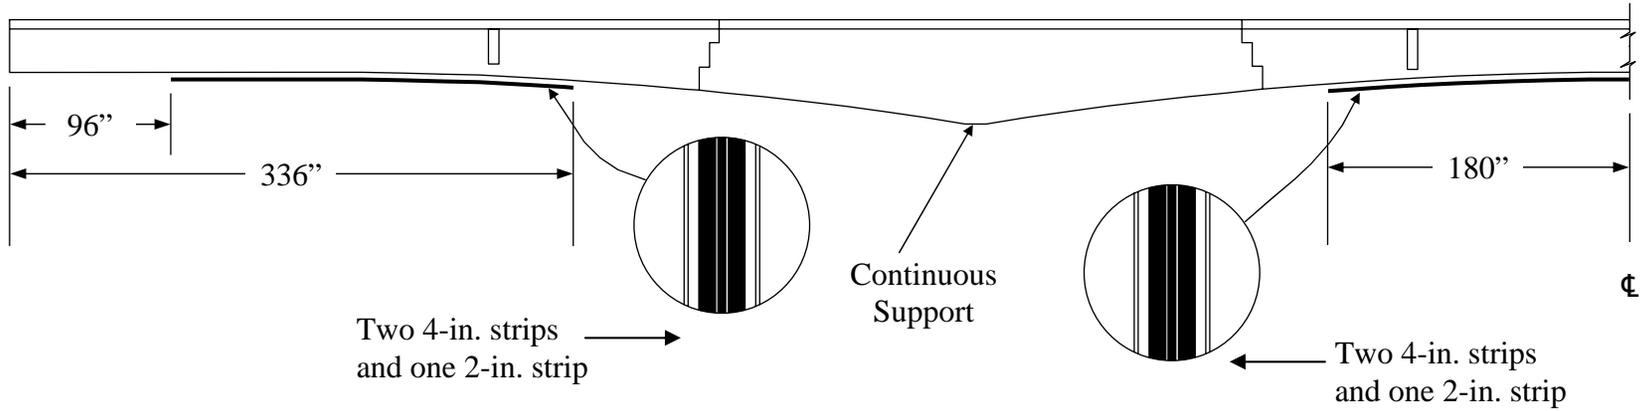
For an exterior girder, a 10-in.-wide section comprised of two 4-in. strips and one 2-in. strip was required. For end spans, the strips extended between points located 96 in. and 336 in. from the end of the bridge. For the center span, the exterior girder strips extended 180 in. on each side of midspan. For each interior girder, an 8-in.-wide section comprised of two 4-in. strips was required. For end spans, the strips extended between points located 116 in. and 320 in. from the end of the bridge. For the center span, interior girder strips extended 204 in. on each side of midspan. The installation of the composite is discussed in the following sections.

Figure 4.1 Location of Composite on Typical Exterior Girder

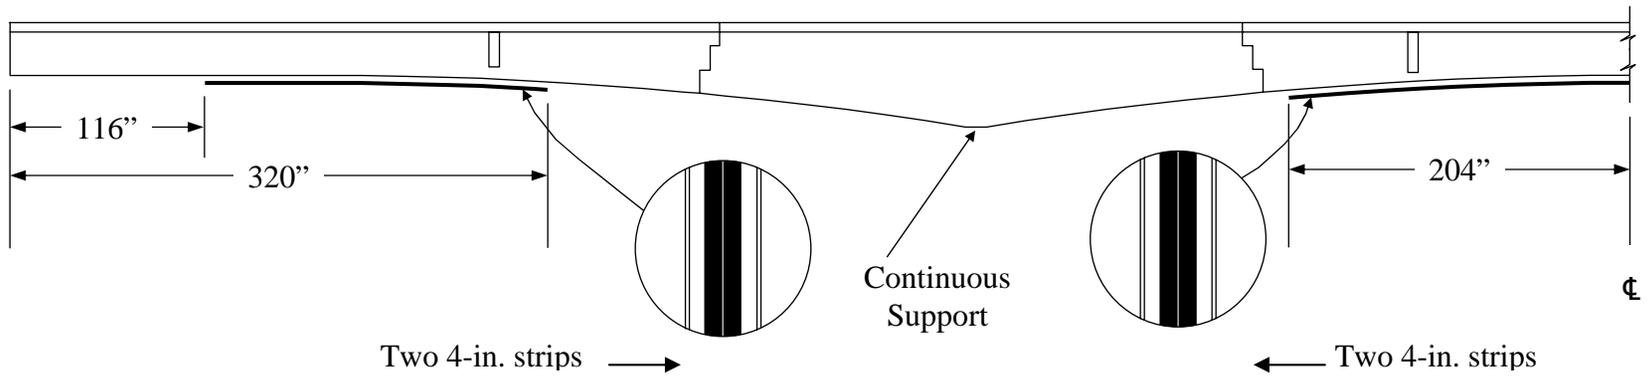
Figure 4.2 Location of Composite on Typical Interior Girder

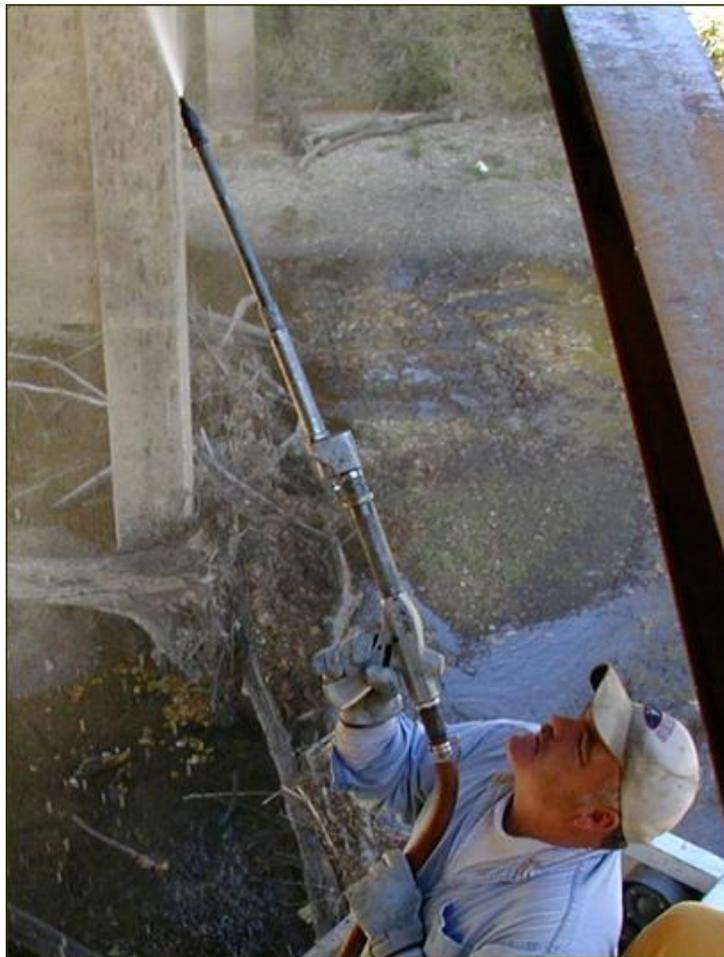
Figure 4.3 Hydroblasting the War Memorial Bridge

After surface profiling was complete, residual debris and dust that might have interfered with the composite bond to the girder surface were removed by water blasting, shown in Figure 4.3. Surfaces were allowed to dry completely before commencing subsequent stages of the FRP installation.

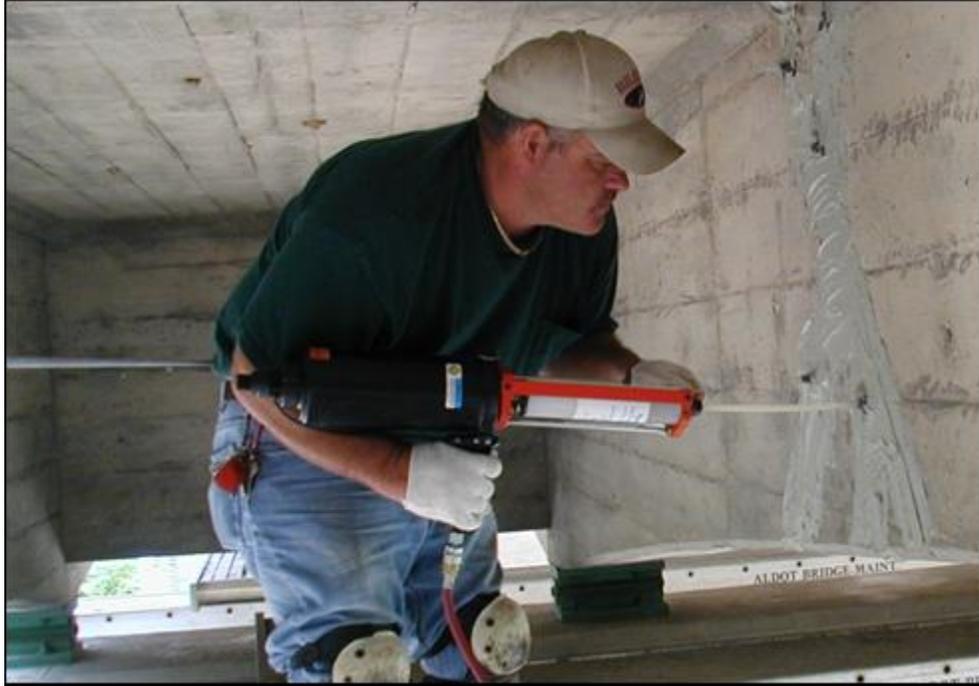
Figure 4.4 Crack Injection of the War Memorial Bridge

The ACI Committee 224 (1993) recommended procedure for epoxy injection consists of installing injection ports at close intervals, sealing the crack along its length and around the port, and pressure injecting epoxy into the cracks. The same procedure can be used for crack groups and construction joints. Injection of a crack group is shown in Figure 4.4. First, the crack surface was sealed along the crack length on both sides of the girder. Venting ports were installed every 6–8 in. along the length of the crack. The ports were bonded flush with the surface of the concrete and sealed around the base. Seals were allowed to harden for 24 hours before injection. Injection was performed by mechanical means from both sides of the girder starting at the bottom port. Once epoxy became visible in the port immediately above the port being injected, the port being injected was capped. Injection then began in the port immediately above. This procedure continued until all ports were injected.

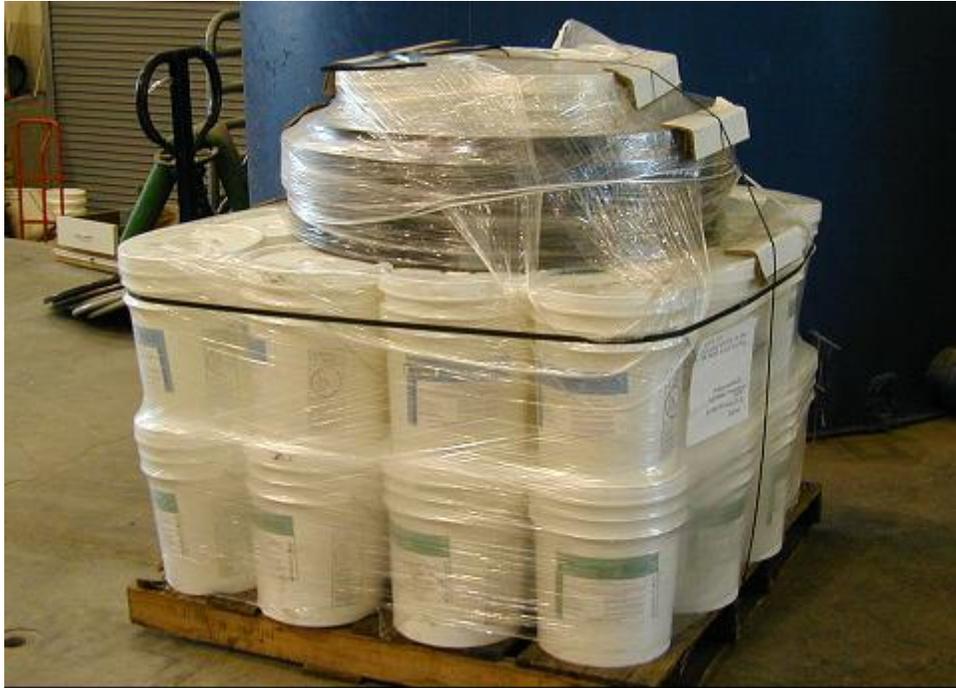
Figure 4.5 FRP System Components, Shown as Shipped

All FRP preparation was performed on site. Composite strips were unrolled, and strips were cut to required lengths using a circular saw with a carbide-tipped blade. To prevent the composite from splitting or fraying during cutting, the ends of the FRP strips were temporarily wrapped in duct tape. Once cut, the abraded (lackluster) side of the composite was thoroughly cleaned with lint-free rags soaked in acetone or methyl-ethyl-ketone (MEK). The cleaning solvent was allowed to dry thoroughly before proceeding with the application.

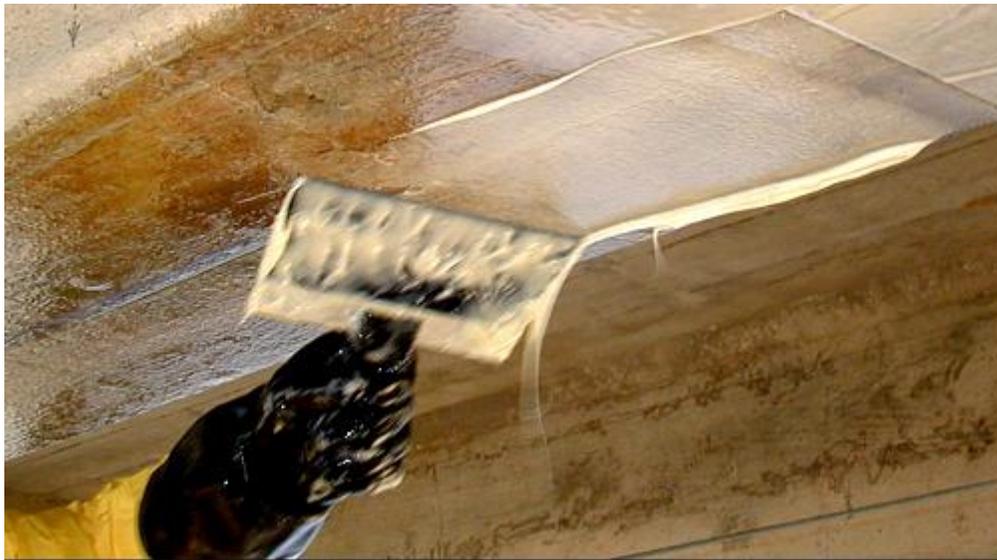
Figure 4.6 Application of Tyfo TC Epoxy Using an 8-inch Taping Knife

application procedure was to use an 8-in. taping knife to apply epoxy to the girder soffit as shown in Figure 4.6. The thickness of the application was controlled by finishing the surface with a V-notched trowel with a 3/16-in. notch depth. This method resulted in an initial (3/32-in. average) thickness 50 percent larger than the thickness recommended. While this was greater than specified, it compensated for slightly less epoxy than specified being applied to the FRP strips (described below) and proved to be the ideal application method. This method was used for application of Tyfo TC Epoxy to all but the first girder.

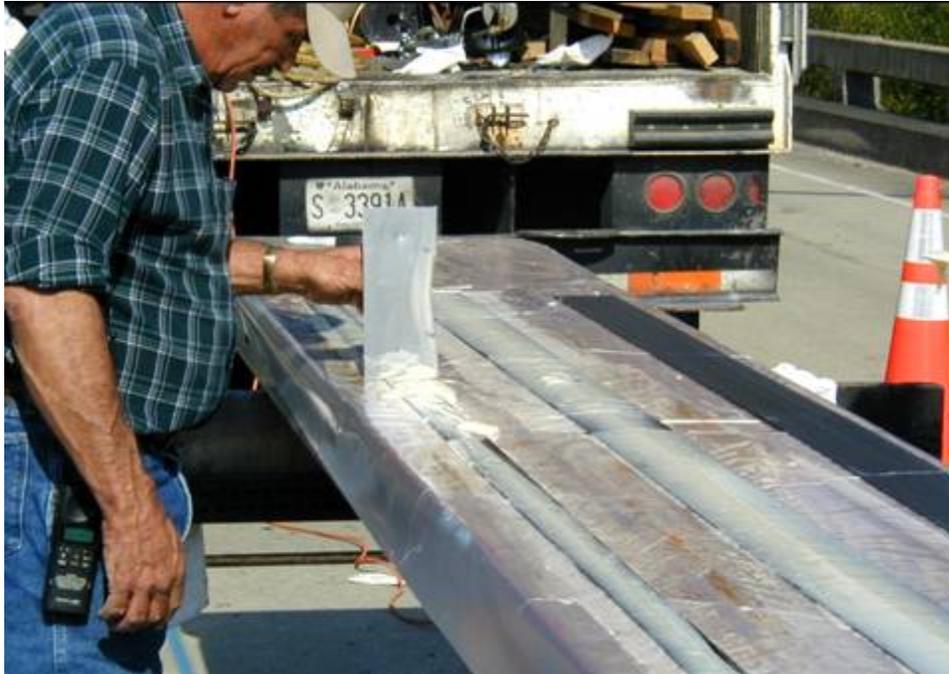
Figure 4.7 Application of Tyfo TC Epoxy to the Composite Strip

Application of epoxy to the FRP composite was performed on the bridge deck. Preparation of the composite—including measuring, cutting, and cleaning the composite surface—was completed before epoxy application. After the cleaning solvent had evaporated, Tyfo TC Epoxy was applied to the surface of the composite as depicted in Figure 4.7. A minimum thickness of 1/16 in. was recommended. Tyfo TC Epoxy was applied with a modified V-notched trowel like the one shown in Figure 4.8. The trowels were modified by cutting V-shaped notches of 1/8-in. depth at the peak and tapering to 1/16-in. depth at the edges. This was done for both 2- and 4-in. strip application. Use of this tool resulted in slightly less than 1/16 in. epoxy thickness. However, the recommended amount of epoxy was applied in combination with the Tyfo TC Epoxy on the strip and girder.

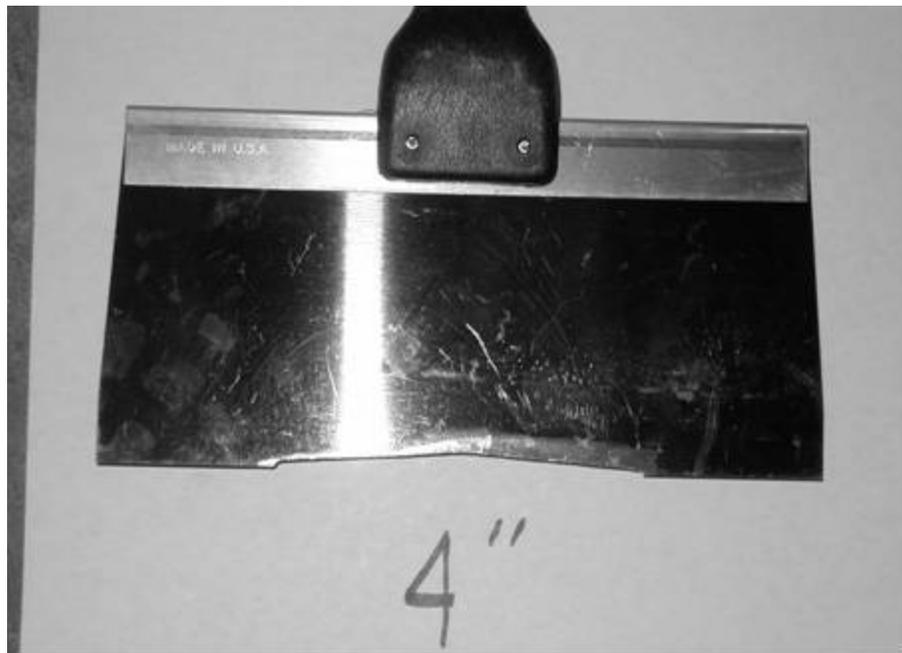
Figure 4.8 Modified 4-inch V-notched Trowel

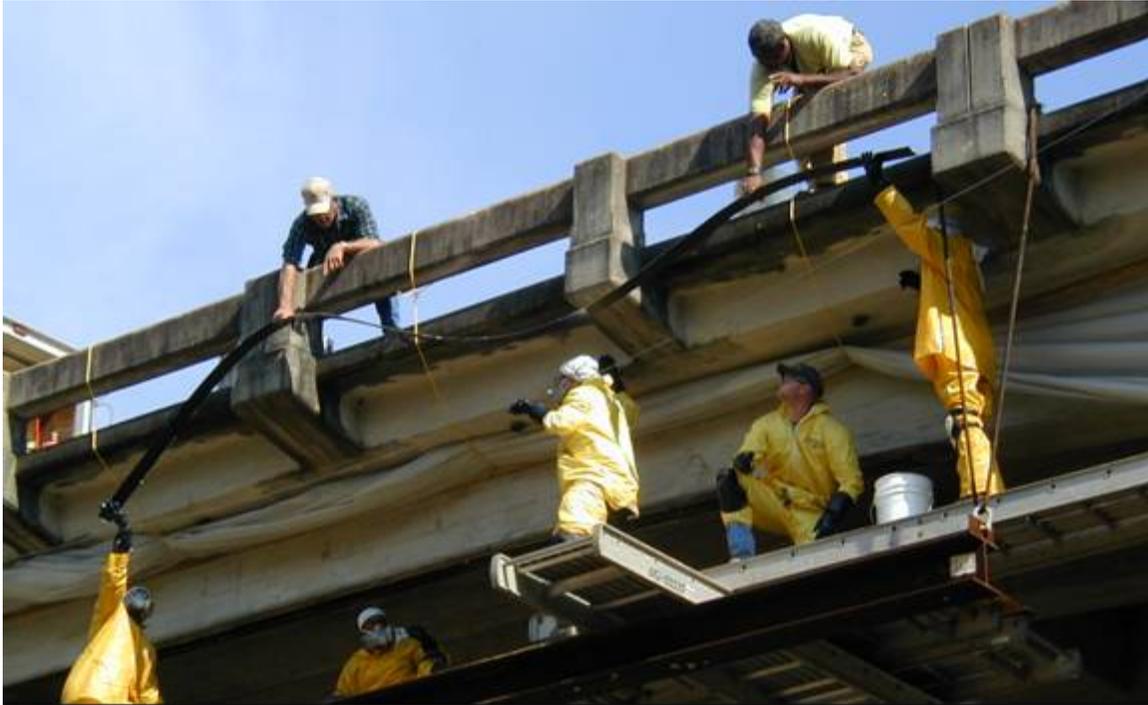
Figure 4.9 Transfer of Epoxy-Coated Strip from Bridge Deck to Scaffolding

once it was placed. Personnel on the bridge deck handed the epoxy-coated strip over the deck railing to workers on the scaffolding below as shown in Figure 4.9.

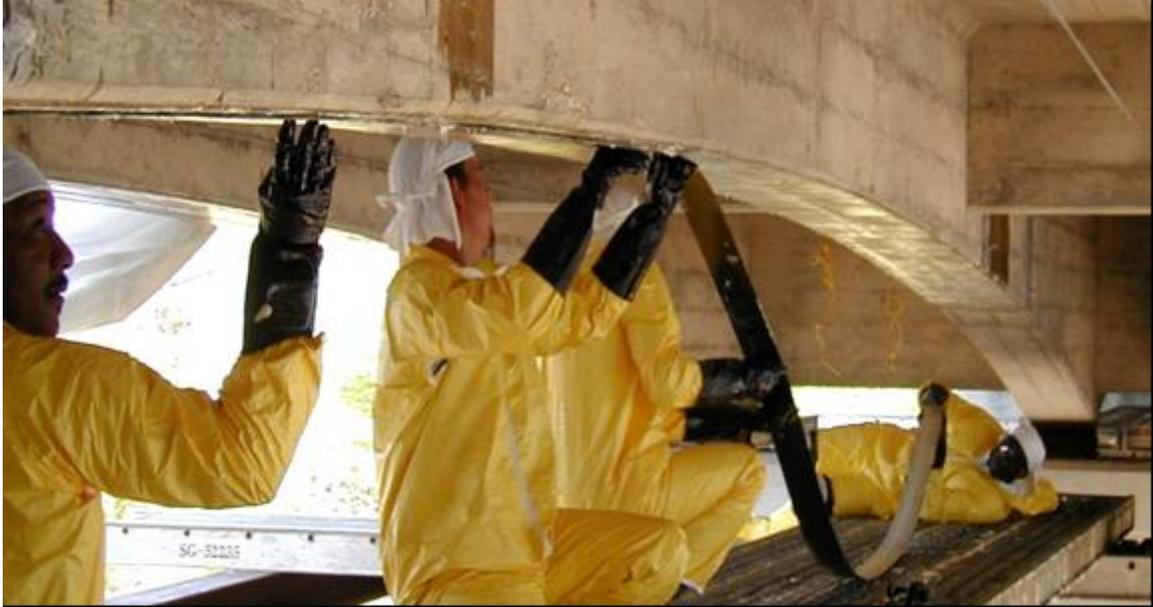
Figure 4.10 Application of the Composite Strip to a Girder

After placing and aligning the FRP strip, excess epoxy was troweled off the surface of the composite using firm pressure. Next, the composite was seated along its length using a 3-in. J-roller. Figure 4.11 shows the seating of an FRP strip using a J-roller. A firm back-and-forth motion was employed to guarantee complete contact and remove any voids beneath the surface of the strip. For aesthetic purposes, the composite surface was finished by a final removal of excess epoxy with a trowel. Subsequent visual inspection of the composite edges was performed to check for voids. If voids were indeed present along these edges, excess Tyfo TC Epoxy from the girder soffit was utilized to fill them.

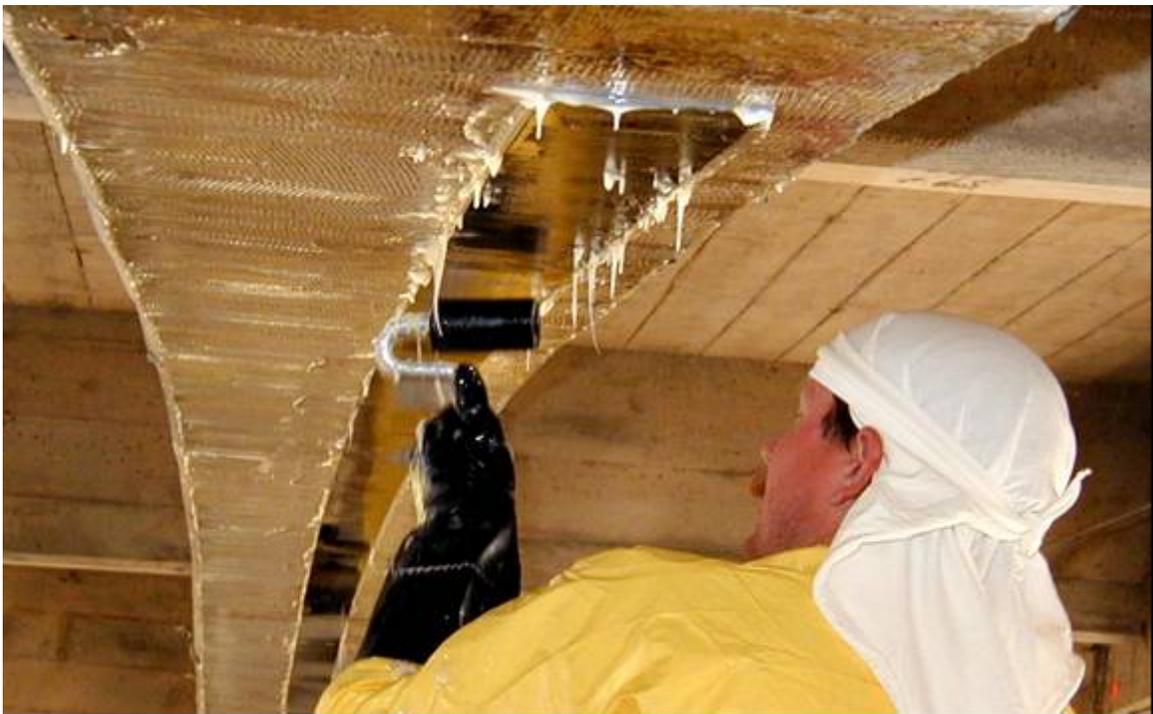
Figure 4.11 Seating an FRP Strip Using a J-Roller

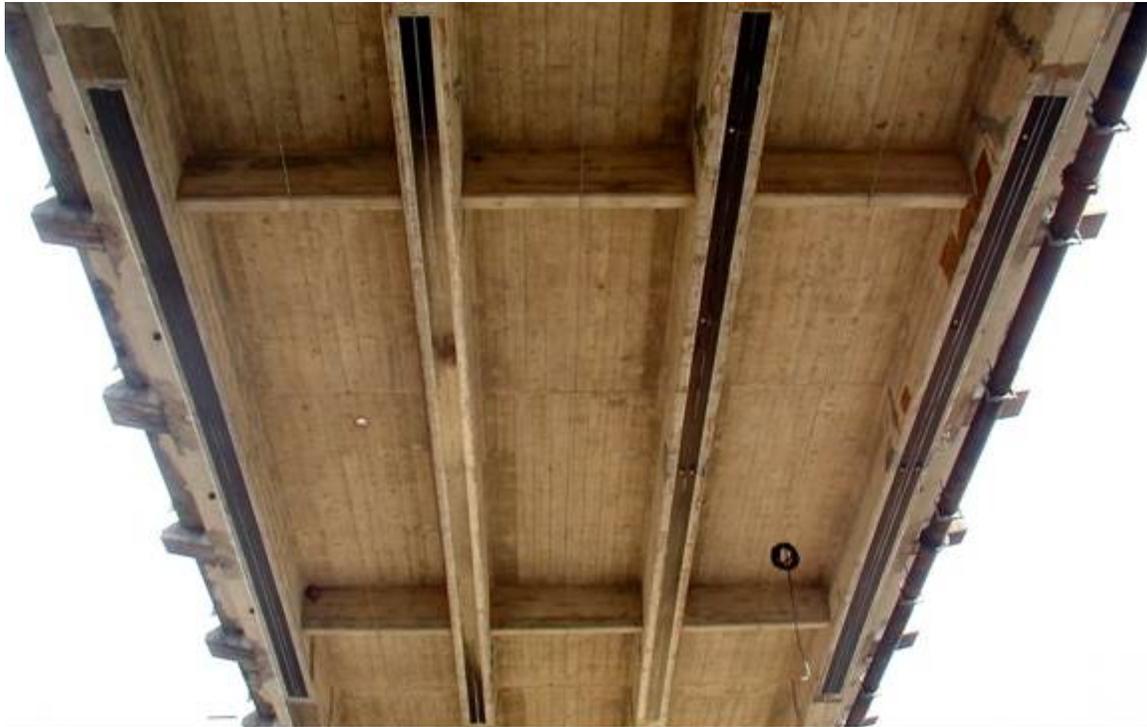
Figure 4.12 Completed Installation of Composite to Center Span Girders

The installation of composite to a typical interior girder consisted of two Tyfo 4UC55 Strips resulting in an eight-inch total width. The two 4-in. strips were centered on the girder soffit again leaving a gap of approximately 1/16–1/8 in. between strips. Figure 4.12 shows the finished installation of the Tyfo UC Composite to the soffit of the center span girders.

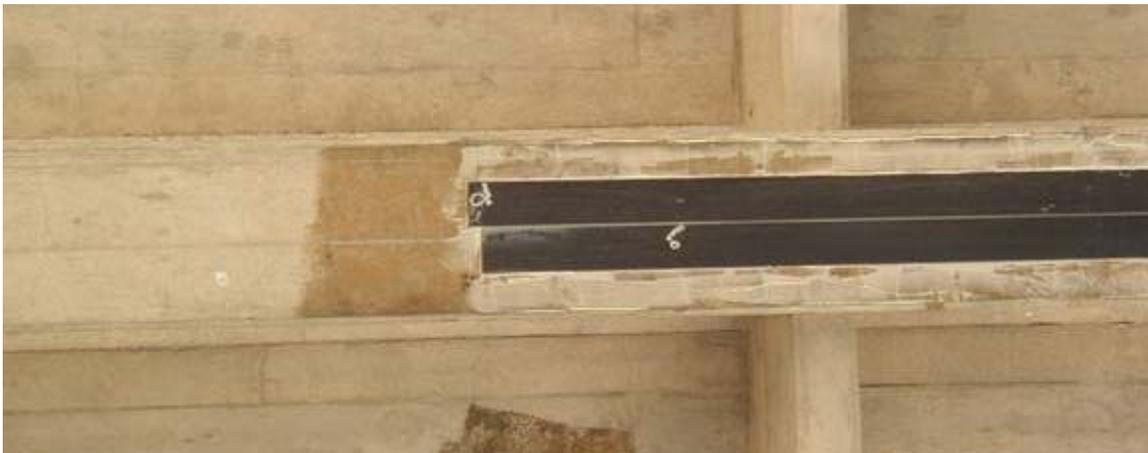
Once FRP composite had been installed on all girders, the FRP was inspected for bond quality. Researchers accomplished this by searching for any voids and determining their size related to surface area. A void is defined as a location between the FRP composite and concrete substrate that was not filled with epoxy during installation through air being present or other mechanism. ACI Committee 440 (2002) recommends guidelines for evaluation of wet lay FRP systems. Voids less than 2 in² are acceptable, provided that the total void surface area is less than 5 percent of the total bonded area and the frequency is less than 10 voids per 10 ft². Based on these guidelines, the integrity of the system was evaluated with the tap test. The tap test is a method for locating voids or delaminations based upon the sound produced when the composite surface is struck with a blunt object. A U.S. quarter-dollar coin was used to tap the surface of all FRP composite installed on the girders. When tapped, an air void beneath the surface of the composite will produce a hollow sound. The results of the tap test proved that less than 0.1 percent of the evaluated surface area contained air voids. Small voids beneath the composite surface detected by the tap test are indicated in Figure 4.13. The largest void measured was approximately 3–4 in². While larger than recommended, this single void should not have significantly affected the overall performance of the composite system as it lay within a few inches of the end of the FRP strip. Based on tap test results, repairs to the installed FRP were deemed unnecessary.

Figure 4.13 Voids (Marked with White Circles) on FRP
