Final Report RP-930-466-2

**REPAIR OF THE UPHAPEE CREEK BRIDGE WITH FRP
LAMINATES**

Alabama Department of Transportation
Research Project 930-466
Montgomery, Alabama

November 2005

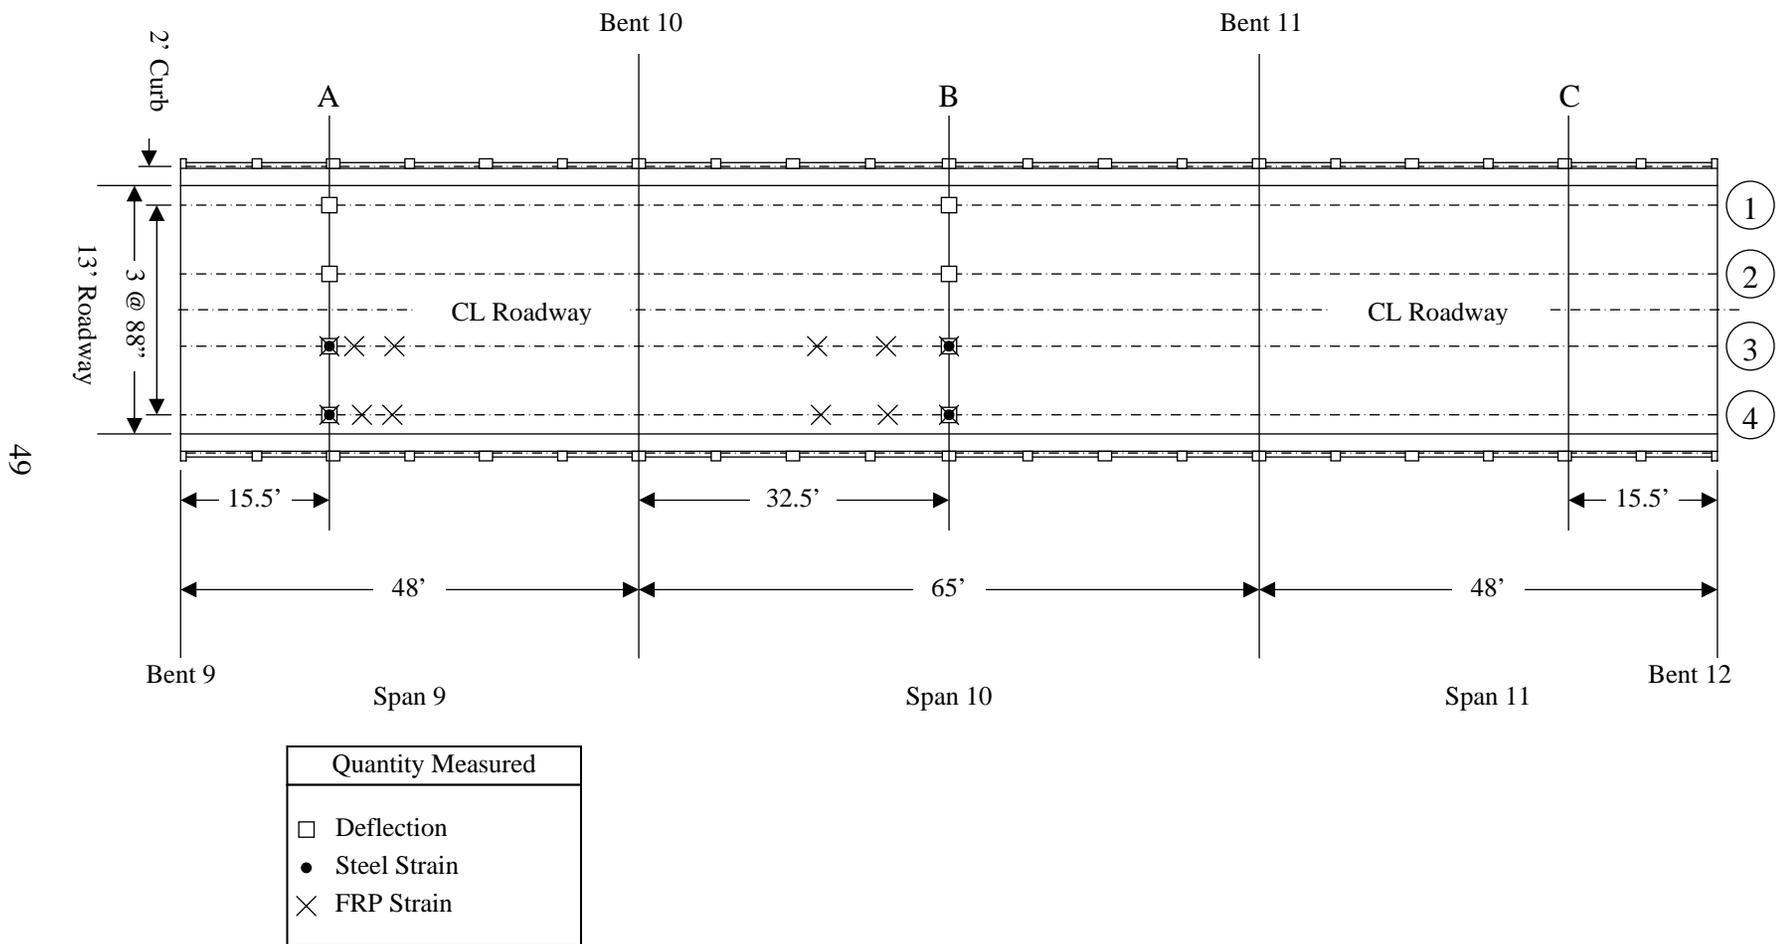
Figure 5.1 Plan View with Sensor Locations

Locations of steel strain gauges are shown in Figure 5.1. For both instrumented girders in Span 9, the location of the critical design section was 186 in. from the noncontinuous end of the bridge. For both instrumented girders in Span 10, the location of the critical design section was at midspan (966 in. from the end of the bridge). Figure 5.3 shows a typical strain gauge installation at the exposed layer of steel reinforcement. Each piece of bar was instrumented with one strain gauge at the critical location. Two redundant gauges were installed on the two interior bars, approximately 2 in. north of the critical locations. Figure 3.4 shows cross sections with reinforcing details for the 186 in. and 966 in. sections. After gauges were installed and coated, the sections were patched using Thoro Roadpatch DOT, a cement-based, fiber-reinforced, fast-setting repair material. This was done to protect the reinforcing steel, prepare for testing, and provide a smooth surface for FRP installation.

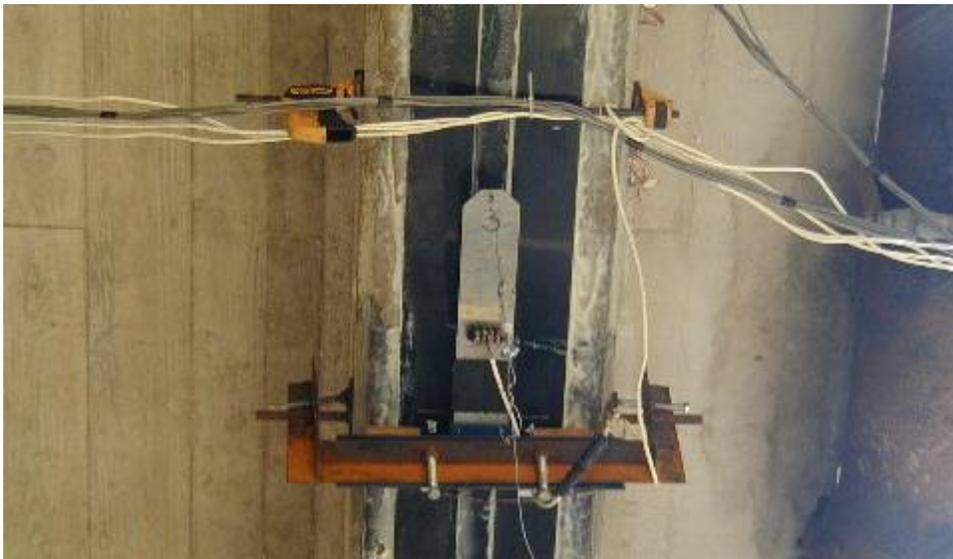
The deflectometers used were made of a tongue-like piece of aluminum attached to a steel bracket. A typical deflectometer installation at the critical section is shown in Figure 5.2. The bracket was attached to the girder soffit at the critical section—the point of interest for measuring deflections. The other end of the tongue was attached to a cable, and the cable was tensioned and attached to a tie-down point located directly below the tongue. Therefore, the tip end of the tongue remained relatively fixed when the bridge girder deflected. Four strain gauges were mounted on the tongue in a full-bridge, bending strain configuration. For each deflectometer, the output of this full-bridge circuit was calibrated in the laboratory to indicate the deflection of the bracket relative to the tip end of the tongue.

Figure 5.2 Typical Deflectometer Installation

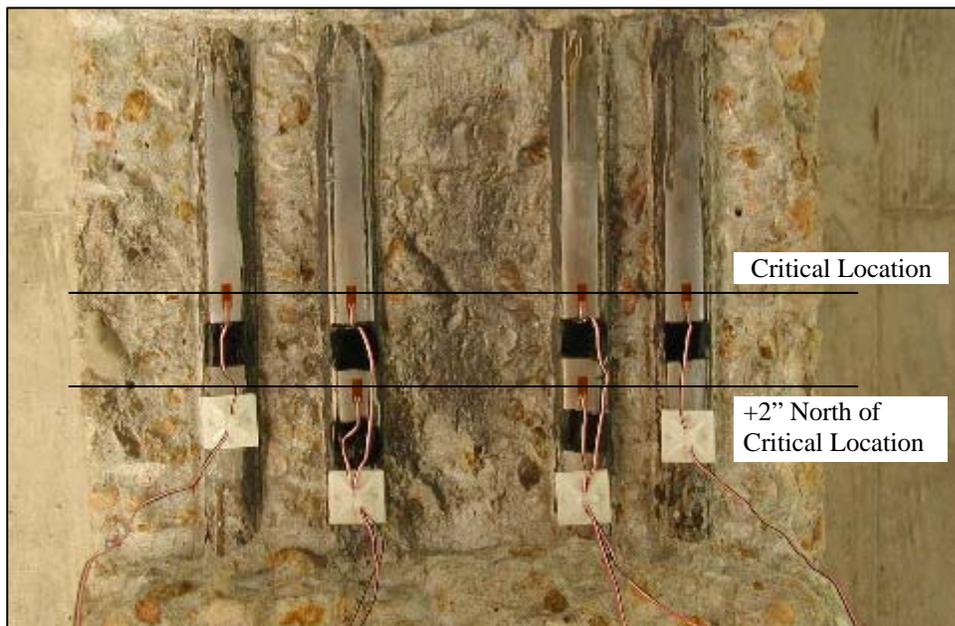
Figure 5.3 Typical Strain Gauge Installation to Steel Reinforcement

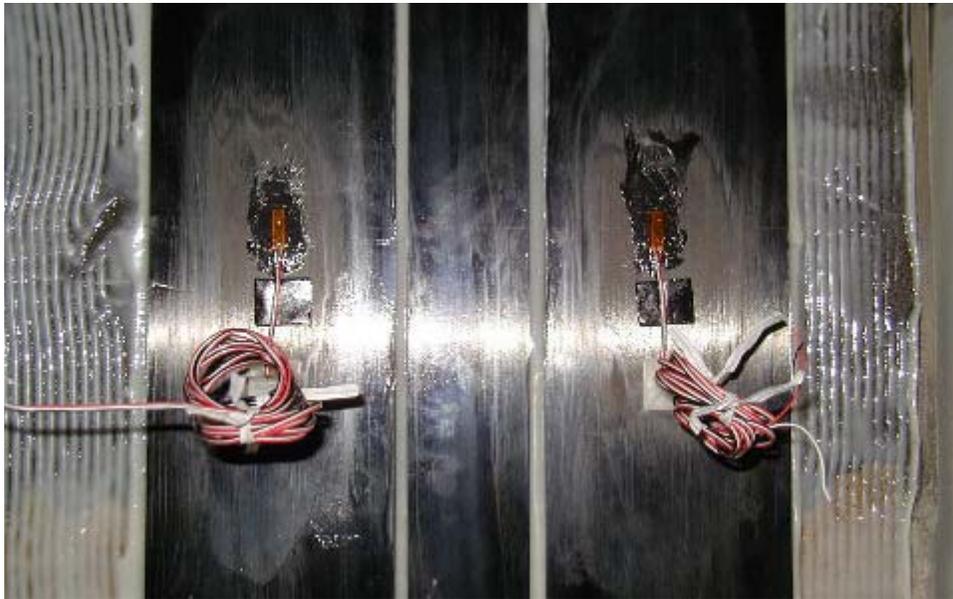
Figure 5.4 Typical Strain Gauge Installation to FRP Surface for Exterior Girder

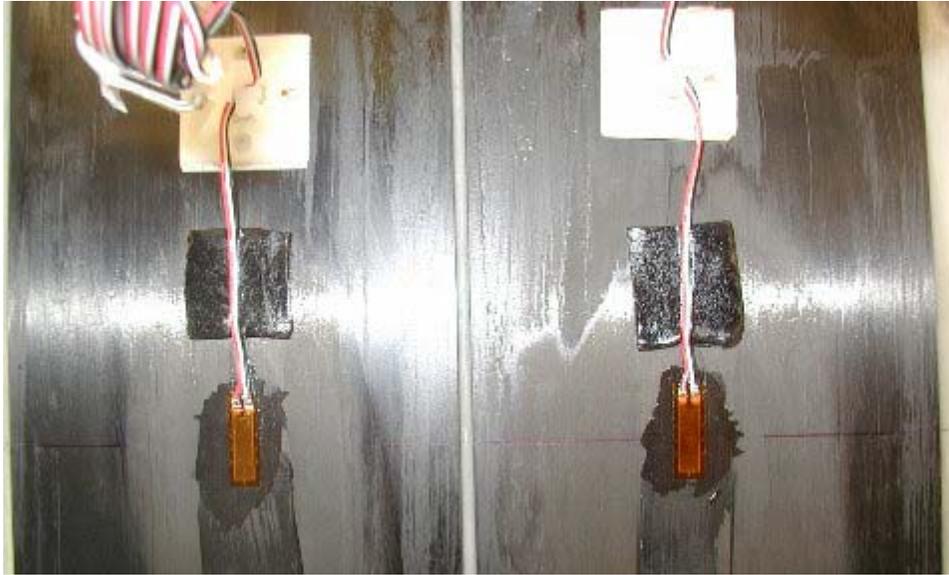
Figure 5.5 Typical Strain Gauge Installation to FRP Surface for Interior Girder

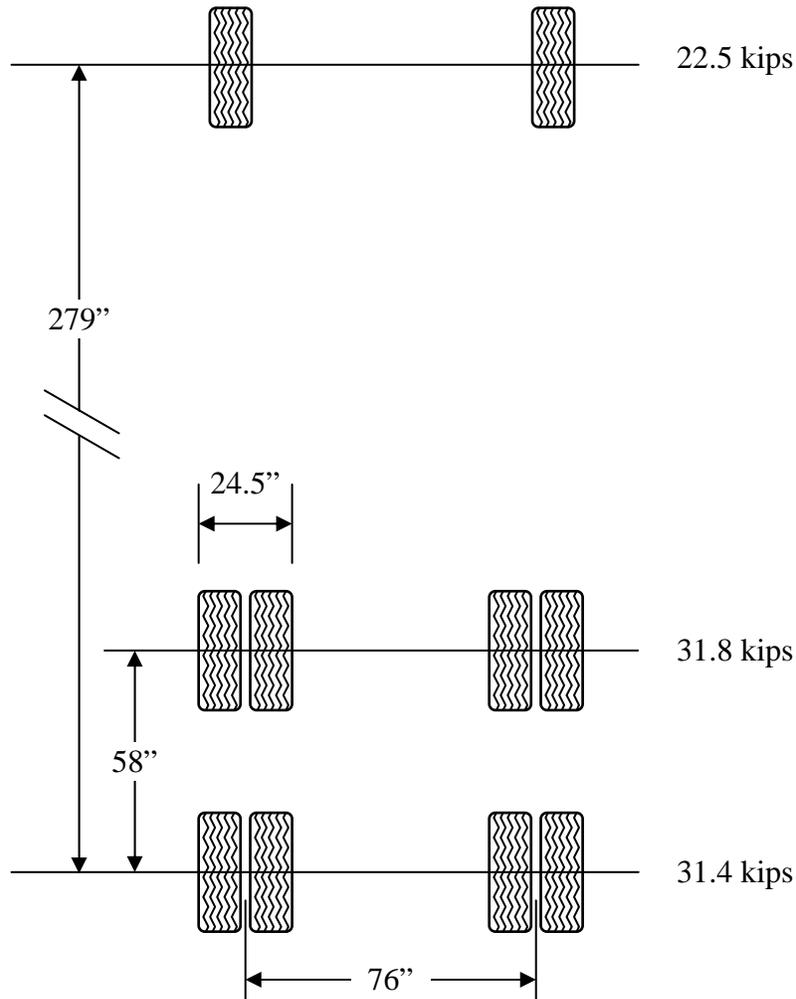
Figure 5.6 Weight and Axle Configuration for LC-5 Truck

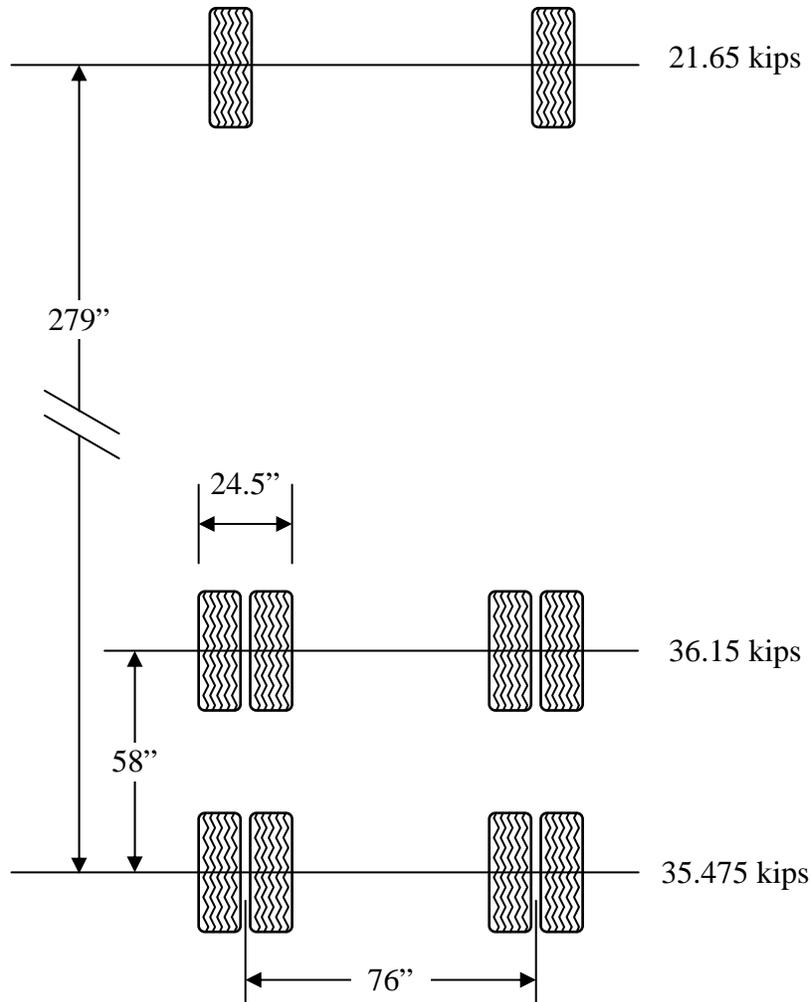
Figure 5.7 Weight and Axle Configuration for LC-6 Truck

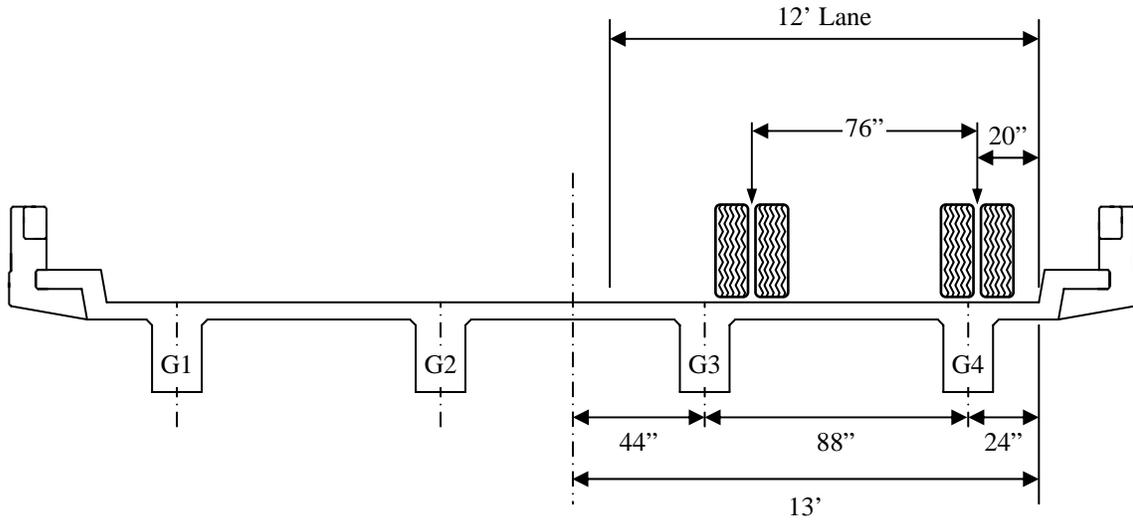
Figure 5.8 AASHTO Critical Loading for Girder 4 (AASHTO Old)

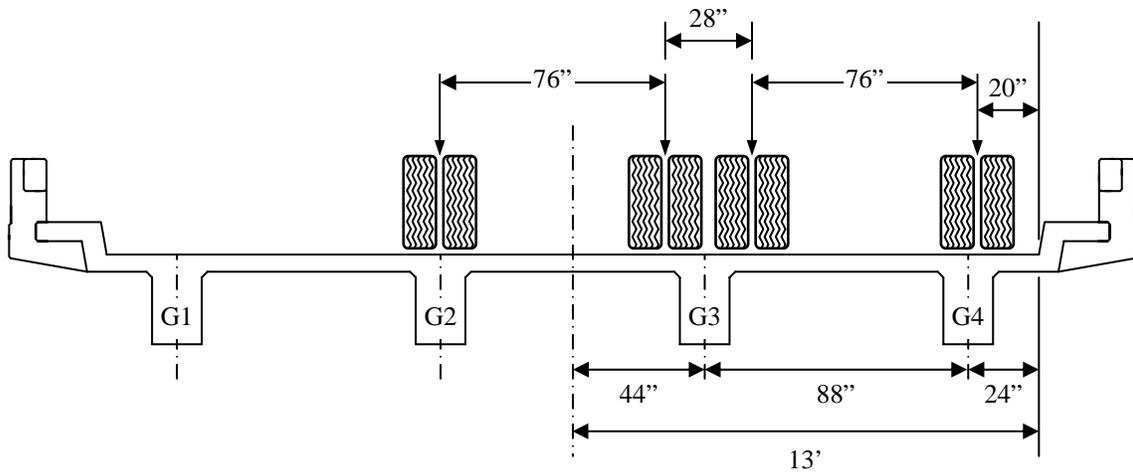
Figure 5.9 Worst-Case Critical Loading for Girder 4 (Tight)

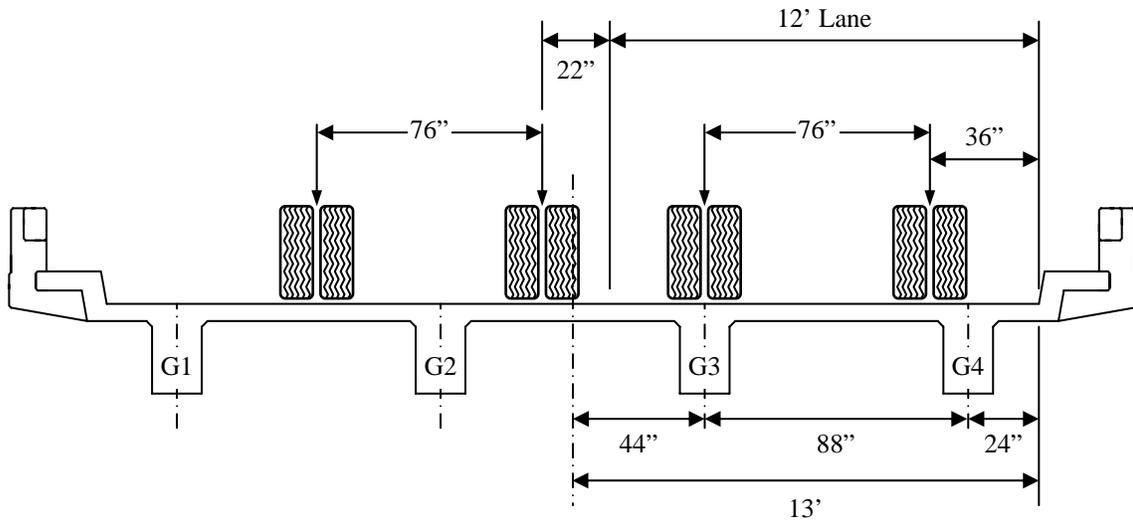
Figure 5.10 AASHTO Critical Loading for Girder 3 (AASHTO)

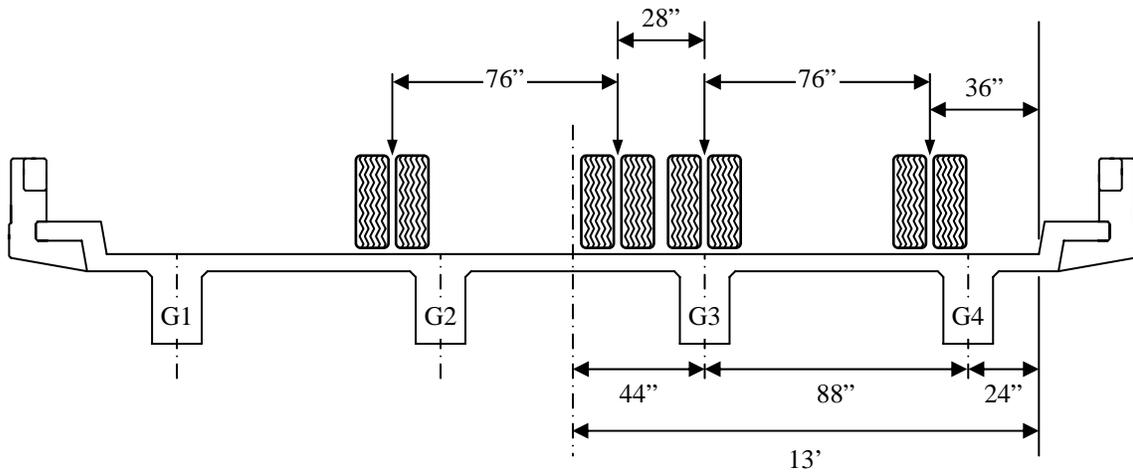
Figure 5.11 Worst-Case Critical Loading for Girder 3 (Tight)

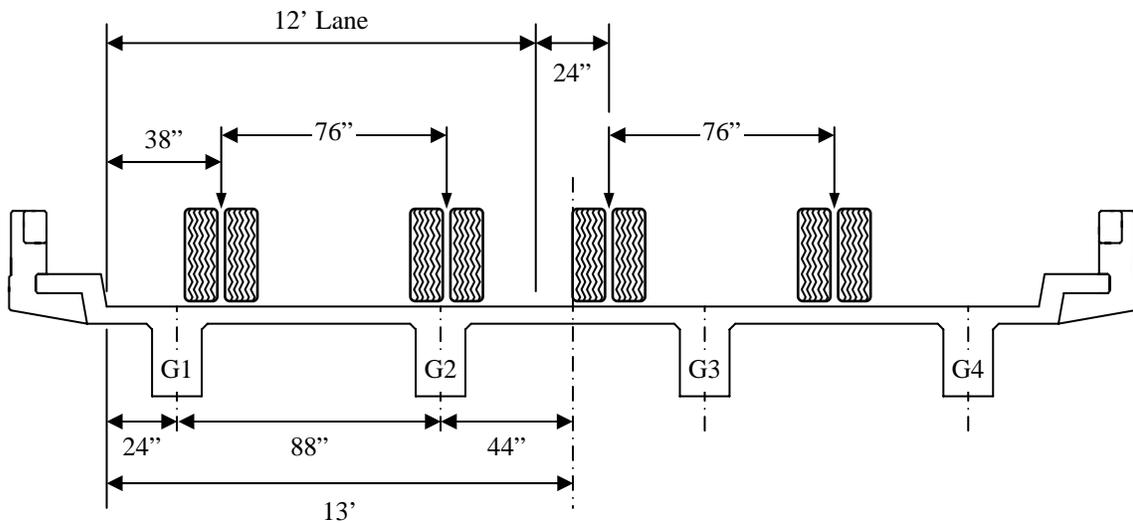
Figure 5.12 AASHTO Critical Loading for Girder 2 (AASHTO)

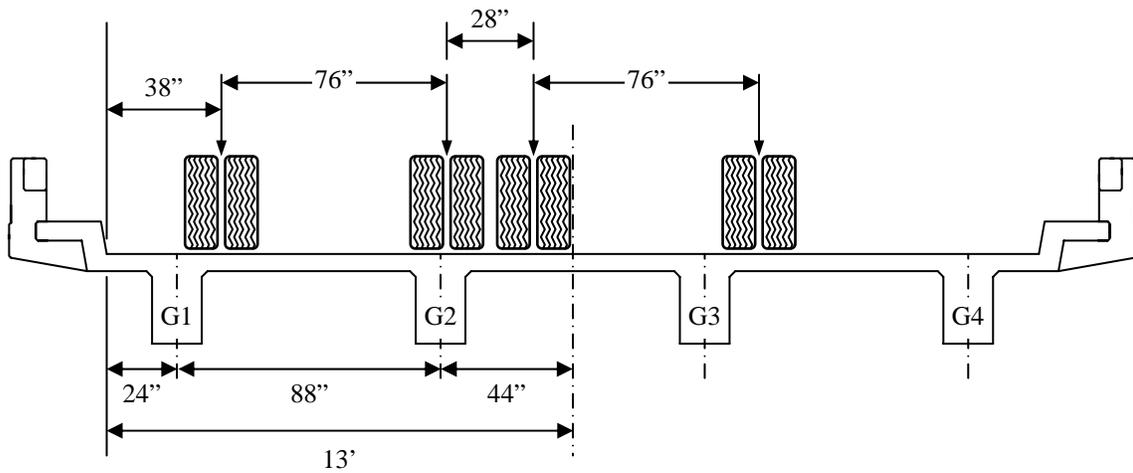
Figure 5.13 Worst-Case Critical Loading for Girder 2 (Tight)

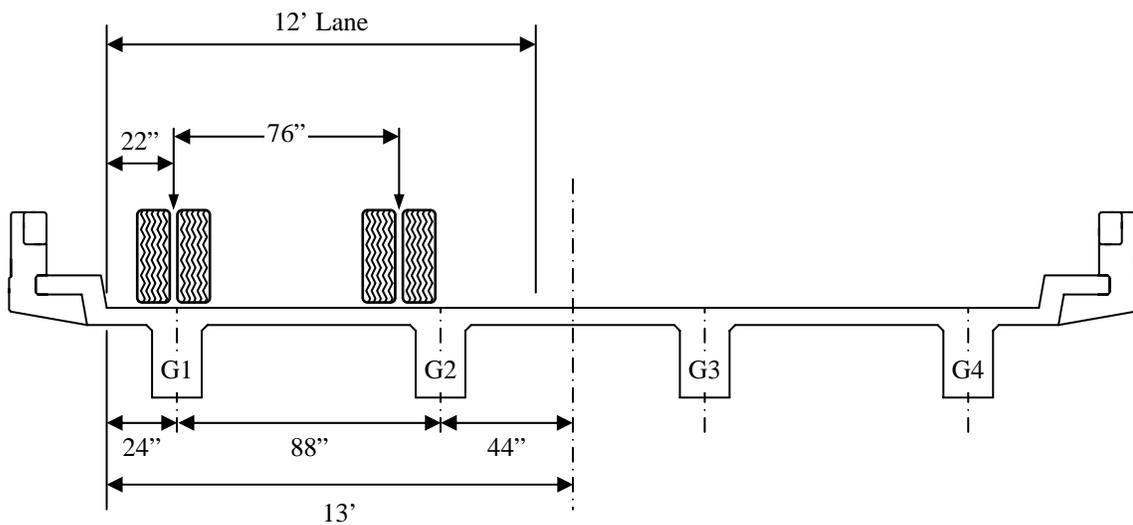
Figure 5.14 AASHTO Critical Loading for Girder 1 (AASHTO Old)

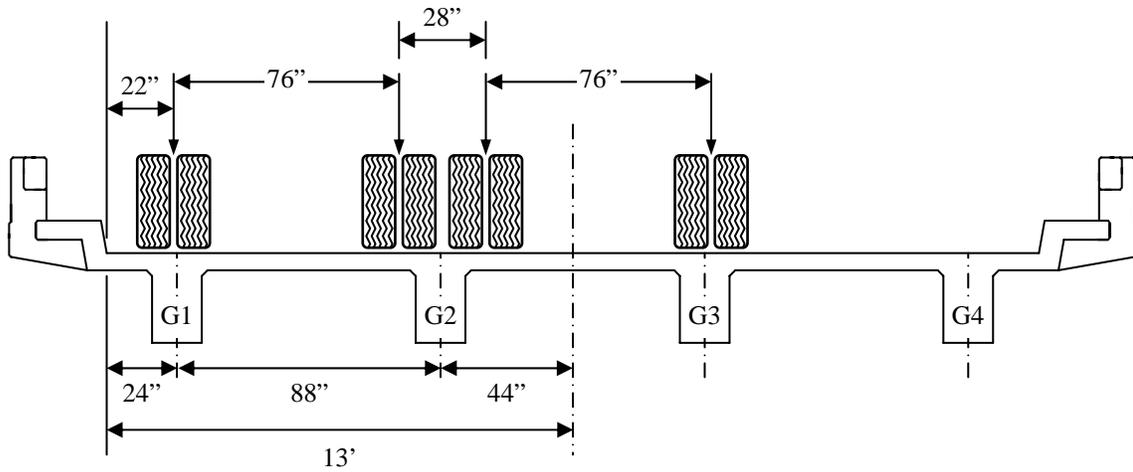
Figure 5.15 Worst-Case Critical Loading for Girder 1 (Tight)

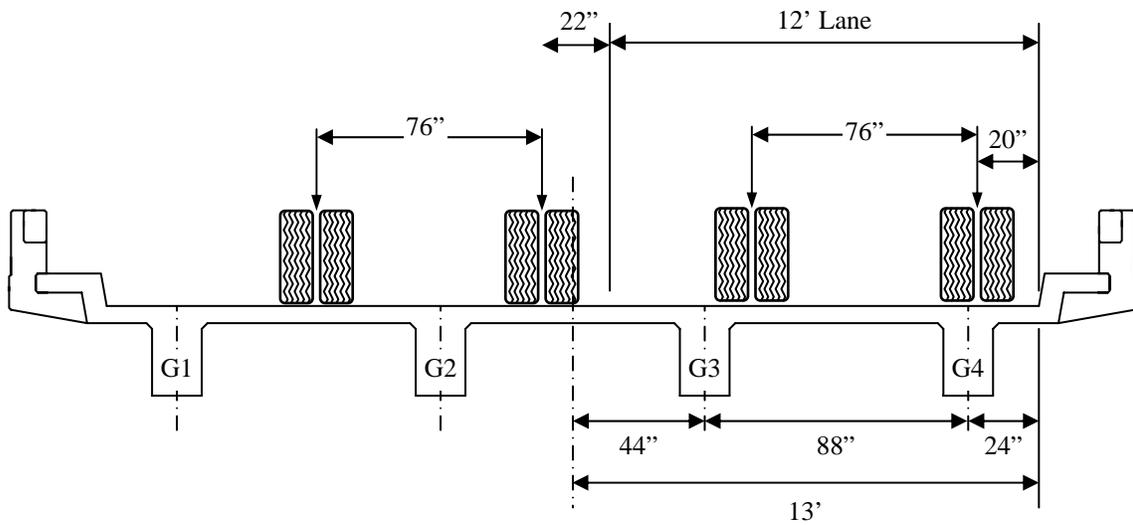
Figure 5.16 AASHTO Critical Loading for Girder 4 (AASHTO New)

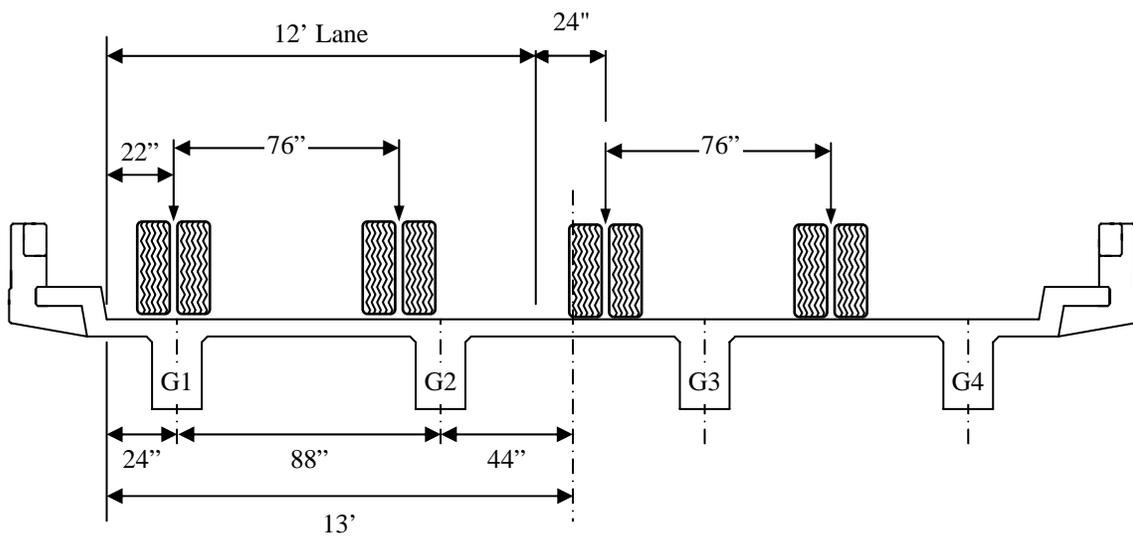
Figure 5.17 AASHTO Critical Loading for Girder 1 (AASHTO New)

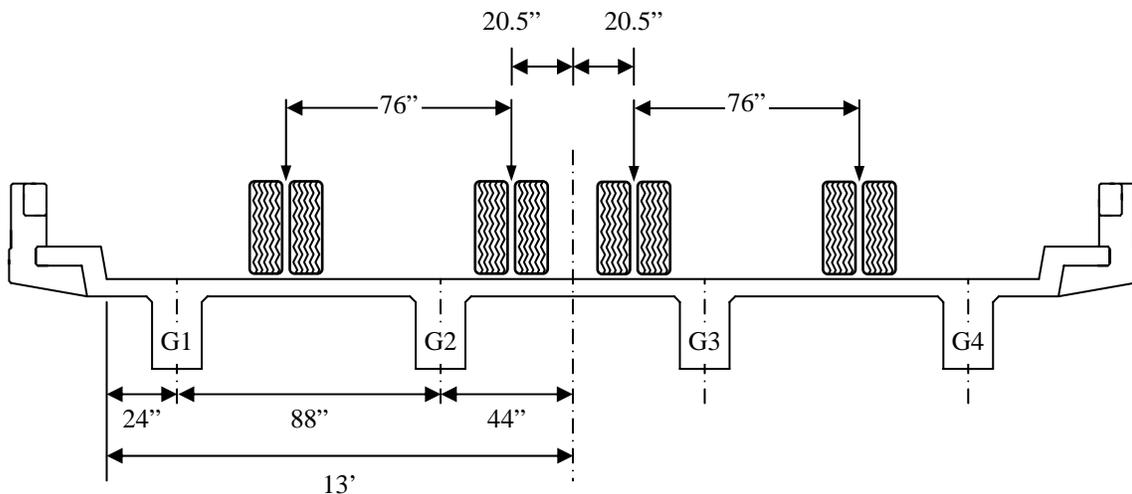
Dynamic live load tests were performed with the load test trucks traveling side-by-side over the bridge at a target constant speed of 45 mph. The load test trucks were positioned in the center of each traffic lane as shown in the midlane configuration in Figure 5.18. The number of dynamic tests performed in each direction was dependent on the quality of the tests. Load test truck position within the lanes was a difficult parameter to control for dynamic tests, and the test was repeated until adequate (transverse and longitudinal) alignment was achieved. Actual truck speeds for dynamic tests ranged from 42–55 miles per hour for both the northbound and southbound directions.

Figure 5.18 Midlane Loading Truck Configuration

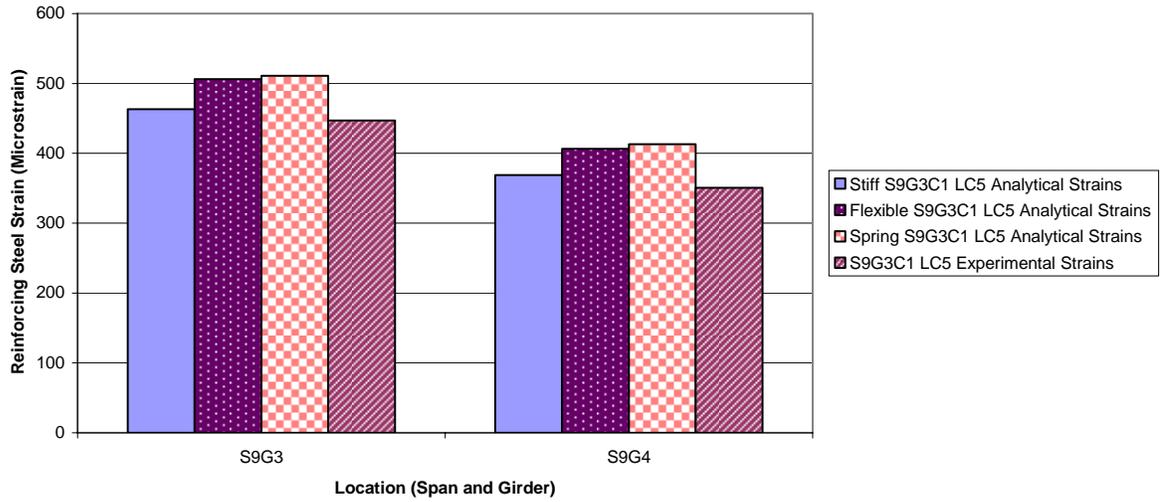
Analytical vs. Experimental Strain for Span 9 Girder 3 AASHTO LC5 Load Configuration

Figure 7.1 Model Comparison for Span 9 Girder 3 AASHTO Loading

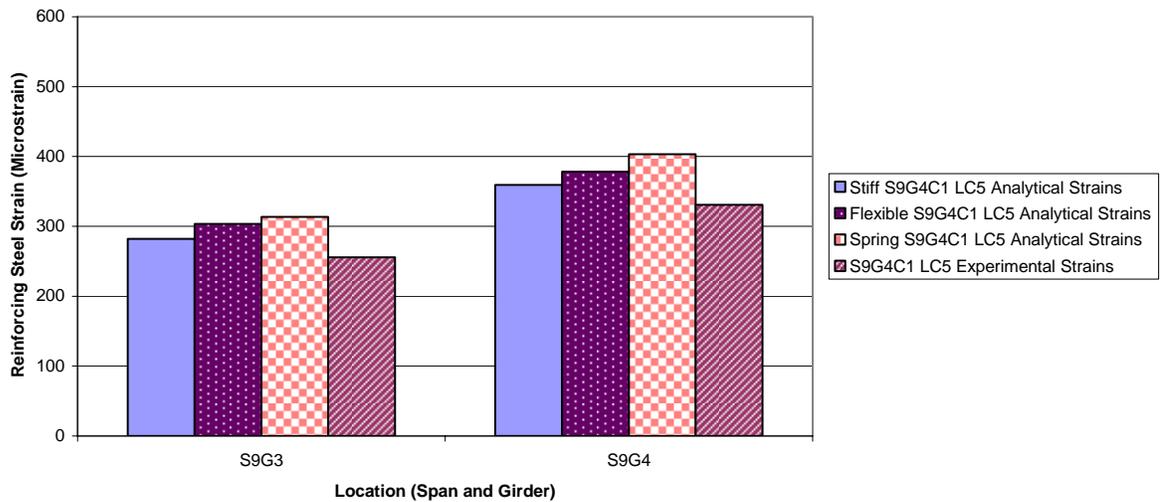
Analytical vs. Experimental Strain for Span 9 Girder 4 AASHTO (Old) LC5 Load Configuration

Figure 7.2 Model Comparison for Span 9 Girder 4 AASHTO (Old) Loading

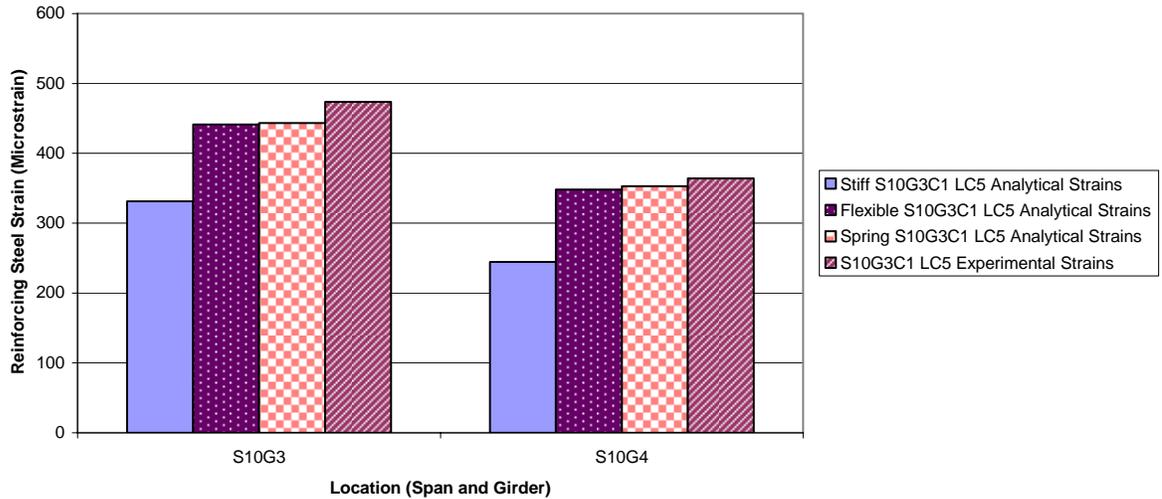
Analytical vs. Experimental Strain for Span 10 Girder 3 AASHTO LC5 Load Configuration

Figure 7.3 Model Comparison for Span 10 Girder 3 AASHTO Loading

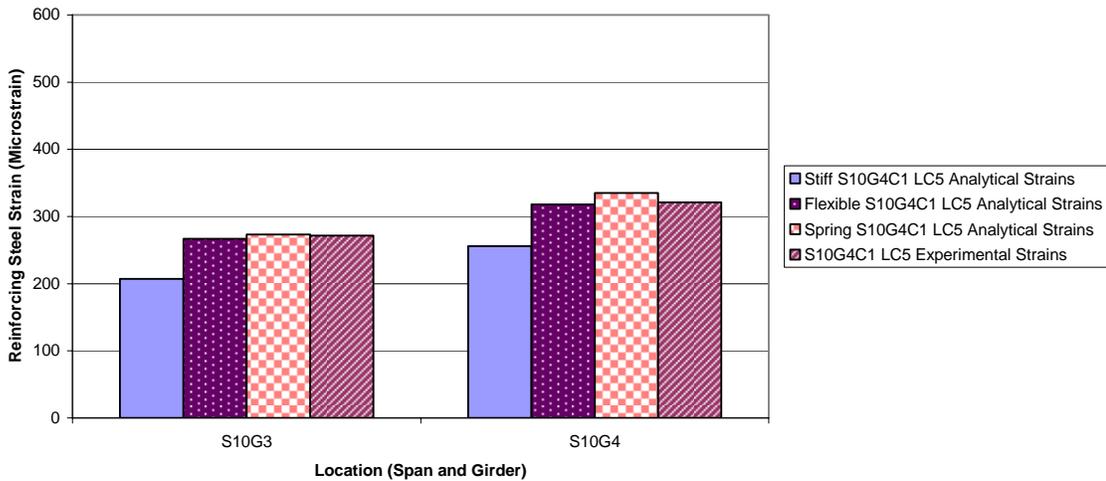
Analytical vs. Experimental Strain for Span 10 Girder 4 AASHTO (Old) LC5 Load Configuration

Figure 7.4 Model Comparison for Span 10 Girder 4 AASHTO (Old) Loading

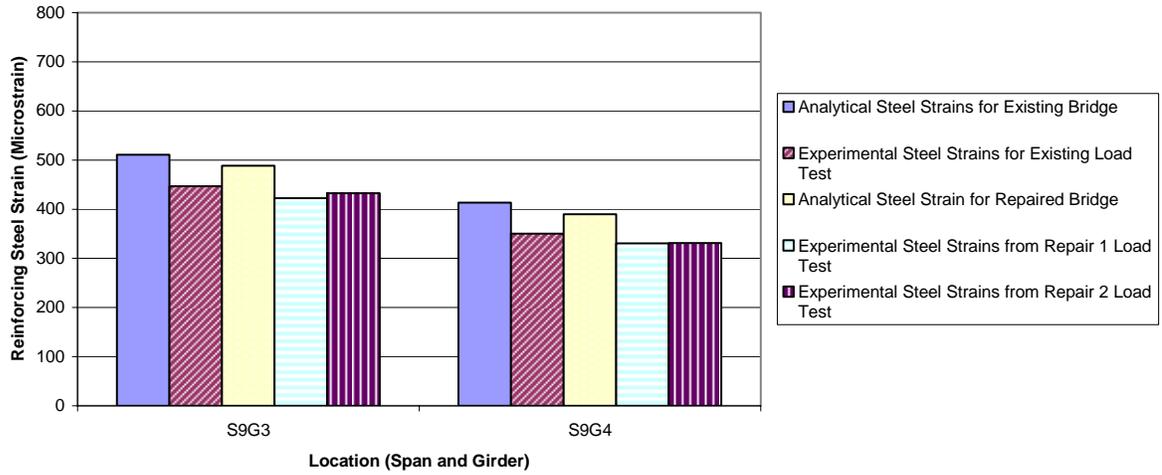
Analytical vs. Experimental Steel Strain for Span 9 Girder 3 AASHTO LC5 Spring Load Configuration

Figure 7.5 Steel Strain Comparison for Span 9 Girder 3 AASHTO Loading

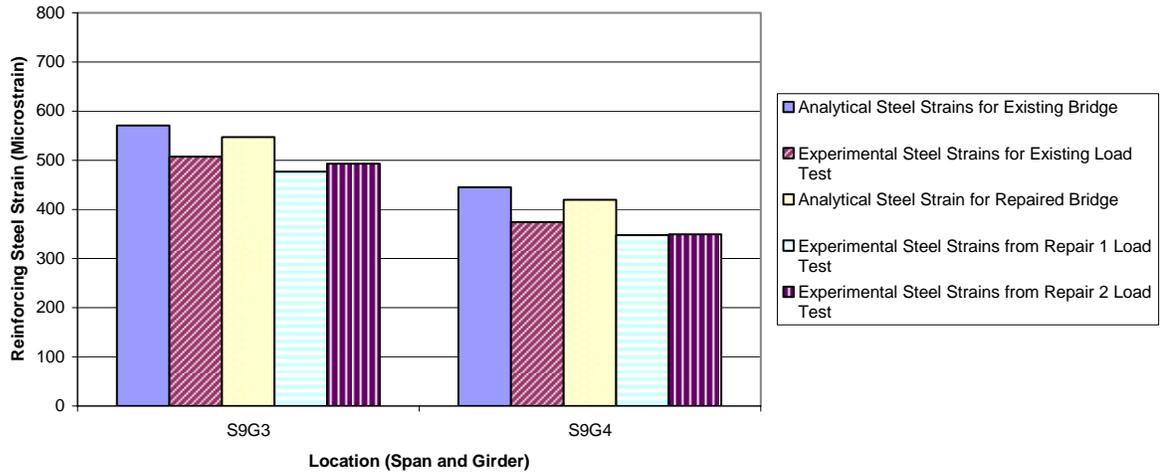
Analytical vs. Experimental Steel Strain for Span 9 Girder 3 Tight LC5 Spring Load Configuration

Figure 7.6 Steel Strain Comparison for Span 9 Girder 3 Tight Loading

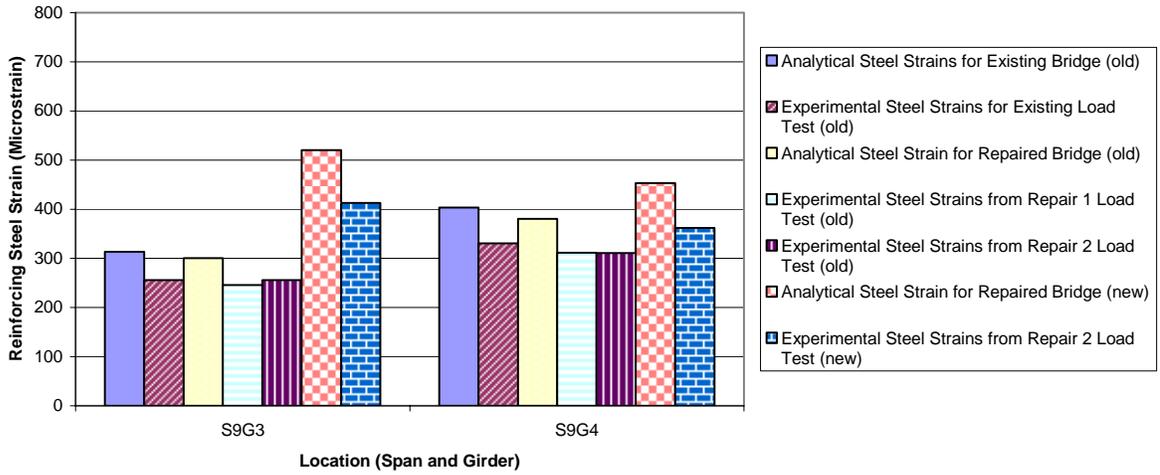
Analytical vs. Experimental Steel Strain for Span 9 Girder 4 AASHTO LC5 Spring Load Configuration

Figure 7.7 Steel Strain Comparison for Span 9 Girder 4 AASHTO Loading

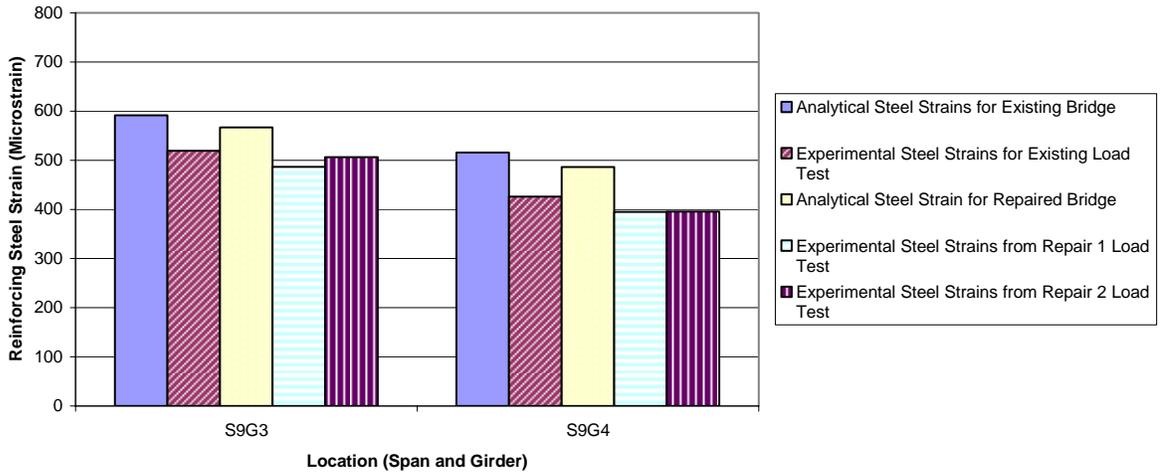
Analytical vs. Experimental Steel Strain for Span 9 Girder 4 Tight LC5 Spring Load Configuration

Figure 7.8 Steel Strain Comparison for Span 9 Girder 4 Tight Loading

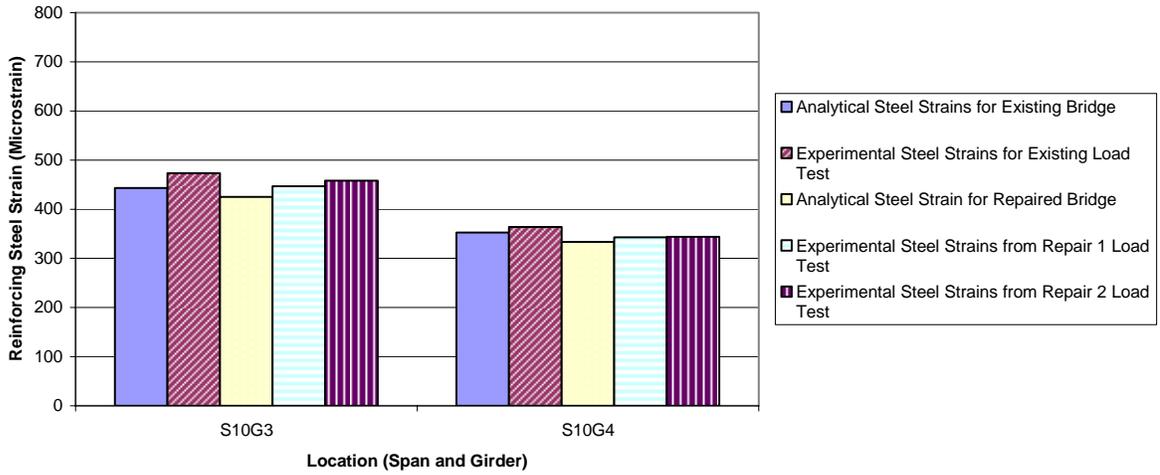
Analytical vs. Experimental Steel Strain for Span 10 Girder 3 AASHTO LC5 Spring Load Configuration

Figure 7.9 Steel Strain Comparison for Span 10 Girder 3 AASHTO Loading

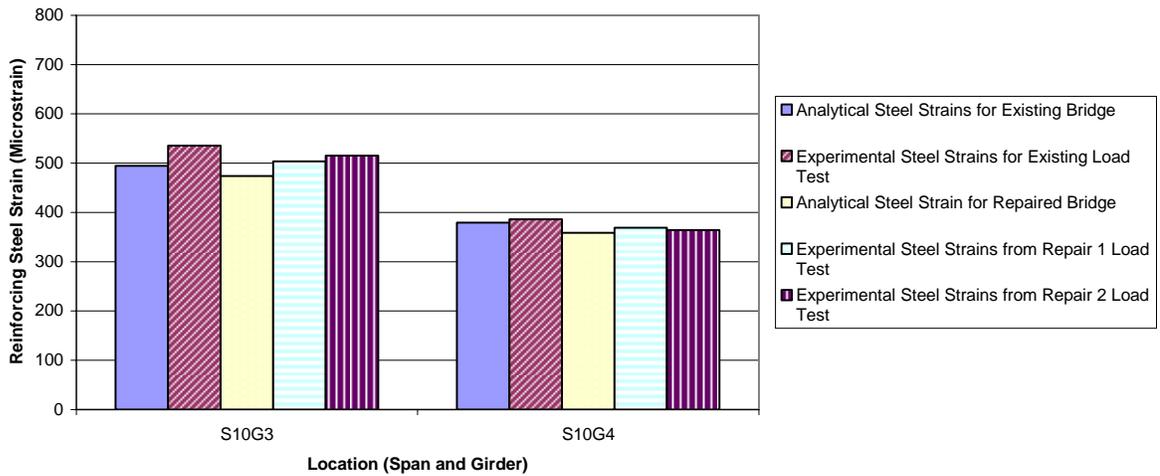
Analytical vs. Experimental Steel Strain for Span 10 Girder 3 Tight LC5 Spring Load Configuration

Figure 7.10 Steel Strain Comparison for Span 10 Girder 3 Tight Loading

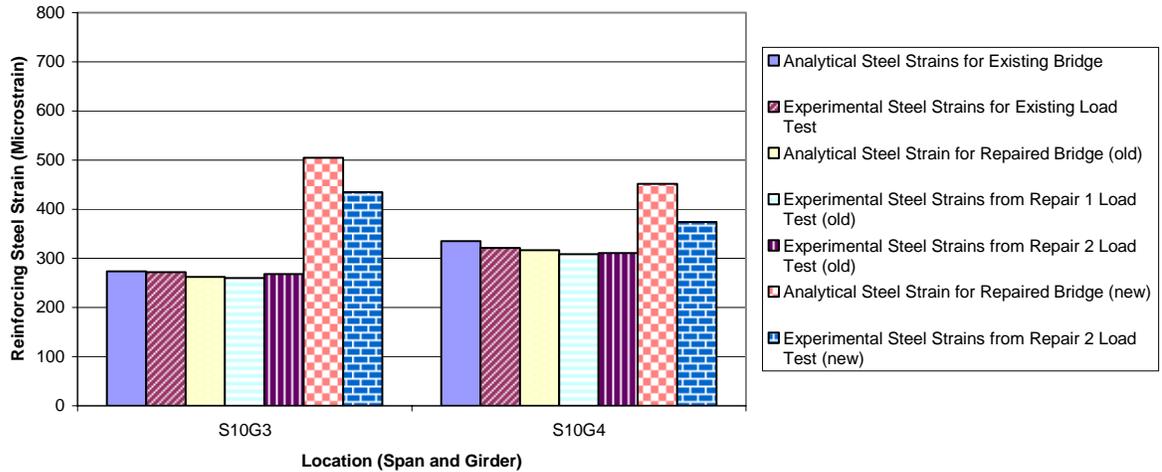
Analytical vs. Experimental Steel Strain for Span 10 Girder 4 AASHTO LC5 Spring Load Configuration

Figure 7.11 Steel Strain Comparison for Span 10 Girder 4 AASHTO Loading

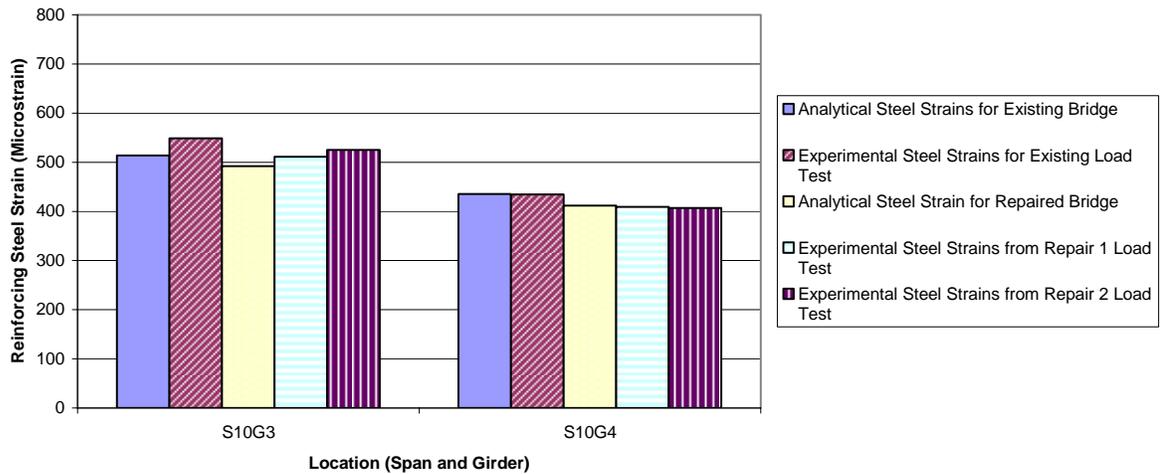
Analytical vs. Experimental Steel Strain for Span 10 Girder 4 Tight LC5 Spring Load Configuration

Figure 7.12 Steel Strain Comparison for Span 10 Girder 4 Tight Loading

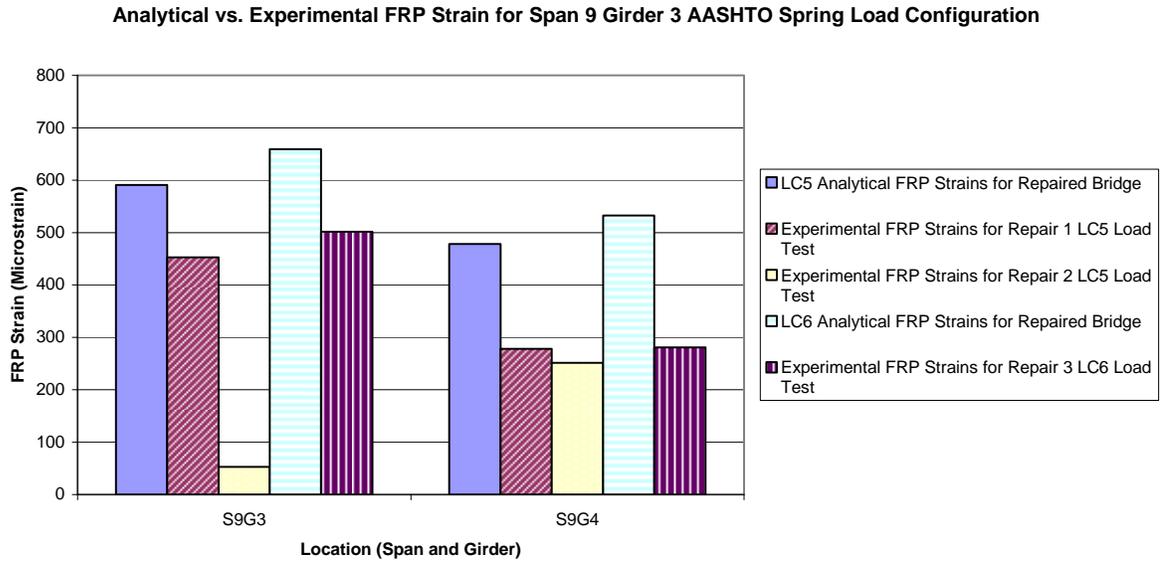
Figure 7.13 FRP Strain Comparison for Span 9 Girder 3 AASHTO Loading

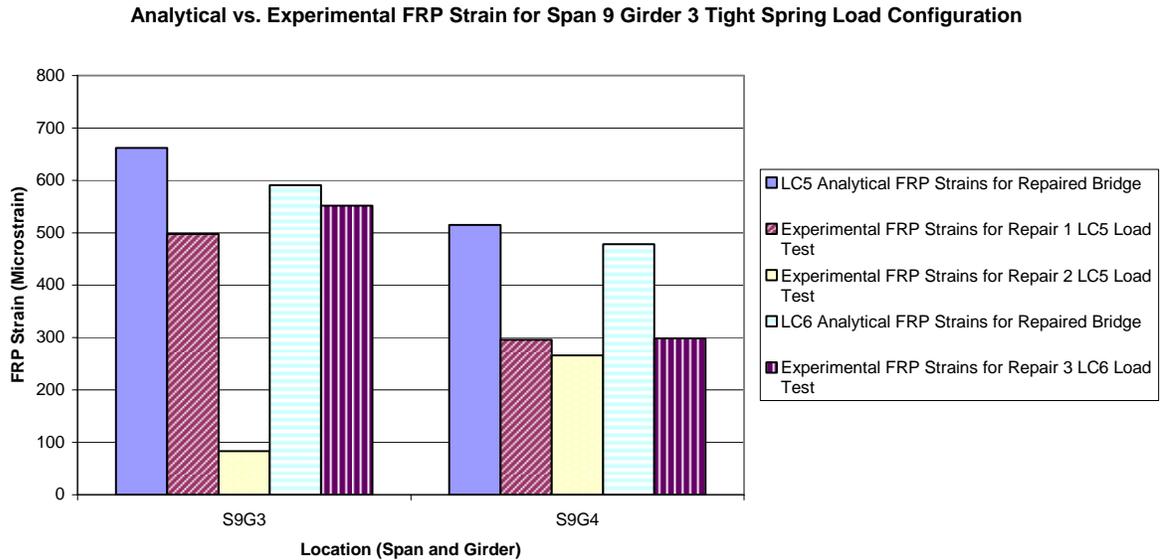
Figure 7.14 FRP Strain Comparison for Span 9 Girder 3 Tight Loading

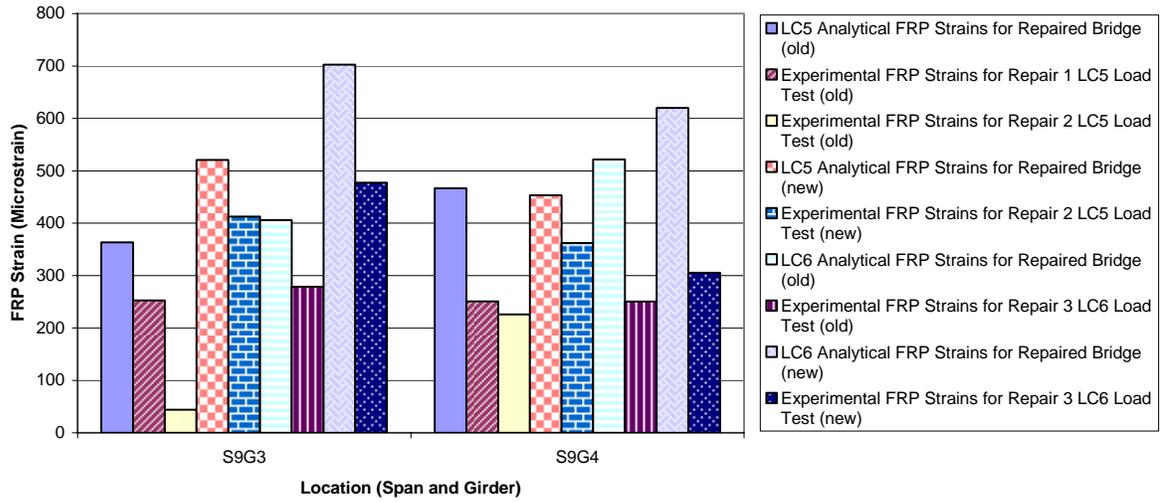
Analytical vs. Experimental FRP Strain for Span 9 Girder 4 AASHTO Spring Load Configuration

Figure 7.15 FRP Strain Comparison for Span 9 Girder 4 AASHTO Loading

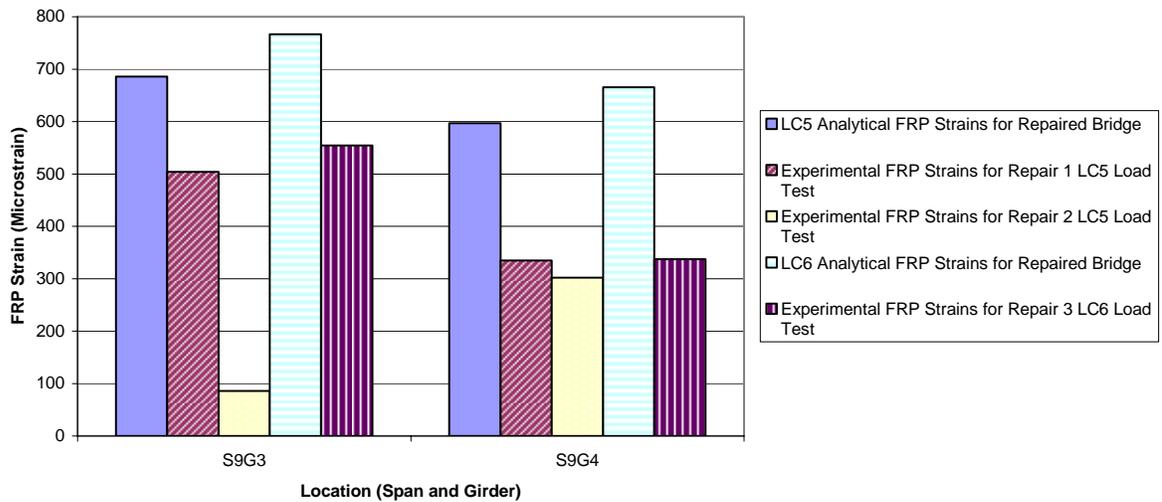
Analytical vs. Experimental FRP Strain for Span 9 Girder 4 Tight Spring Load Configuration

Figure 7.16 FRP Strain Comparison for Span 9 Girder 4 Tight Loading

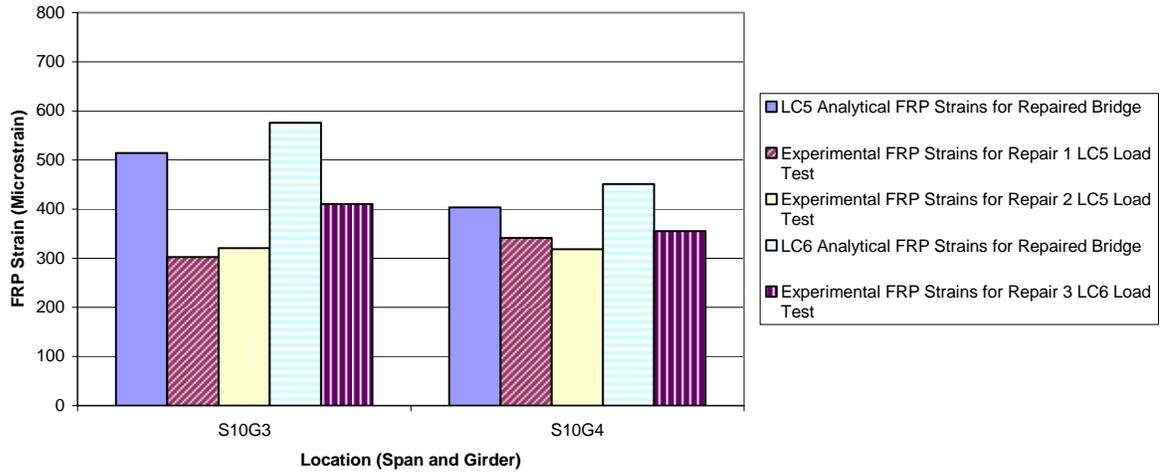
Figure 7.17 FRP Strain Comparison for Span 10 Girder 3 AASHTO Loading
