Final Report RP-930-466-2

**REPAIR OF THE UPHAPEE CREEK BRIDGE WITH FRP
LAMINATES**

Alabama Department of Transportation
Research Project 930-466
Montgomery, Alabama

November 2005

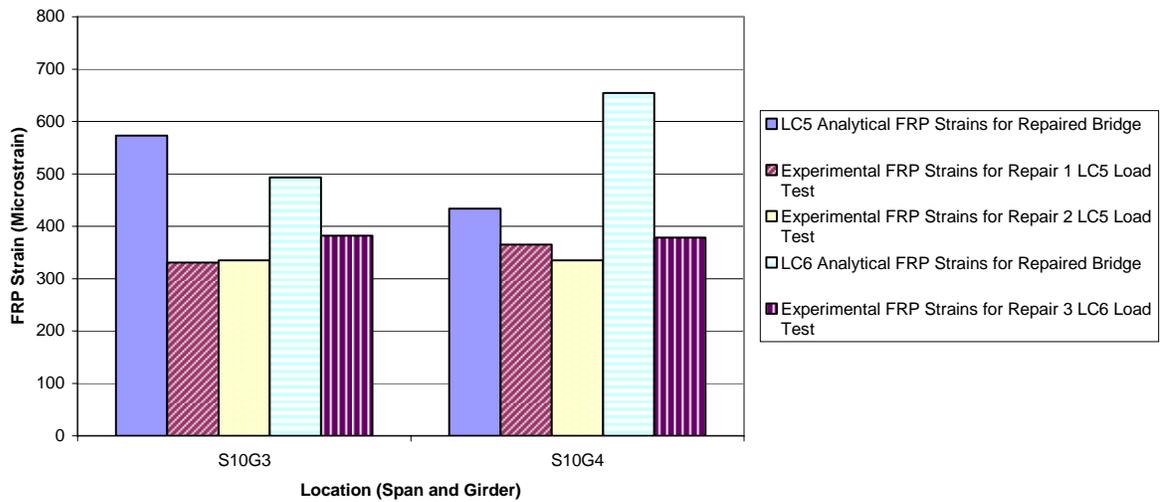
Figure 7.18 FRP Strain Comparison for Span 10 Girder 3 Tight Loading

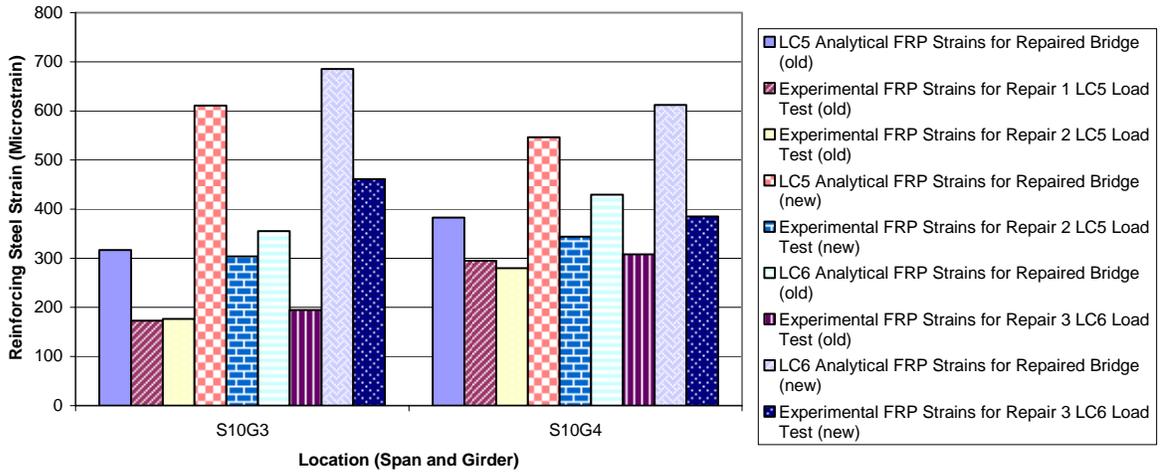
Figure 7.19 FRP Strain Comparison for Span 10 Girder 4 AASHTO Loading

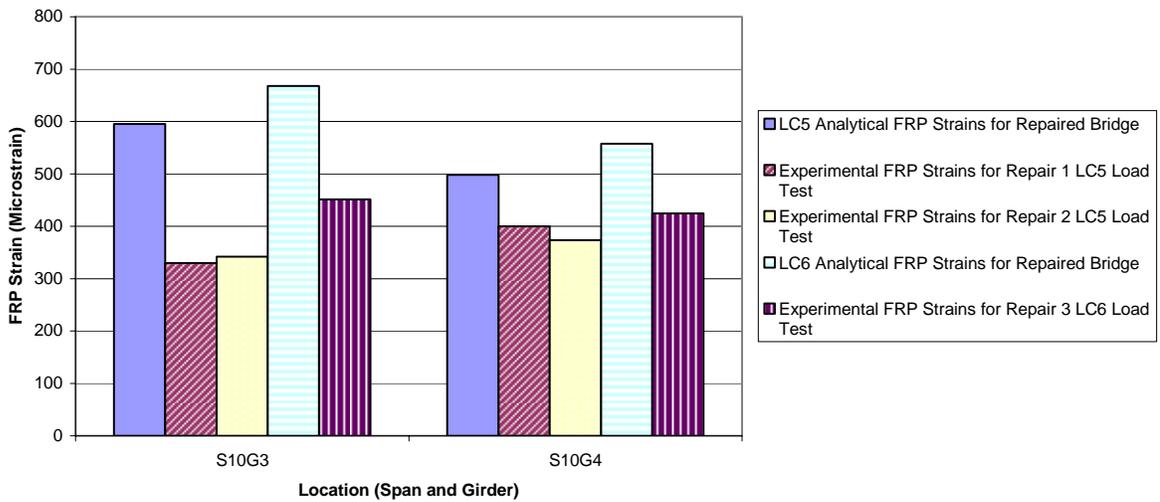
Figure 7.20 FRP Strain Comparison for Span 10 Girder 4 Tight Loading
