Research Report No. 1 for ALDOT Project 930-601

**DEVELOPMENT OF ACOUSTIC EMISSION
EVALUATION METHOD FOR REPAIRED
PRESTRESSED CONCRETE BRIDGE GIRDERS**

Research Report FHWA/ALDOT 930-601-1

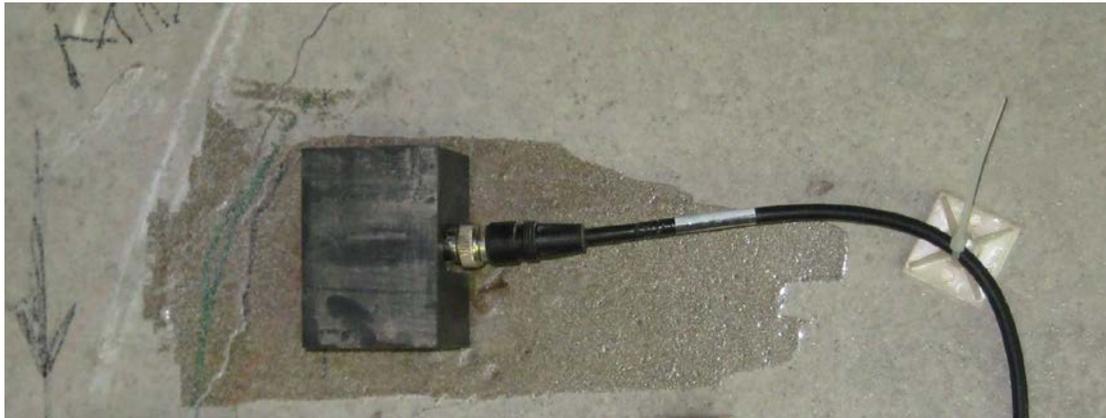
Once the magnetic hold-down device was properly placed over the sensor, the cable was secured using cable ties and mounting pads. This was done to prevent any movement and interference. The sensor was restricted so no movement caused by the weight of the cable occurred. Once the cables were tied down, the sensor installation was complete. The entire sensor setup can be seen in Figure 4-6.

Figure 4-6: Sensor installation

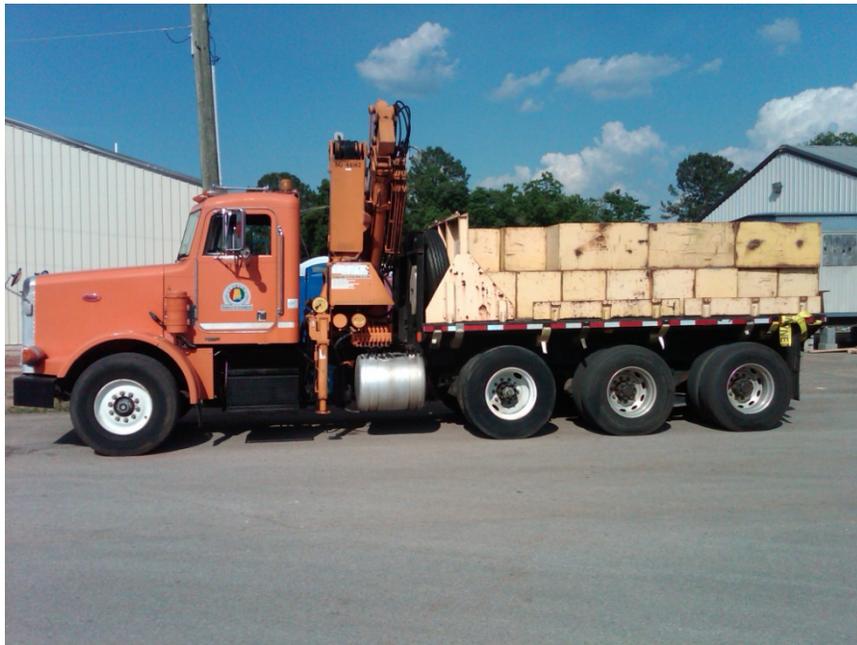
Loading of the bridge girders was performed by moving load trucks onto the bridge. Since the AE testing method is a measure of damage growth, it is dependent on load history. Therefore, loading patterns were designed to produce useful data and utilize the AE method to evaluate the integrity of the concrete girders. Two different load test trucks, provided by the Alabama Department of Transportation (ALDOT), were used for the test. The trucks, ST-6400 and ST-6538, can be seen in Figure 4-11 and Figure 4-12.

Figure 4-11: Standard load truck ST-6400 (pre-repair and post-repair)

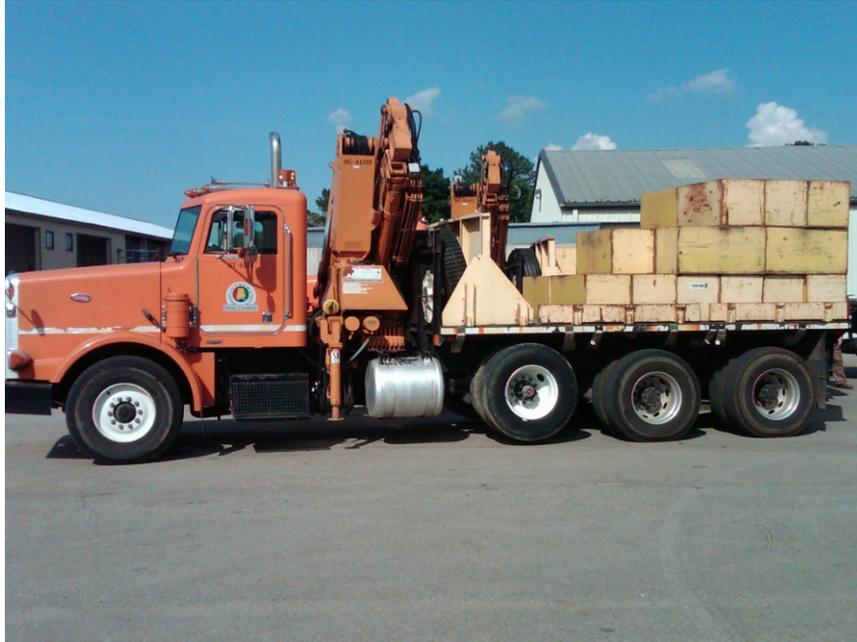
Figure 4-12: Standard load truck ST-6538 (post-repair)

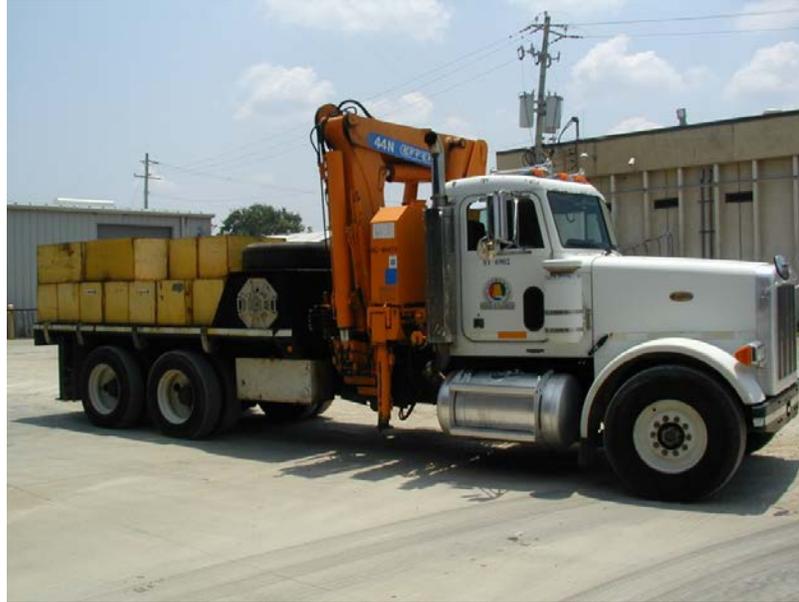
Figure 5-9: Load truck ST-6902 (pre-repair unconventional truck)

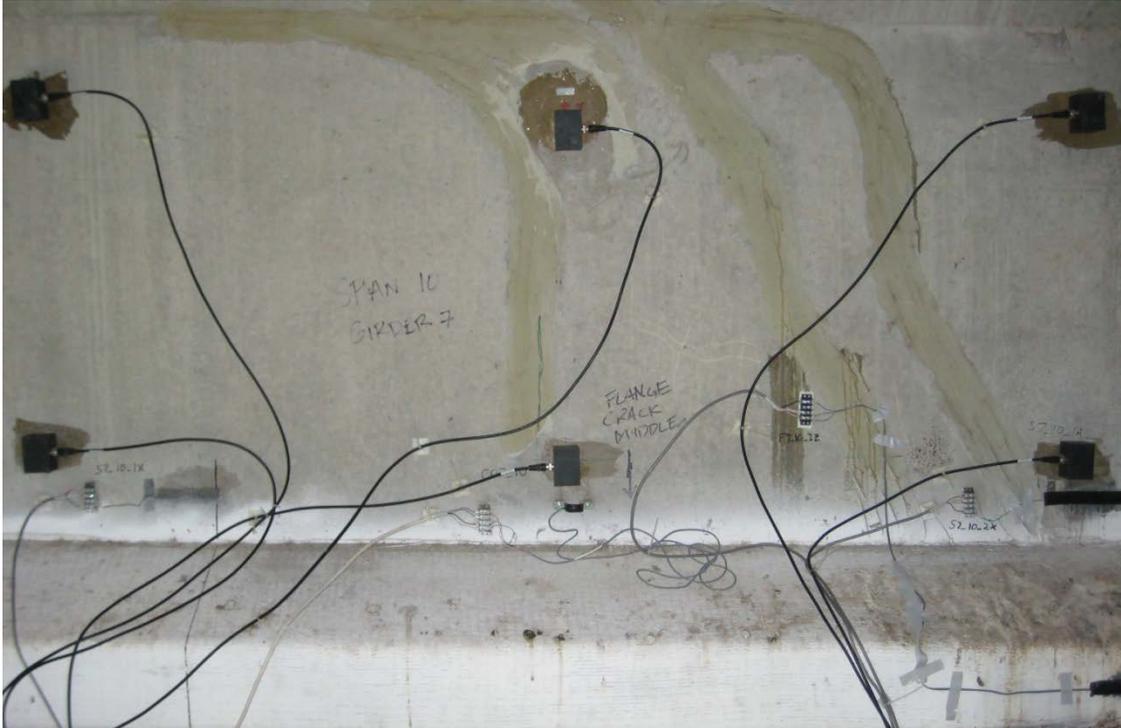
Figure D-3: Visible cracks on face of SP10G7

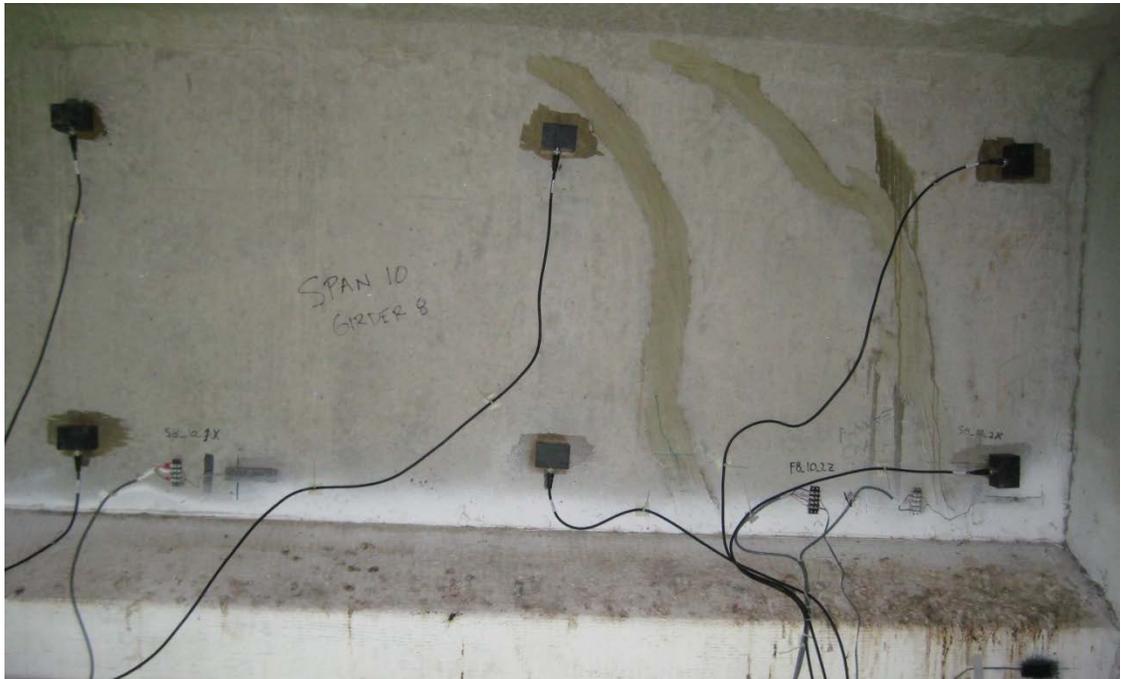
Figure D-4: Visible cracks on face of SP10G8
