**Research Report**

**EVALUATION OF HIGH-PERFORMANCE  
DRILLED SHAFT CONCRETE  
IN THE B.B. COMER BRIDGE**

The Alabama Department of Transportation

**JANUARY 2015**

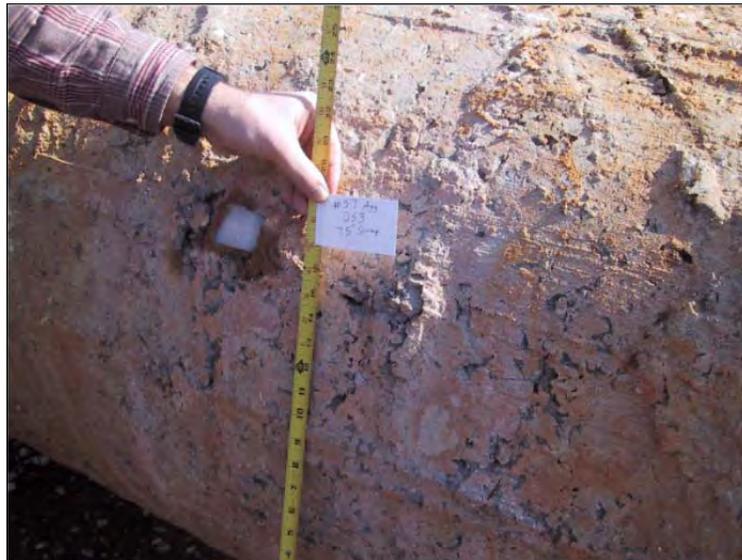
**Figure 1.4:** Surface of a drilled shaft with many voids caused by poor consolidation in the cover region of the shaft (Brown 2004)

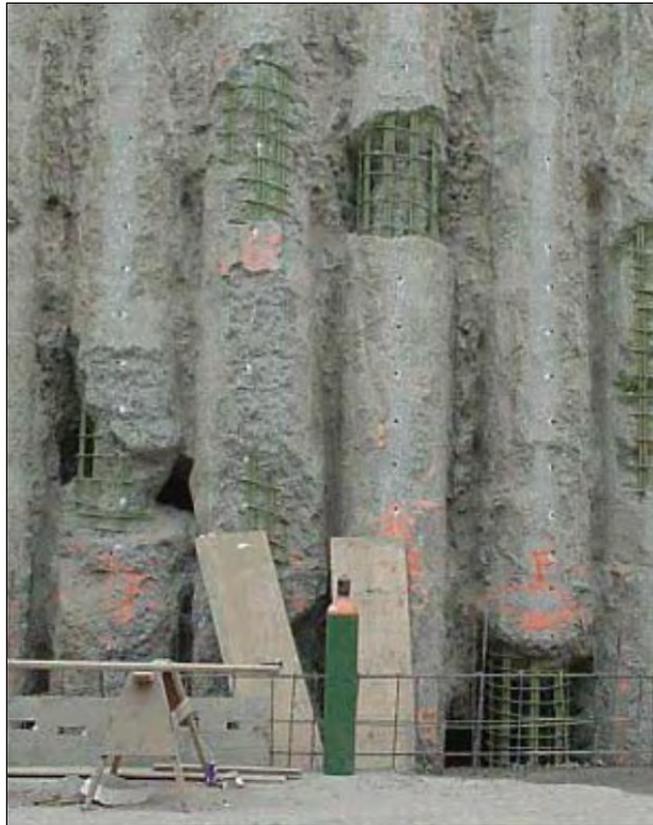
**Figure 1.5:** Shaft defects due to loss of workability (photo by Dan Brown)

Problems will also occur when the concrete is not able to stay workable for the duration of the concrete placement. Concrete that arrives at the site workable may not have the ability to stay workable for the duration of concrete placement. If the concrete lacks this ability, it will be difficult to maintain tremie flow during placement. Due to these difficulties, the tremie is often lifted to improve the concrete flow; however, the tremie must not be lifted high enough to risk breaching the concrete surface. A picture of shafts that had this problem during construction is shown in Figure 1.5.

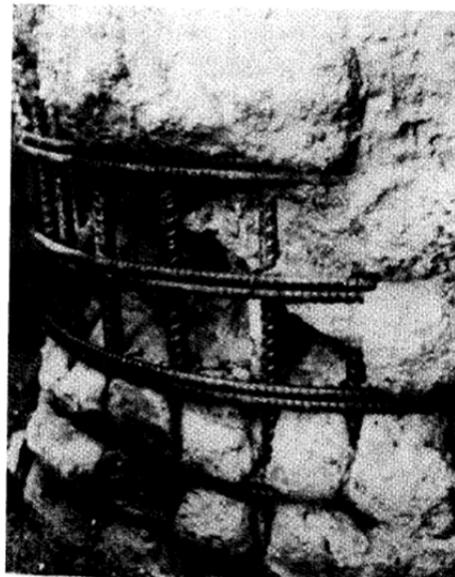
**Figure 2.9:** Defect in a drilled shaft caused by interruption in concrete supply during pumping (Photograph courtesy of Caltrans) (O'Neil and Reese 1999)

If there are delays during construction, such as delays in the arrival of the concrete truck, problems with losing the concrete workability can occur. Brown (2004) notes that even without delays, if the shaft is very large, it may take hours to complete the concrete placement. If the concrete starts losing its workability before the conclusion of the placement, debris can become trapped as the fresh concrete escaping the tremie pipe takes the path of least resistance and instead of displacing the old concrete, moves through the old concrete to the surface. This act can cause laitance and debris to become trapped outside of the reinforcement cage (O'Neil and Reese 1999; Brown 2004). A diagram of this anomaly is presented in Figure 2.8. A large void caused by this anomaly is shown in Figure 2.9.

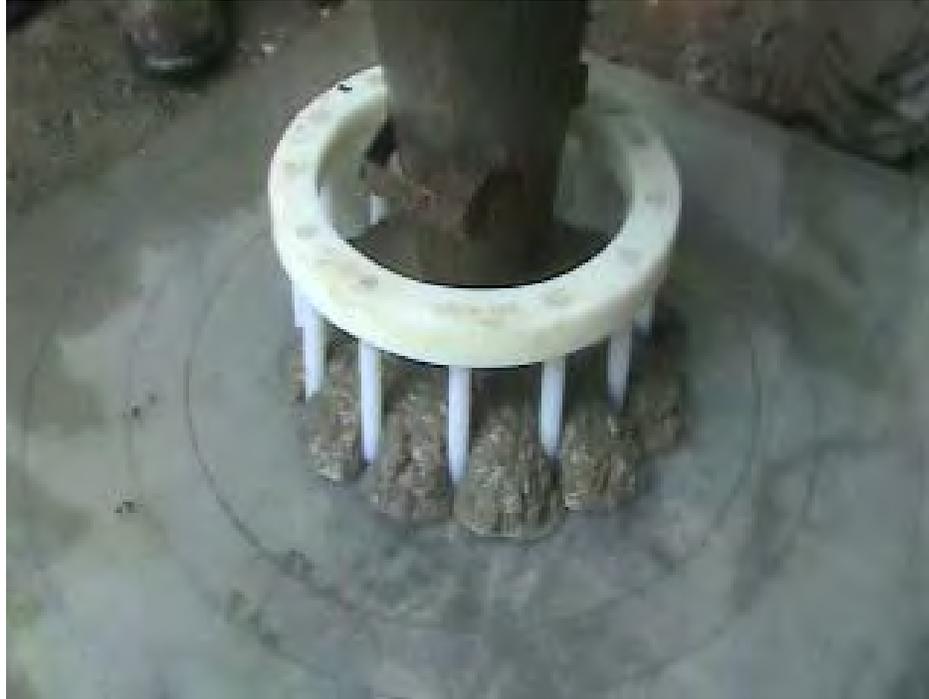
**Figure 2.13:** Modified J-Ring test being conducted

The standard J-Ring test was considered too congested for drilled shaft applications. Because of this, a modified J-Ring test was created. This modified J-Ring test is conducted in the same manner, but the modified J-Ring has 13 bars around the 12 in. diameter ring, instead of the ASTM specified 16 bars. This changed the bar spacing from 1.74 in. to 2.27 in. (Dachelet 2008).

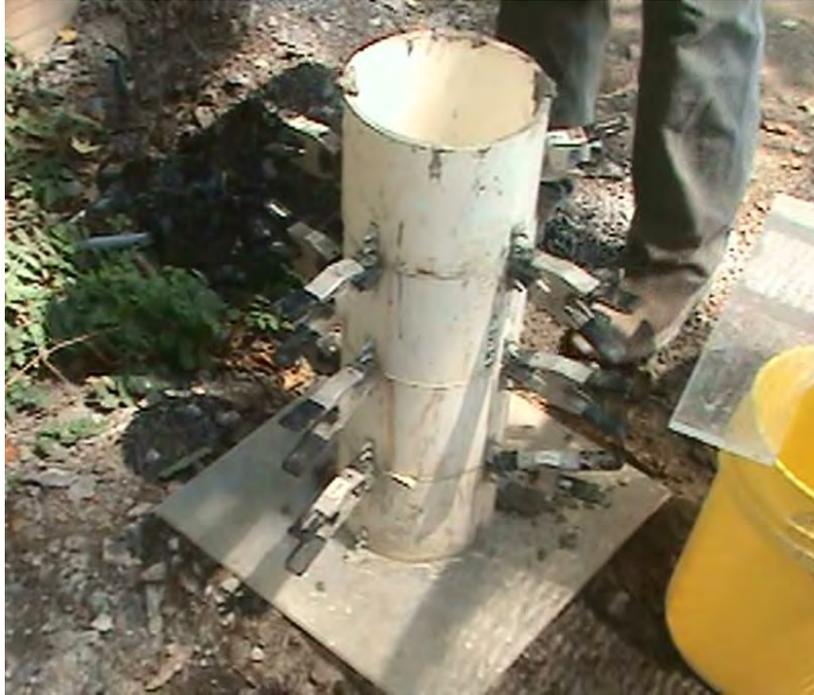
**Figure 2.14:** Segregation column

This test characterizes the stability of the fresh concrete. The specification for this test can be found in ASTM C 1610 (2006). This test is performed using a column that can be separated into three sections: lower, middle, and upper. Intact, the column is filled with the fresh SCC. After a 10 min. period, the column is then carefully taken apart in order to sieve the contents of the top and bottom sections of the column. This is done separately through a No. 4 sieve. The weight of the sieved contents of the top is compared to the weight of the sieved contents of the bottom. The percent segregation is taken as the percent difference in these weights. A picture of the segregation column is presented in Figure 2.14.

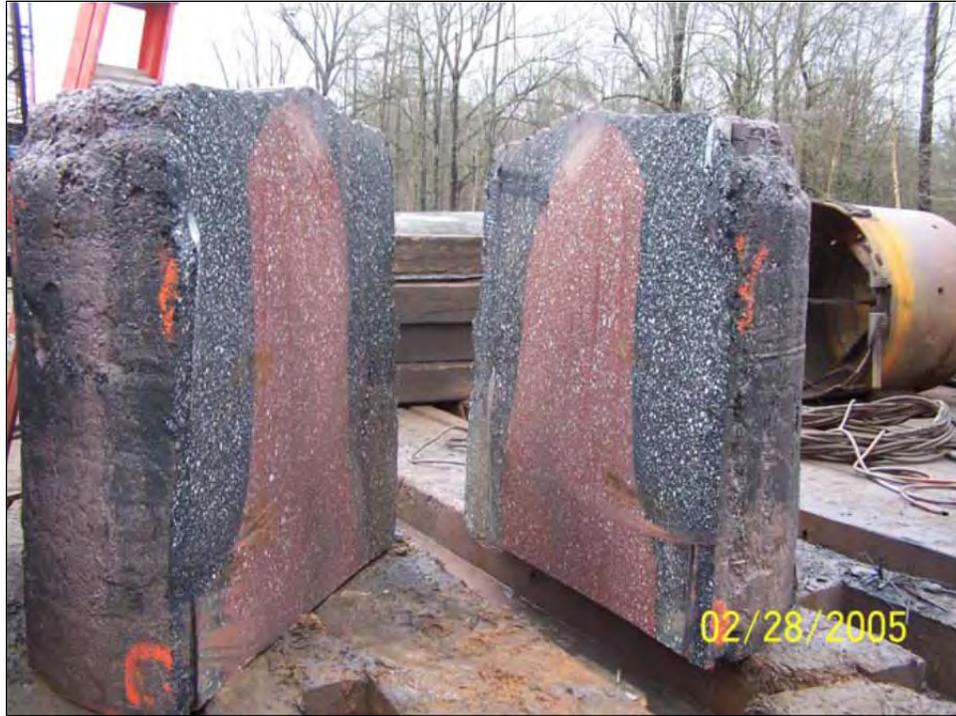
**Figure 2.16:** Dyed concrete showing the first concrete in the shaft staying near the bottom, filling the bottom corners of the shaft (Holley et al. 2005)

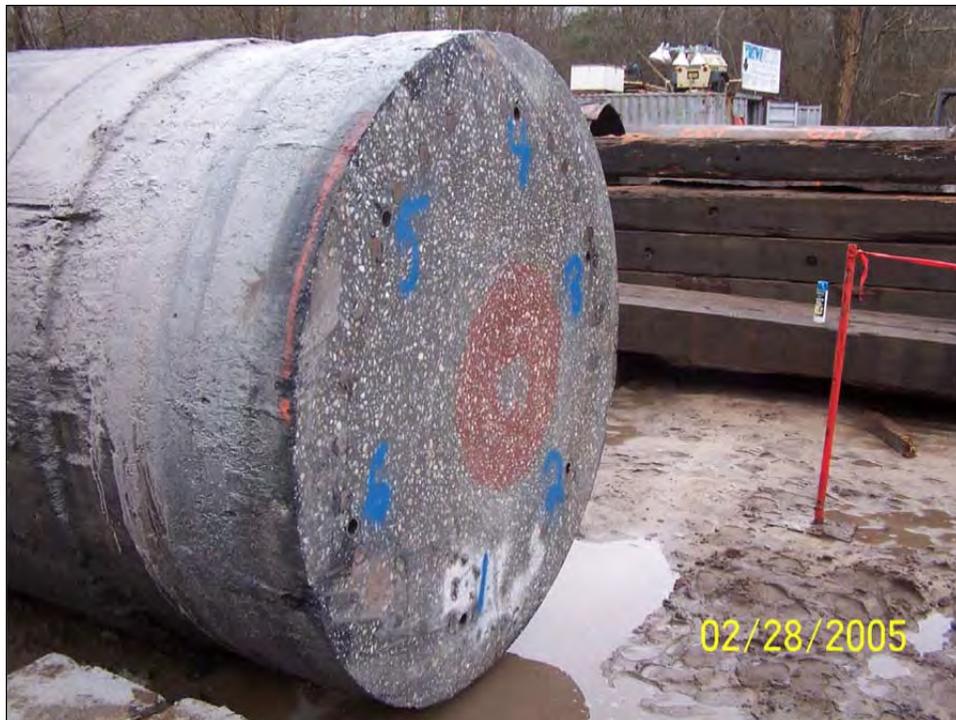
**Figure 2.17:** SC SCC: Cross-sectional Cut 6 ft from Bottom (Holley et al. 2005)

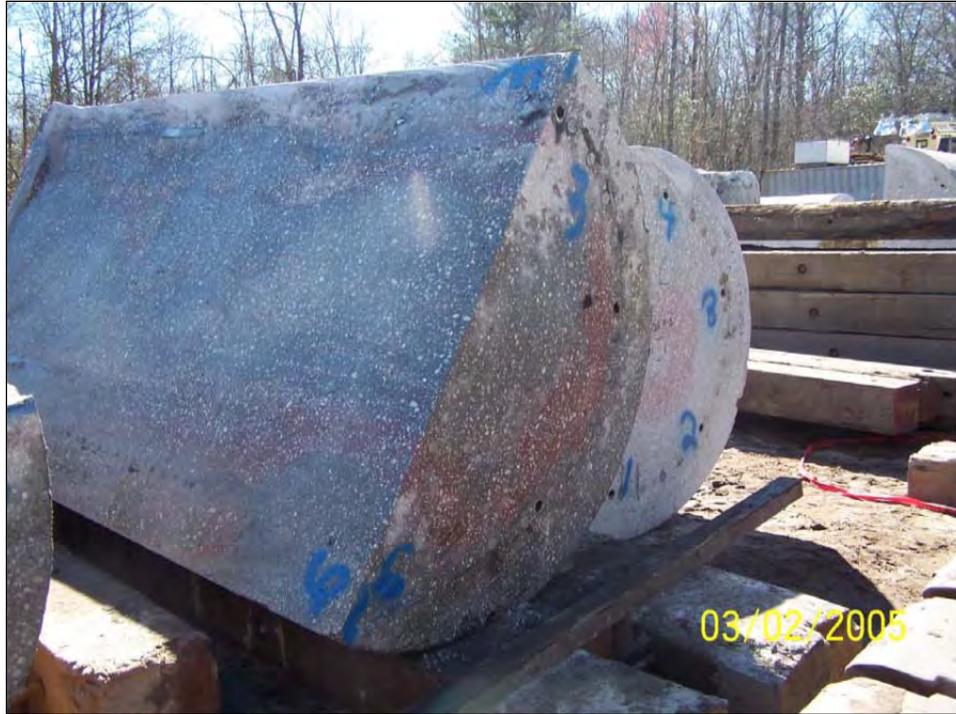
**Figure 2.18:** SC SCC: Cross-section 13 ft from Bottom (Holley et al. 2005)

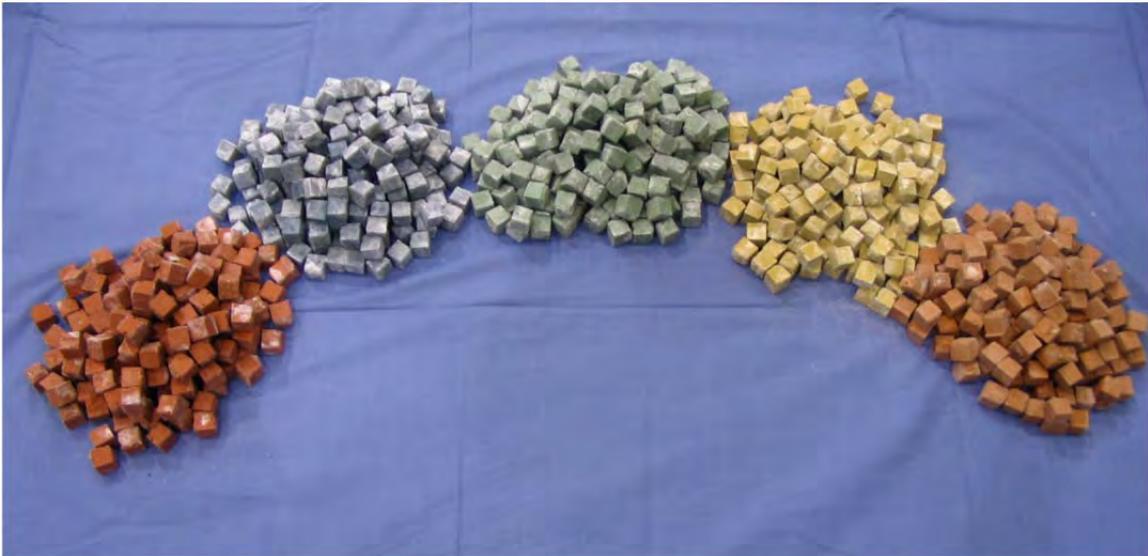
**Figure 3.5:** Colored mortar cubes for use in experimental shafts

These cubes were added to the concrete while the concrete was placed into the back of the pump truck. These cubes were placed into the concrete at a time when the concrete depth is known. Each color was introduced at a different depth.

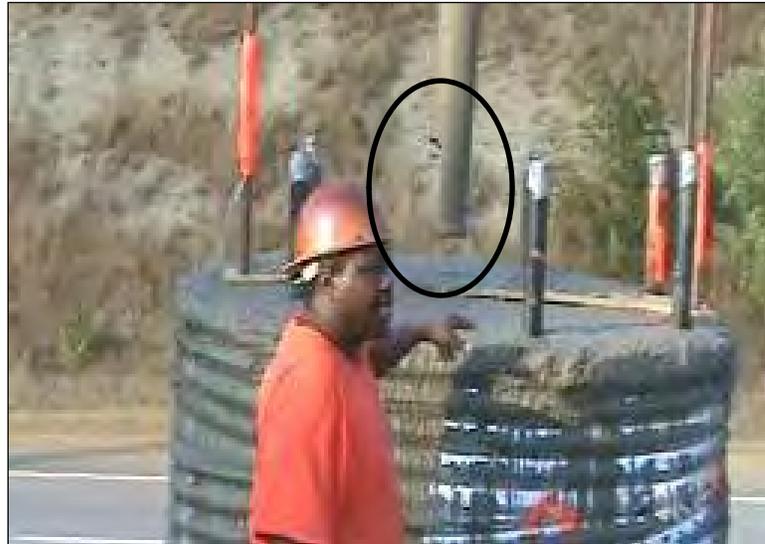
**Figure 3.16:** Bottom of tremie pipe

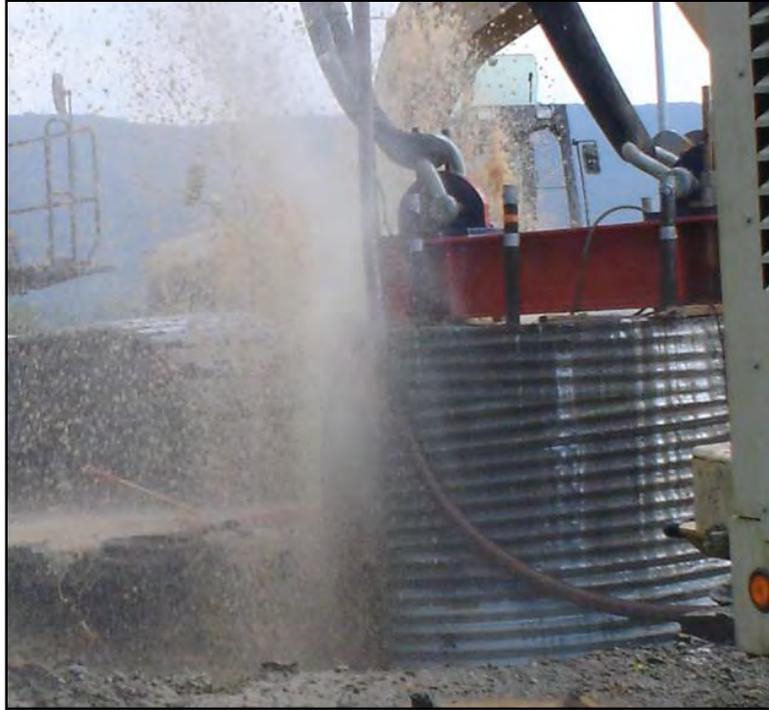
**Figure 3.26:** Loose sand removal with pressurized water

On September 10, 2008, the experimental shafts were exhumed. In order to remove the shafts, a crane assisted workers to attach a steel frame to the threaded reinforcement bars. Pressurized water was used to remove the loose sand from outside the steel casing of each shaft. This was performed by using a long steel rod with holes throughout. This rod was pushed into the ground, outside of the steel casing, and then the high-pressure water was used to “blow” the loose material away from the in-place shaft. This removal process is presented in the Figure 3.26. After the loose material was removed, a crane was utilized to raise the shaft as presented in the Figure 3.27. After removal from the ground, each exhumed shaft was set on its side as shown in Figure 3.28.

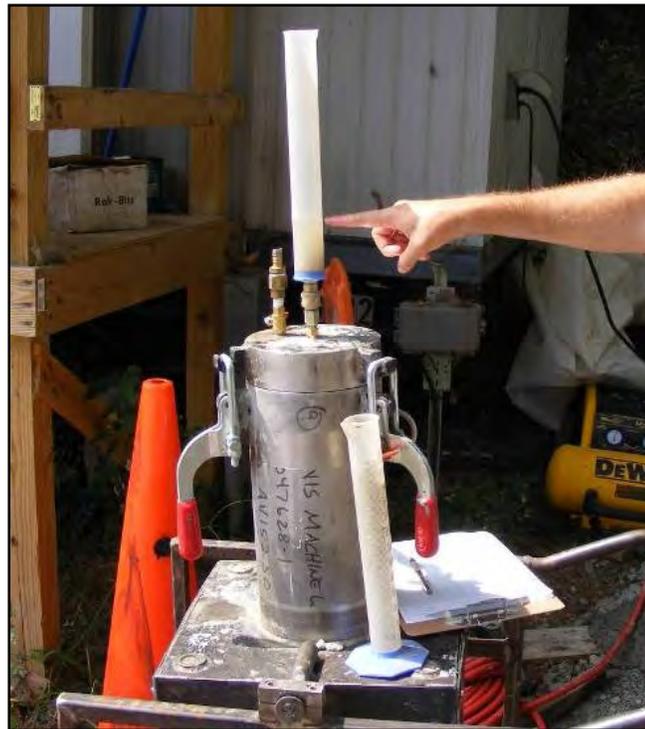
**Figure 3.45:** Pressurized bleed test being conducted

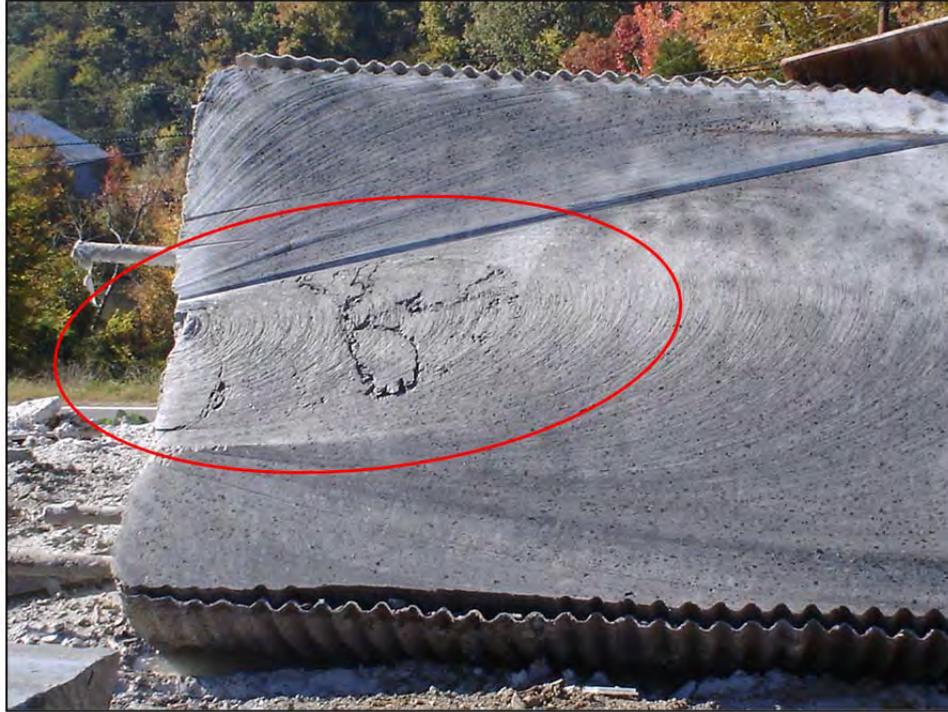
**Figure 3.57:** Anomaly observed near the top of the SCC-LP shaft

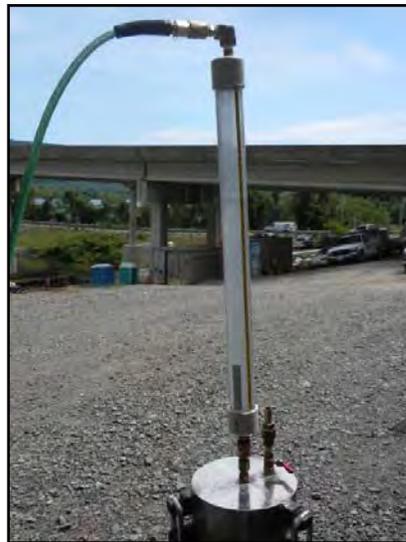
**Figure 4.6:** Pressurized beaker installed on the pressurized bleed chamber

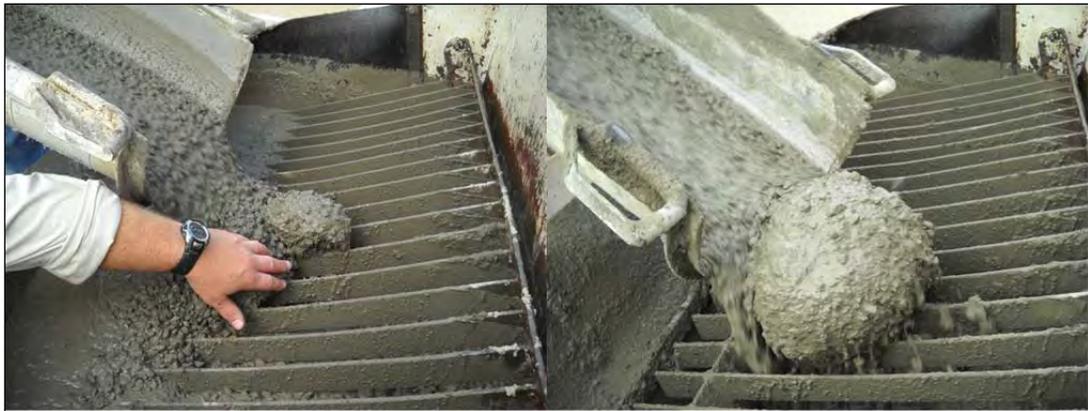
**Figure 4.17:** Cement balls on the pump truck grate

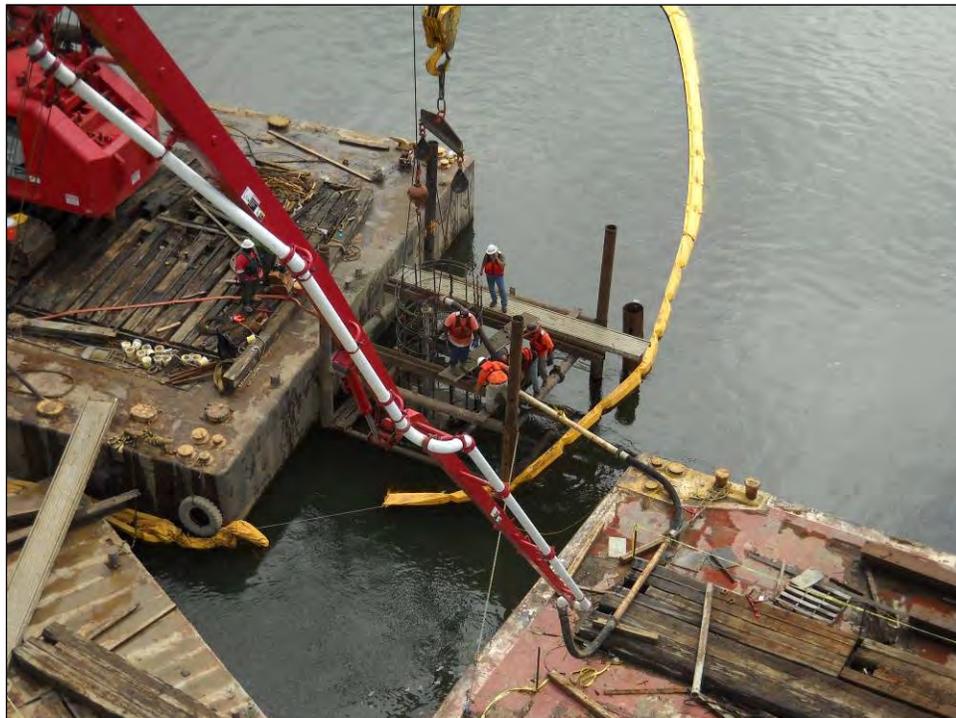
**Figure 4.18:** Pump line and tremie configuration

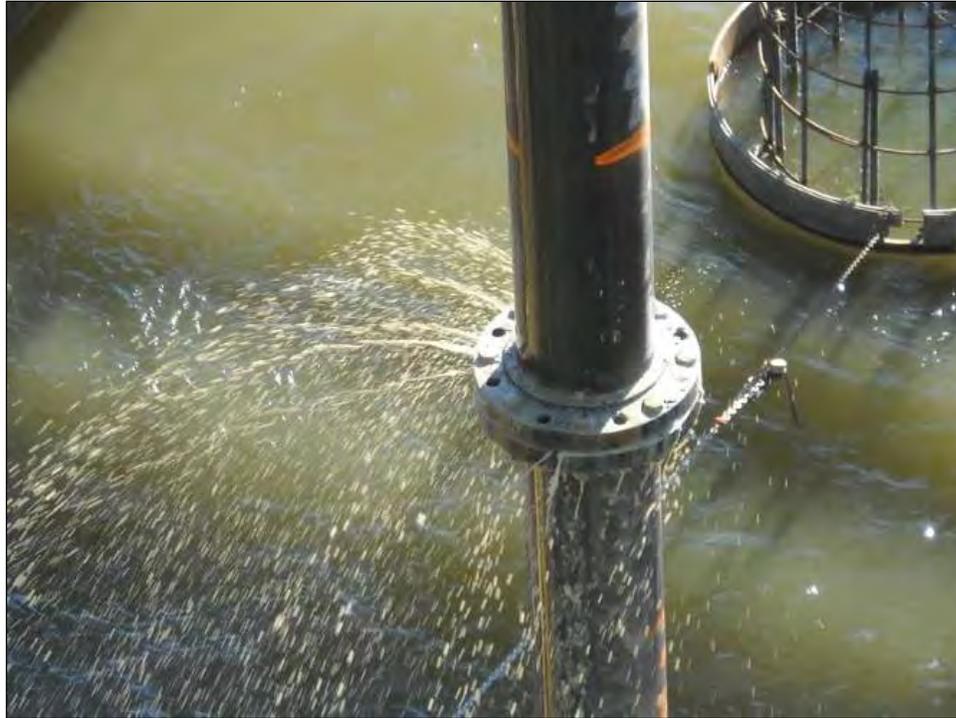
**Figure 4.19:** Water leaking from gasket on Shaft No. 5 of Pier No. 7
