# PERFORMANCE OF RUBBLIZED PAVEMENT SECTIONS IN ALABAMA

**Final Report**

**Highway Research Center**

**Auburn University**

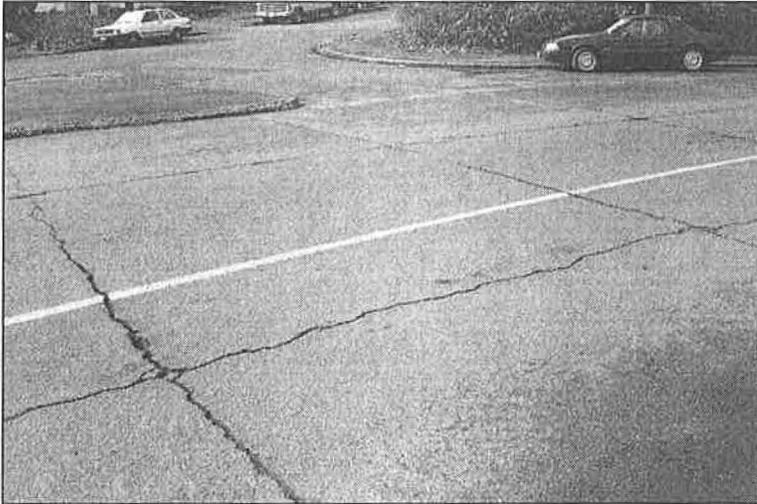
**Figure 2.1 Reflective Cracking.**

When rehabilitating PCC pavements, a common practice is to place an HMA overlay on top of the existing pavement structure (Freeman, 2002). However, a problem that has presented itself when utilizing an overlay is the development of reflective cracking through the depth of the newly placed overlay. This problem, known as joint reflective cracking, is a distress unique only to materials that have been laid over PCC pavements (Shahin, 1994). This type cracking is illustrated in Figure 2.1. The main concern with reflective cracking in HMA overlays is that reflective cracks accelerate the deterioration of the pavement structure. This deterioration is caused by water and incompressible solids filling the cracks that over time degrade the HMA (Yoder and Witczak, 1975).

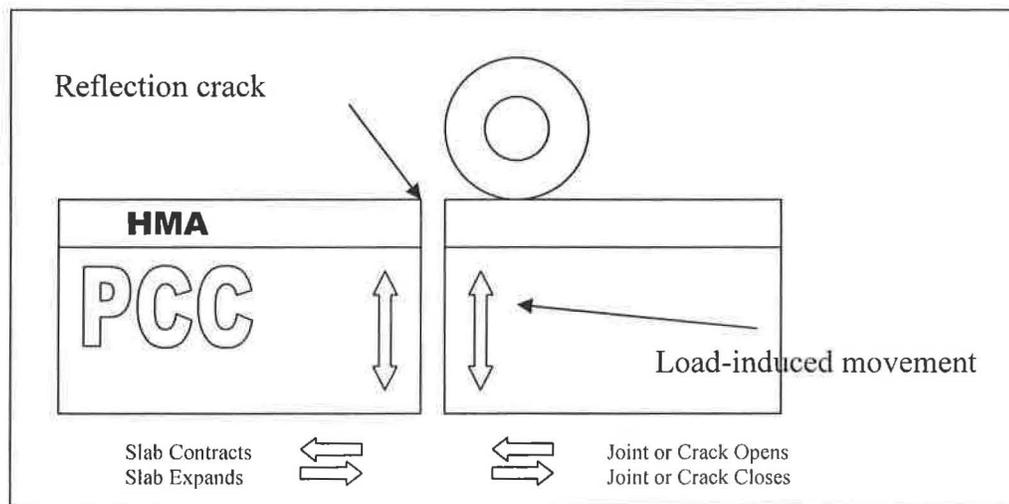
**Figure 2.2 Reflective Cracking Description(After Fitts, 2001).**

Jayawickrama and Lytton (1987) stated that formation of reflective cracking is caused by shearing, bending, and thermal stresses. These three stresses are a function of traffic loading, thermally induced expansions and/or contractions or a combination of both. Figure 2.2 illustrates the theory behind the mechanisms that produce reflective cracks.

It is important to keep in mind that even though the reasons for the movement of the PCC are still in debate, it is common understanding that it is the movement that causes the reflective cracks to occur in the HMA overlay. The movement of the PCC slab causes excessively high strain levels to develop at the bottom of the asphalt layer, above the joints and cracks, which leads to upward crack propagation (Freeman, 2002). Jayawickrama and Lytton (1987) have done extensive research dealing with reflective cracking. Their research was based on the principles of fracture mechanics, which helped determine that PCC pavement movement causes reflective cracking in HMA overlays.

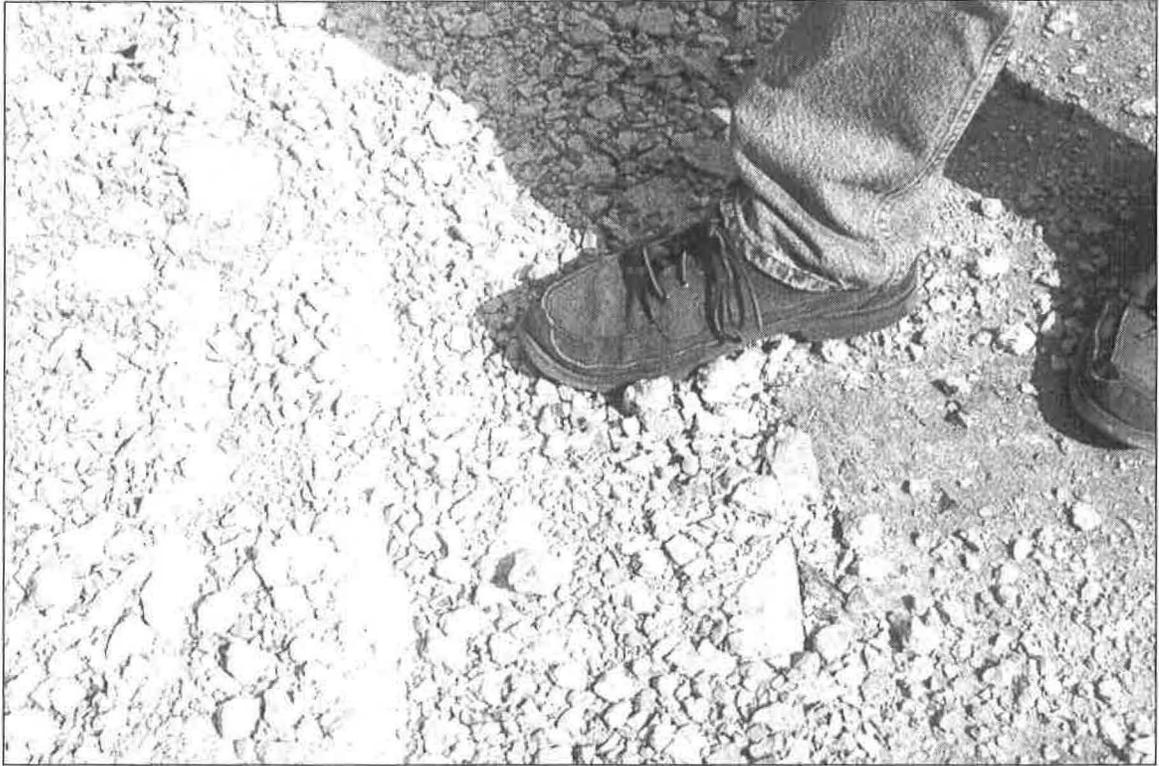
**Figure 2.3 Rubblized Pavement.**

The new granular base is considered to be a high-strength base material because of the particle-shape properties that rubblized particles possess. These properties can be described as a puzzle (Kirk, 2001). The granular puzzle acts as a flexible system using aggregate interlock to transfer the applied loads to the subbase or subgrade.

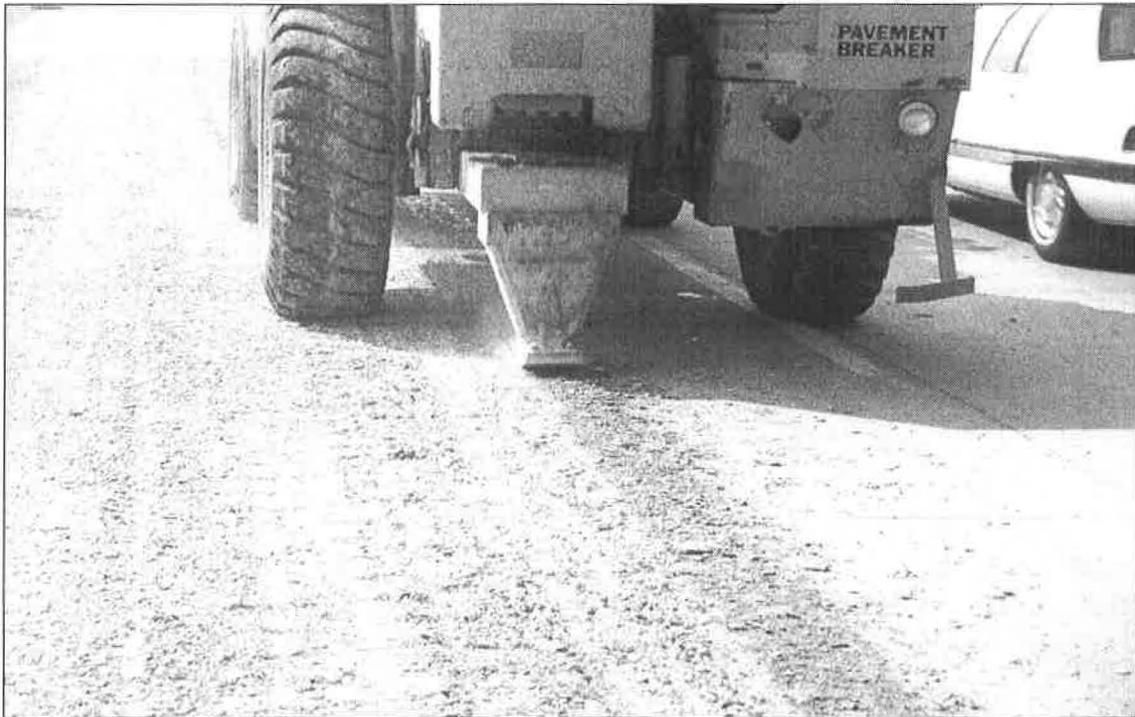
**Figure 2.4 Resonance Frequency Breaker (Photo courtesy of Dr. Kevin Hall, University of Arkansas).**

In 1986 John Brizzell, a New York Department of Transportation materials engineer, observed the resonance breaker and thought that it might eliminate reflective cracking. He recommended that the process be called rubblization (Kirk, 2001). The resonance frequency breaker uses a 15 cm (6 in) shoe located on the end of a pedestal that is connected to a beam with 5443 kg (12,000 lbs) counter weight located at the opposite end of the beam to break up the PCC pavement. This machine uses a low

amplitude (<12.5 mm) high frequency (44 Hz) shoe to deliver energy to the slab that is near the harmonic frequency of PCC. Figure 2.4 shows an illustration of the shoe that is used to rubblize PCC. This results in an area of high tension at the top of the PCC and causes the slab to fracture on a shear plane approximately 35 degrees from the pavement surface (Fitts, 2001).

The resonant frequency breaker can effectively rubblize 1.0 to 1.7 lane-miles/day (1.6 to 2.7 lane kilometers/day). Kirk (2001) suggests, in a study that was performed nine years after the Witczak and Rada study, that rubblization with the resonance breaker may not be the best rehabilitation alternative if the existing subgrade condition is deteriorated significantly, has extensive clays, and/or has entrained water. This observation is important because it stated that even though the rubblization process was originally recommended for all types of subgrade conditions, research suggests that it may perform better under certain circumstances. These conditions are not favorable for rubblization with the resonance breaker because protecting the subgrade is a top priority. With the adverse conditions mentioned earlier, the rubblization process could damage the subgrade (i.e., by forcing fractured PCC pieces into the subgrade causing structural inconsistencies or stress focal points).

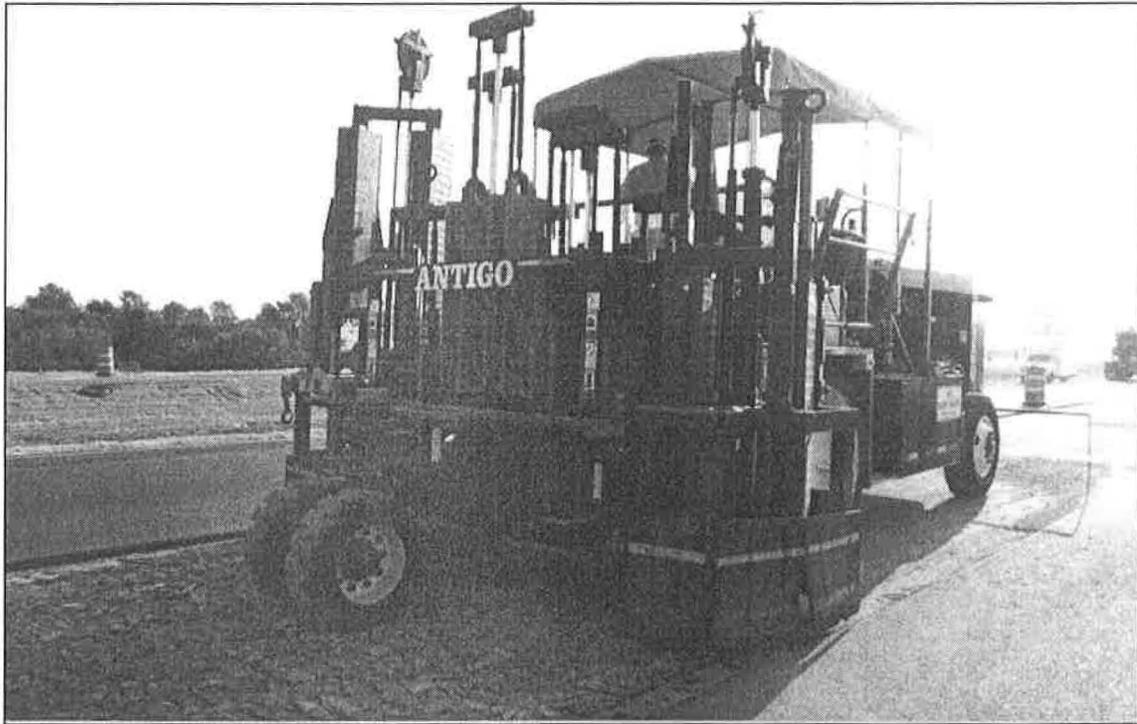
**Figure 2.5 Multi-Head Breaker (photo courtesy of Dr. Kevin Hall, University of Arkansas).**

The MHB (Figure 2.5) operates by dropping a series of twelve to sixteen 102 to 123 lbs. (454 to 545 N) hammers on the PCC slab generating between 2,000 ft-lbs and 12,000 ft-lbs. (2,700 and 16,000 J). This crushes the pavement into a granular base and is capable of pulverizing pavements widths ranging from 2 ft to 12.5 ft (.61 to 4.0 m) (Fitts, 2001). The MHB allows a one-pass rubblization process and eliminates the subgrade stability issues. The one pass approach of the MHB eliminates the shoving or punch through of fractured PCC pieces which damages the subgrade. It can effectively rubblize 0.75 to 1.0 lane-mile/day (1.2 to 1.7 lane-kilometers/day) (Thompson, 1997). It is interesting to note that although the MHB has a one-pass capability, the rate of rubblization per day is less than the rate of the resonance frequency breaker.

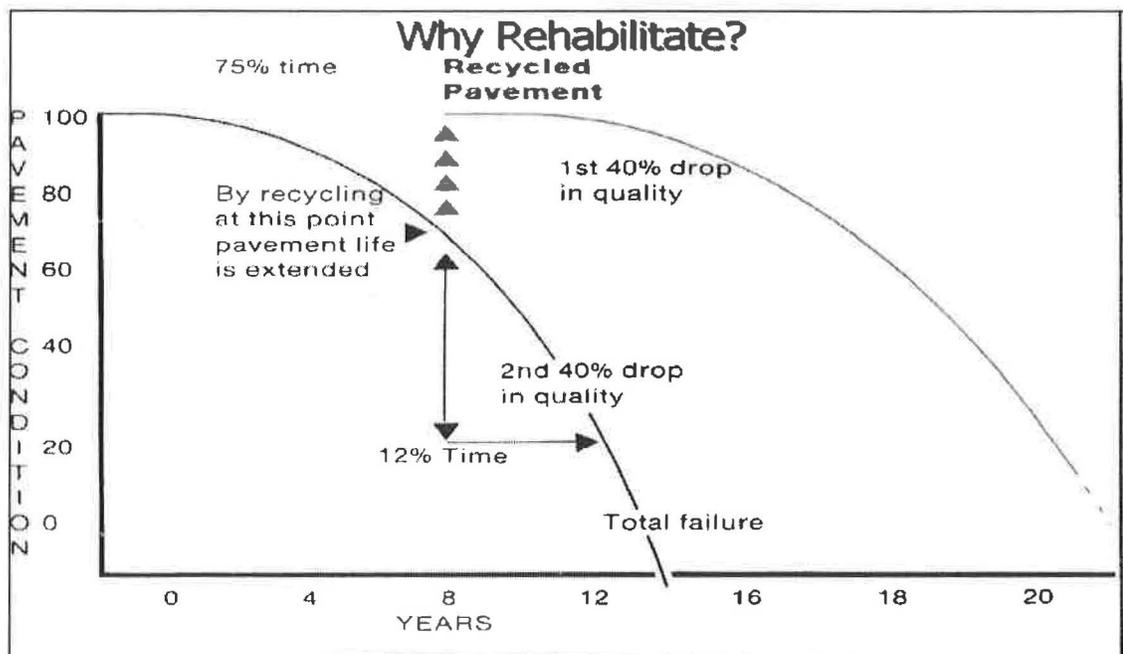
Figure 2.6 Benefits of Pavement Rehabilitation (Asphalt Recycling and Reclaiming Association, 1996).

With research to support the feasibility of the fractured slab procedures, another very important concern that all agencies face when dealing with pavement rehabilitation is the cost of construction. The World Bank (1996) conducted research on the feasibility of pavement system maintenance. They found that it will cost four to five times more if maintenance is delayed until the pavement loses 80% of its original quality than it would if maintenance was done during the first 40% drop in pavement quality (Figure 2.6). It is also important to notice the trend in which the pavement tends to deteriorate; with this downward exponential deterioration rate, not only does the rehabilitation save monetary resources, but also increases the projected life of the pavement tremendously.

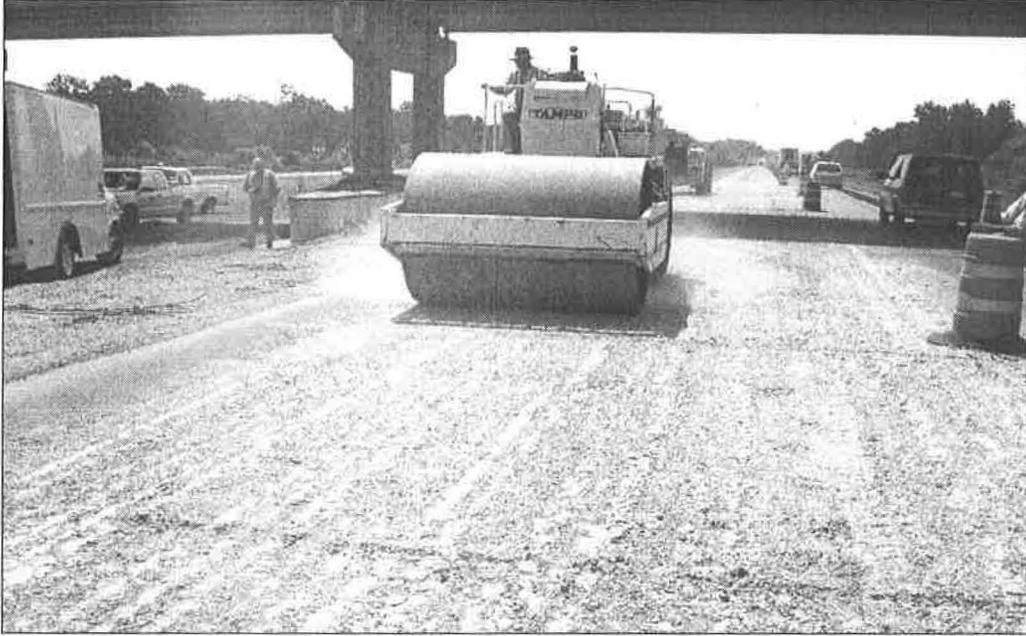
**Figure 2.7 Seating the Pavement (photo by Kevin D. Hall, University of Arkansas).**

Before the HMA can be placed, the proper seating of the rubblized material must be achieved. The compaction is obtained using no less than one pass of a vibratory steel wheel roller having a nominal gross weight of at least 20 tons (ALDOT, 2001). Figure 2.7 demonstrates the use of the steel roller to seat the rubblized pavement. In the next step of the compaction process, the steel wheel roller will be followed by at least one pass of a self-propelled pneumatic roller. The pneumatic roller should have a gross weight of at least 25 tons. This roller is to be followed by two additional passes of the steel wheel roller. When rubblizing reinforced concrete, the reinforcing steel is to be left in place, unless it is exposed at the surface. In the event the reinforcing steel is exposed during the rubblization or compaction process, it is to be cut below the surface and removed from the job site (ALDOT, 2001).

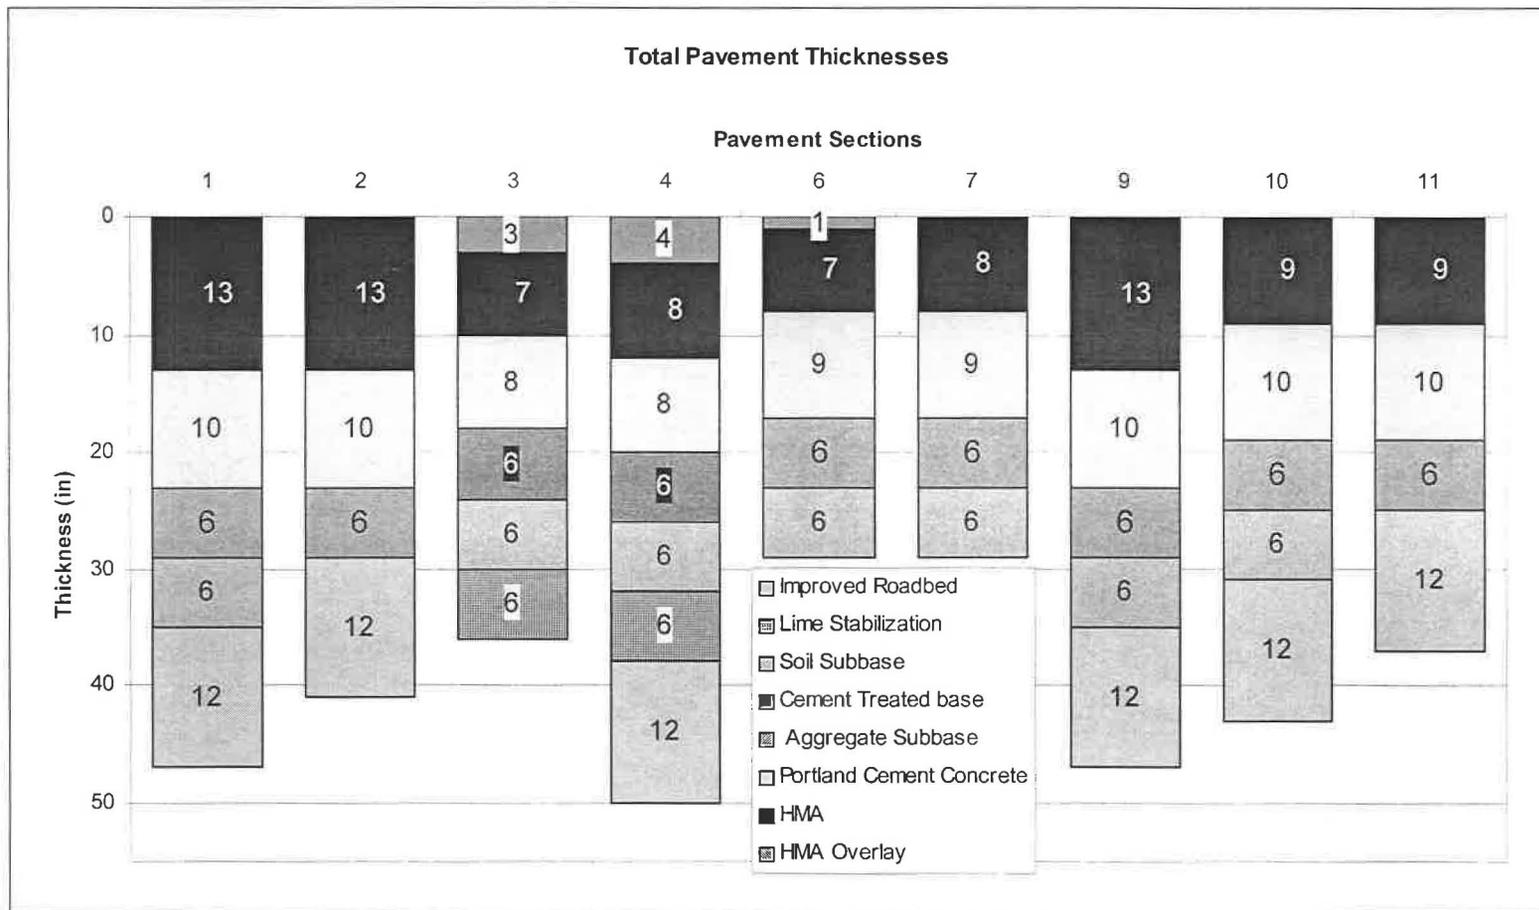
**Figure 3.2 Total Pavement Thicknesses of Rubblized Sections.**

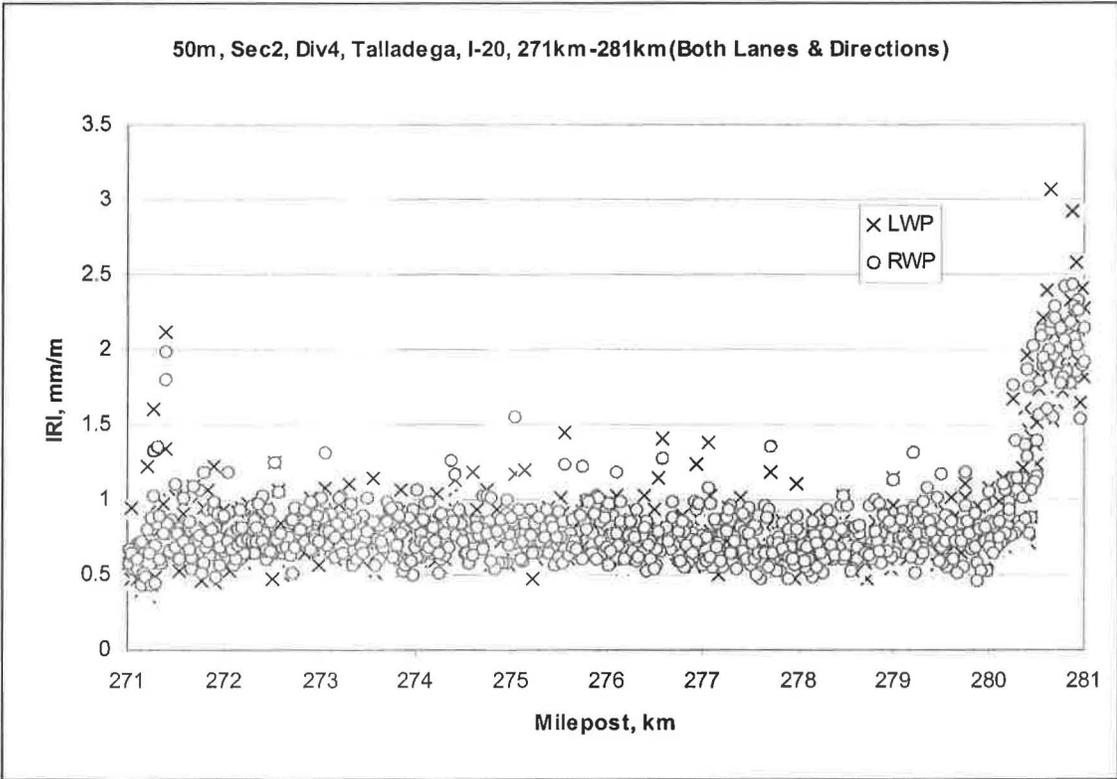
**Figure 4.1 2001 IRI vs. Distance for Section 2.**

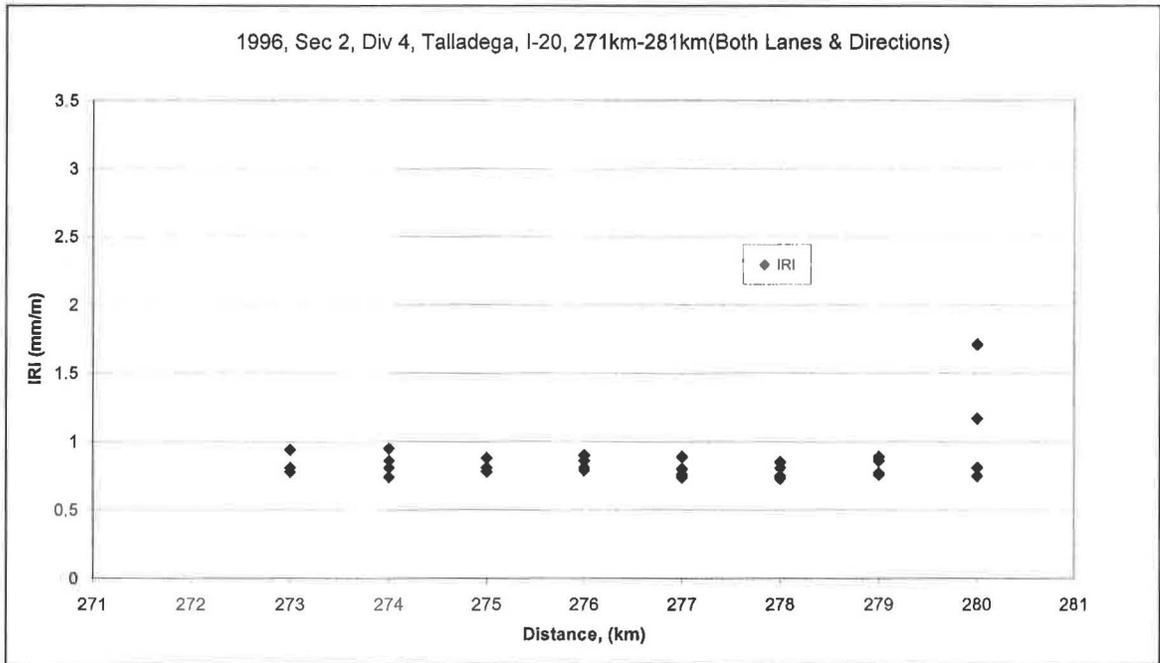
**Figure 4.2 1996 IRI vs. Distance for Section 2.**

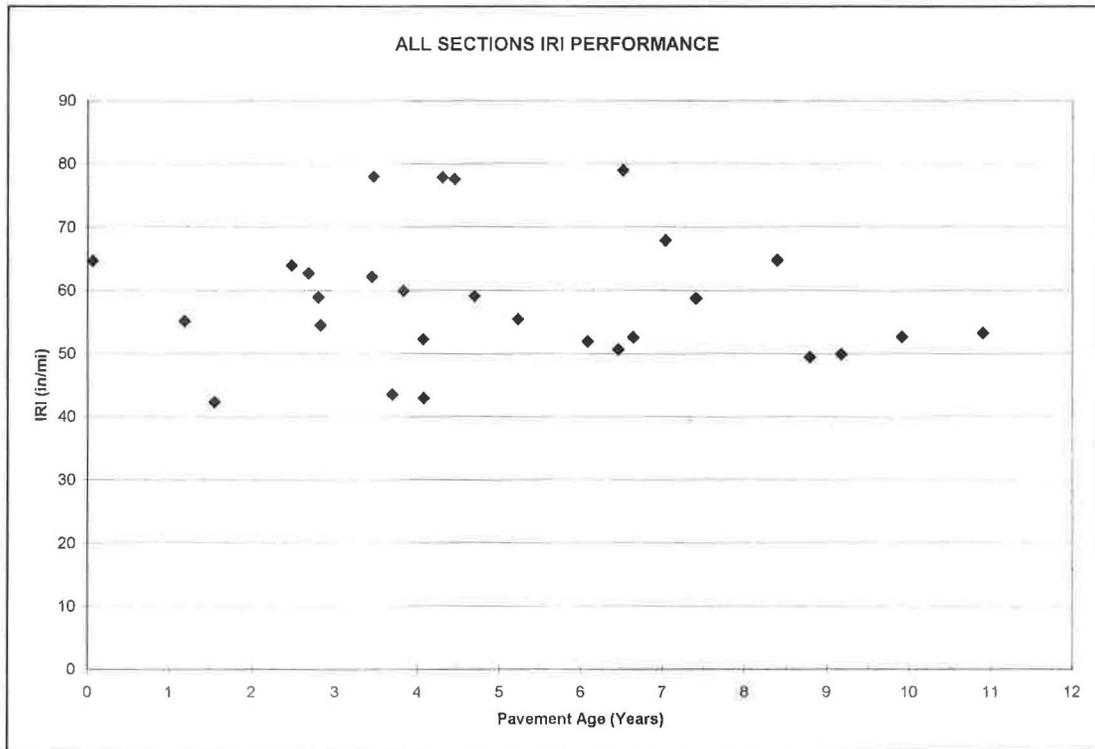
**Figure 4.3 IRI vs. Pavement Age.**

Having discussed the amount of data and types of data available for analysis, the next step was to organize the information in a way to allow the comparison of each rubblized section. To begin the comparison of the rubblized pavement sections, the distresses obtained from ALDOT that were discussed earlier were plotted against the age of the section (Figure 4.3). The format used above proved to be effective in quickly determining the overall performance of the rubblized sections.

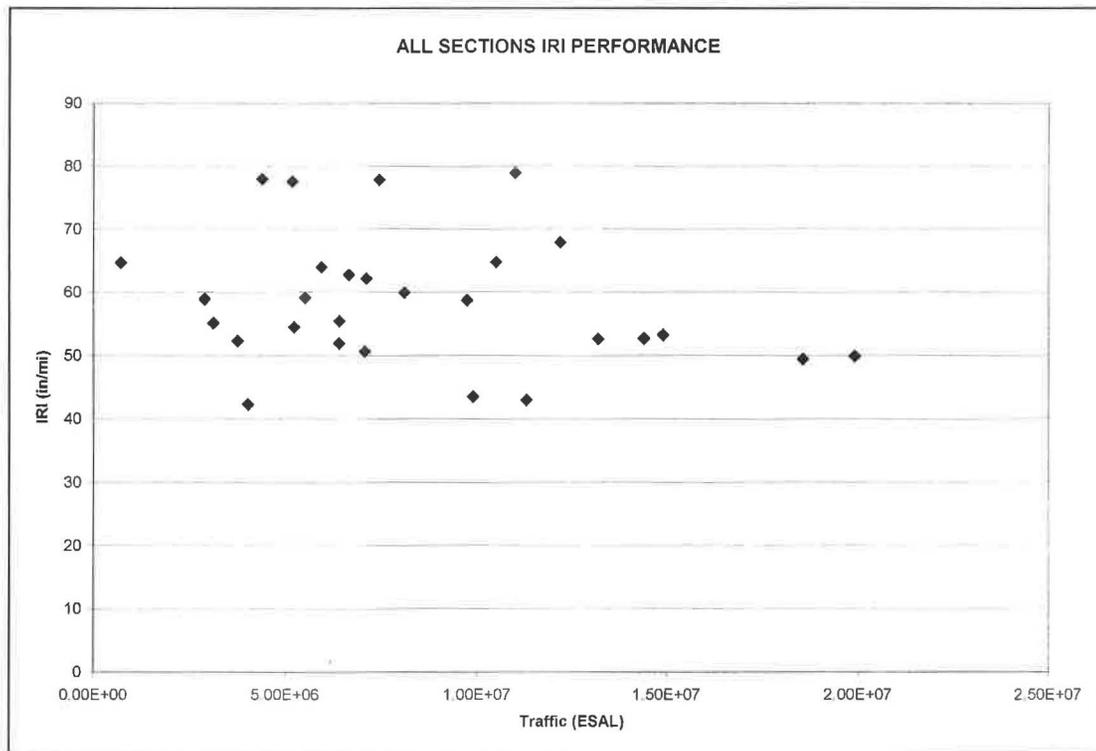
**Figure 4.4 IRI vs. Traffic.**

For the initial comparison, the calculated ESALs were compared to the IRI data from the PMS database. By comparing the ESALs to IRI, it was possible to investigate the effects of traffic on the rubblized pavement sections in terms of roughness (Figure 4.4).

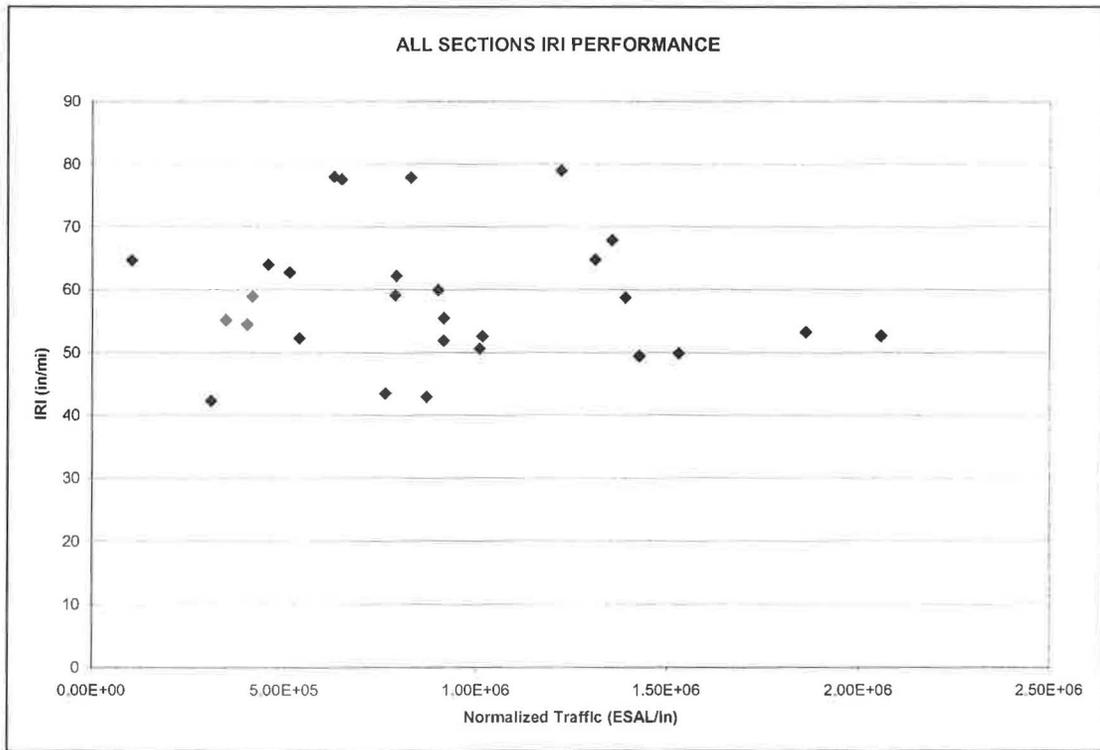
**Figure 4.5 IRI vs. Normalized Traffic.**

The above-mentioned methods of comparing the rubblized pavements were very helpful to understand the effects of traffic on rubblized pavements, with similar site conditions and construction specifications. However, comparing the distress directly to ESALs does not take in consideration the different thicknesses of the HMAC overlays. To account for this variation in overlay thickness the cumulative ESALs were divided by the pavement thickness to yield ESALs per inch (Figure 4.5).

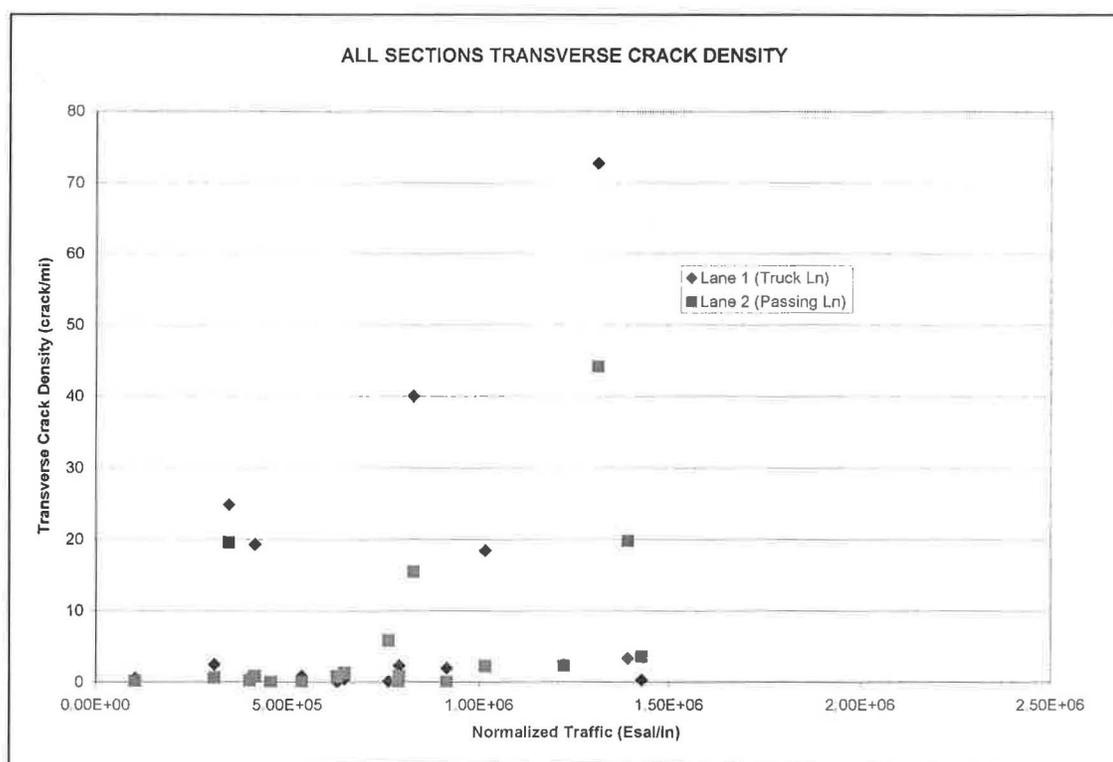
**Figure 5.1 Transverse Crack Densities vs. Normalized Traffic.**

The data from all of the sections were combined and analyzed with no distinction between the individual rubblized sections. The distresses were plotted for the combined data to better understand how the rubblized pavements were performing in general (See Figures 5.1 – 5.5). The first distress that was evaluated against the three standards is the transverse crack density presented in Figure 5.1.

When studying Figure 5.1, it is important to note that lane one has the highest levels of transverse crack density. This observation is logical because the heaviest vehicles tend to travel in lane one or what is commonly referred to as the truck lane. Another important observation is the magnitude of the data also seems to increase as the pavement age increases.

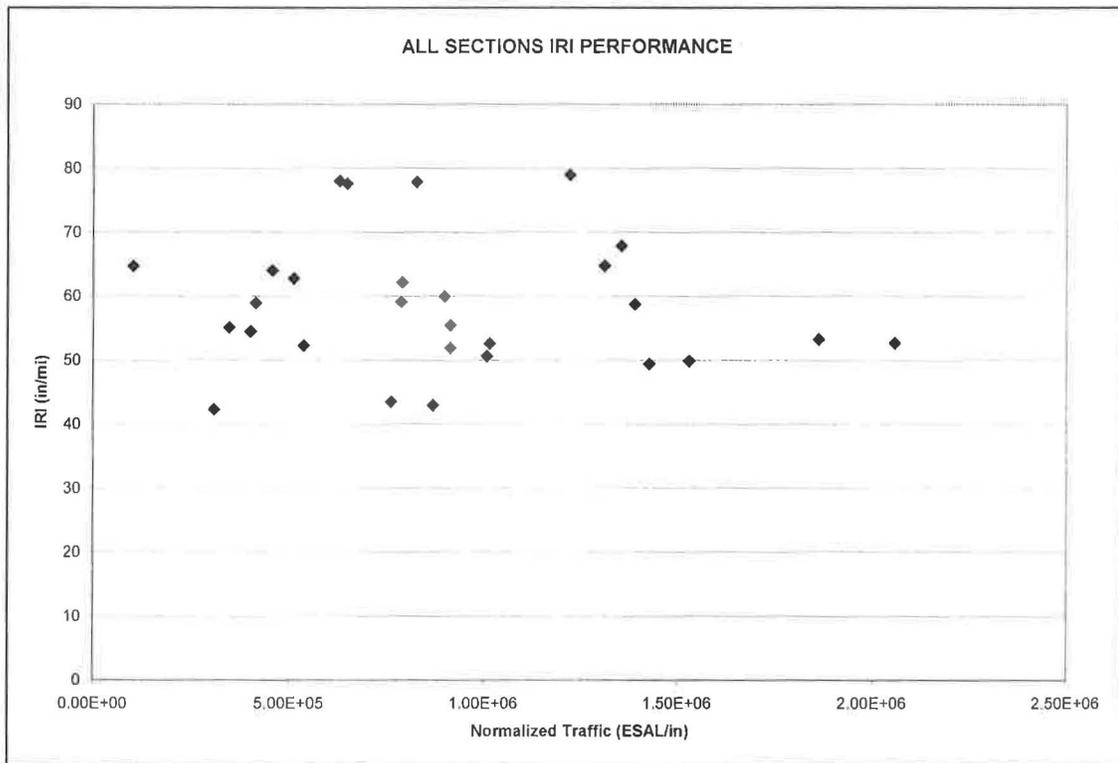
**Figure 5.2 IRI vs. Normalized Traffic.**

The next distress that was plotted was IRI (Figure 5.2). As a whole, all of the sections appeared to have a distress level with a fair amount of scatter, neither increasing nor decreasing since the date of rubblization. The average IRI value for all the rubblized sections was 57 in/mile (0.9 m/km). To gain a better perspective of the IRI performance, the average IRI for the rubblized section was compared to the threshold values mentioned in Chapter 4. The AASHTO 2002 Guide establishes 252 in/mile (3.98 m/km) as a critical threshold and Oregon and Washington Departments of Transportation established a threshold of 133 in/mile (2.10 m/km) for a three-year-old pavement section. Comparing Alabama's rubblized sections with an average age of five years and an average IRI of 57 in/mile (0.9 m/km), it appears that the sections are performing well, surpassing industry standards.

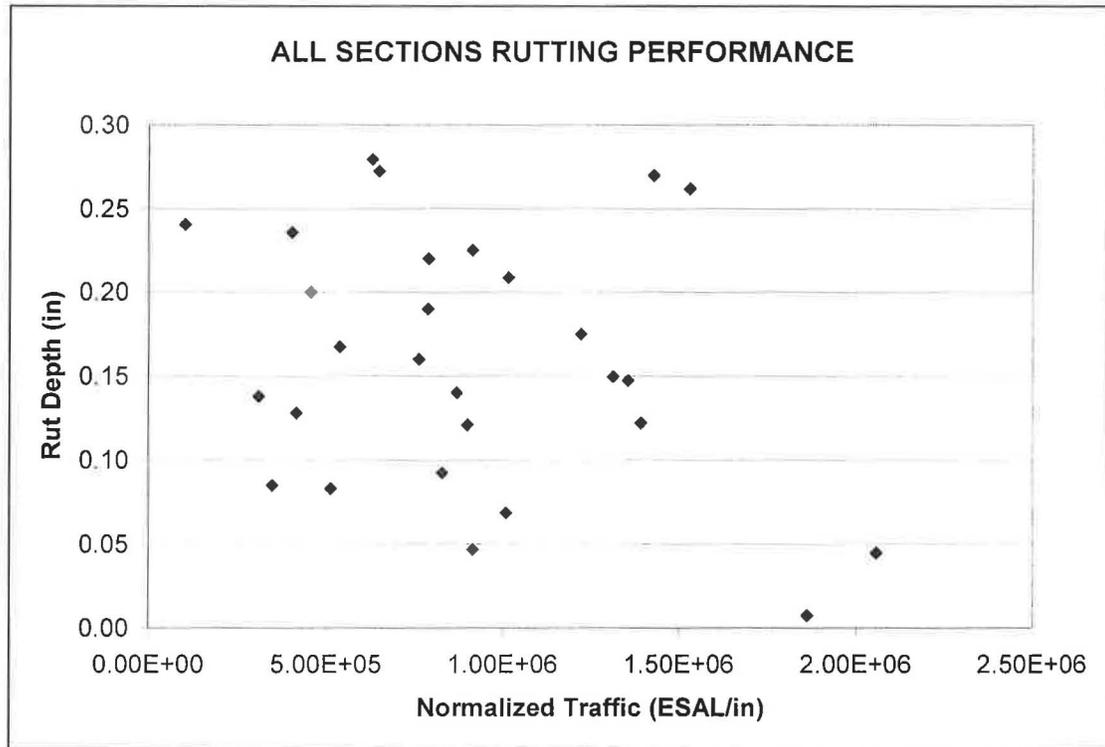
**Figure 5.3 Rut Depths vs. Normalized Traffic.**

In Figure 5.3, the average rutting values were plotted against the normalized traffic of the pavement section. There appeared to be no recognizable pattern to the distribution of the rutting values. It is important to note that none of the rutting values exceed three-tenths of an inch, and all sections combined have an average rut value of 0.16 of an inch. Also noted is that the 0.16 of an inch, at an average pavement age of five years, is well below the 0.75 of an inch value established by AASHTO, 0.375 inch for a three year old pavement section in Oregon and Washington, and finally 0.25 of an inch in Wisconsin for a five year old pavement. This comparison suggests that the rubblized pavement sections are rutting at a minimum level. This minimum amount of rutting could possibly be contributed to the seating of the rubblized PCC pavement or densification of the mix under traffic. The fact that there is not an excessive amount of

rutting present in any of the rubblized sections could be attributed to the significant structural cross sections. In other words, one would not expect to see deep structural rutting due to failure of the subgrade.

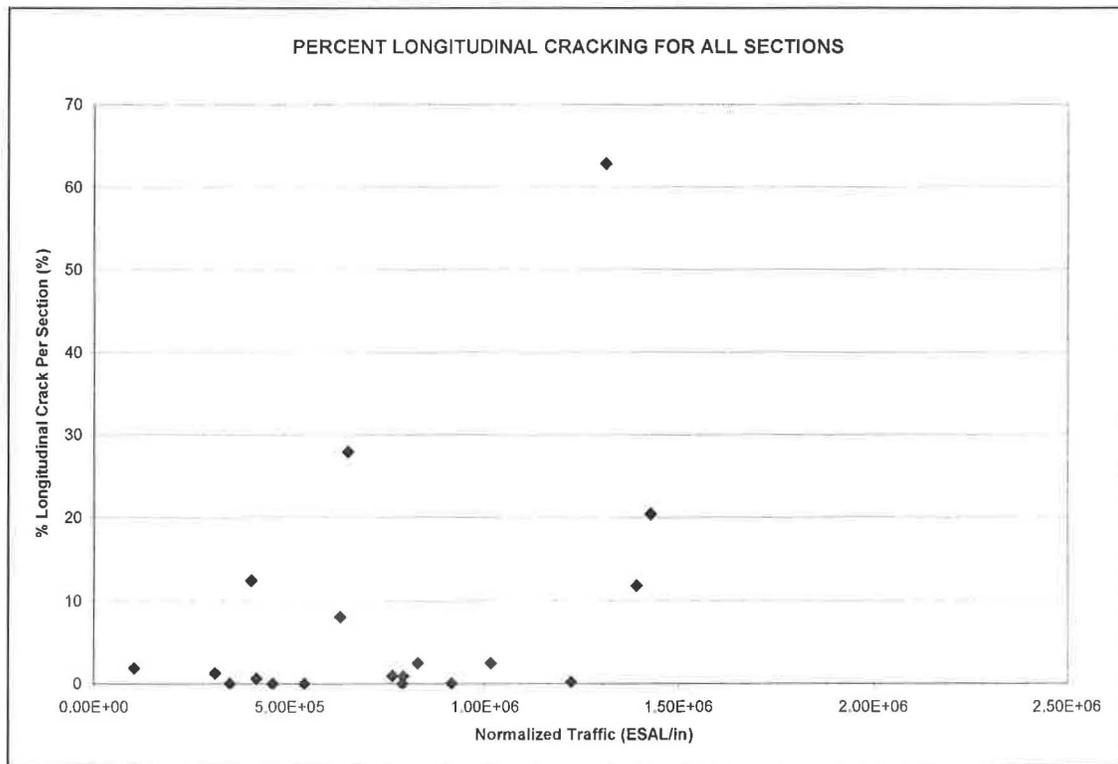
**Figure 5.4 Percent Longitudinal Cracks vs. Normalized Traffic.**

The next performance graphs that were evaluated were the percent longitudinal cracking in the rubblized pavement sections. These data are provided in Figure 5.4. At first glance, the data present a trend that forms a logical pattern. This trend shows that as the pavement age increases, the magnitudes of the distress also increase.

established by proposed AASHTO 2002 Design Guide. When compared to the thresholds established by Oregon and Washington, the eight percent average exceeds the 5.5 percent threshold. This comparison seems to suggest that the Alabama rubblized sections have surpassed the Oregon and Washington thresholds.

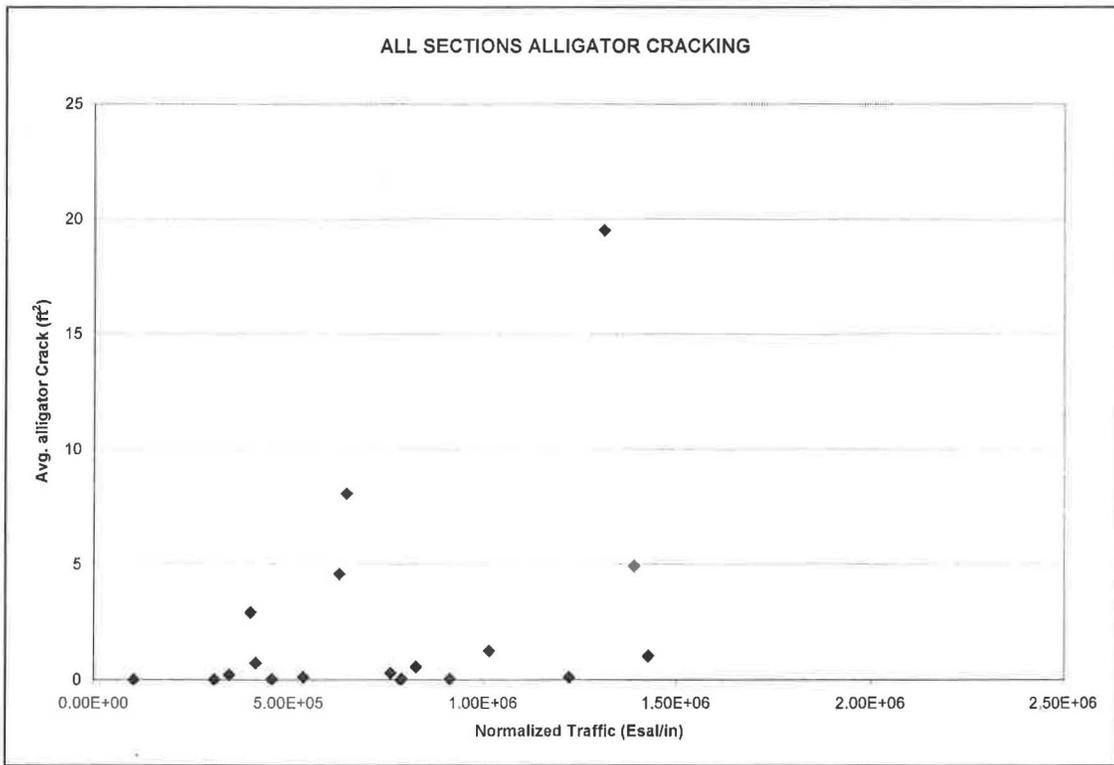
**Figure 5.5 Average Alligator Cracks vs. Normalized Traffic.**

The final pavement distress that was evaluated in this research was alligator cracking. As shown in Figure 5.5, the trend of deterioration seems to follow the pattern observed in Figure 5.4. As the pavement age increases, the magnitude of the distresses also increases. The average alligator cracking for the Alabama rubblized sections is only two square feet per rubblized section. If the two square feet average was compared to the thresholds of eight and ten percent, which are mentioned in Chapter 4, the two feet would be less. When the average two square feet is converted to a percent of total area, assuming 12-foot lanes, the value is less than 0.001 percent. This leaves a lot of room before any maintenance thresholds are met.

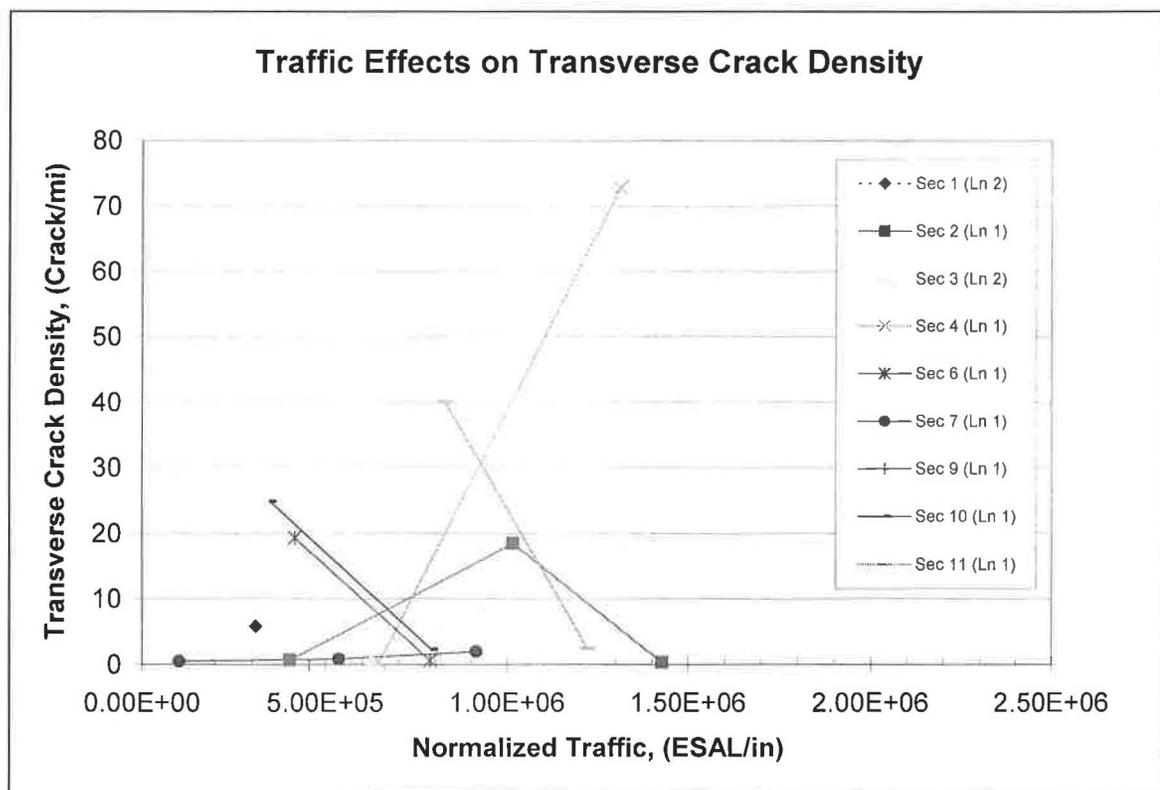
**Figure 5.6 Transverse Crack Density vs. Normalized Traffic.**

Upon analysis of the percent of transverse crack density graph, there were two main points to be noted. The first is that section four has the highest levels of distress. The possible reason for this high level will be stated later. The second point is that in most cases lane one exhibited the highest levels of distress. The fact that the higher levels of distresses are present in lane one seems logical because the higher volume of heavy vehicles travel in this lane.

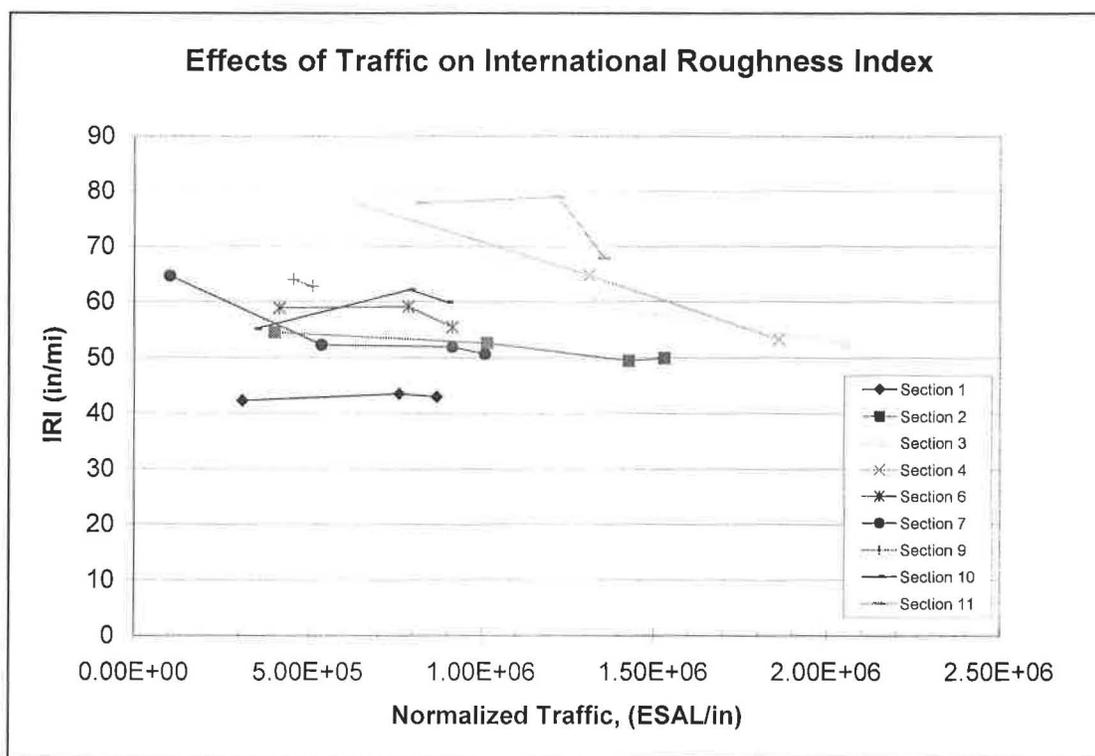
**Figure 5.7 IRI vs. Normalized Traffic.**

In Figure 5.7 the IRI distresses are evaluated for unique trends. There are two major points to recognize when analyzing the IRI graphs. The first is that in most of the sections the values of the given distress decreased initially. After the HMA overlay has been constructed, a certain degree of compaction under vehicular traffic evidently takes place. This reduction in IRI values could possibly be a direct result of the rubblized

pavement seating from increased traffic loading. This trend is also shown in Figure 5.10 where the distress data from Highway 280 are presented. The second point to be made about Figure 5.7 is that sections three and four, the two CRCP, are among the sections exhibiting the highest levels IRI distress.

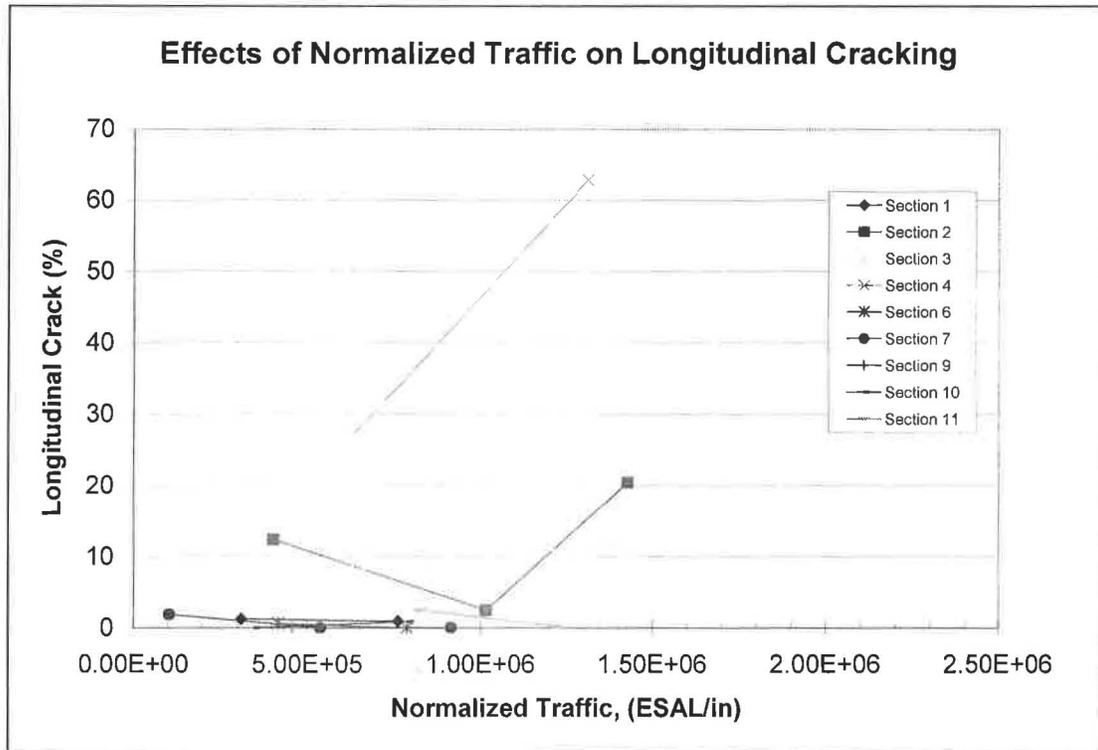
Figure 5.8 Percent Longitudinal Cracking vs. Normalized Traffic.

Next, percent longitudinal cracking and average alligator cracking were explored by pavement section in Figures 5.8 and 5.9. These two distresses will be discussed at the same time because they both have similar trends and are consistent throughout the data. Both distresses are present in low amounts throughout the Alabama rubblized pavements. As noted above, sections three and four are again among the sections that have the largest amounts of distresses present. Reviewing the distresses on section-by-section bases,

provided an important perspective into the performance of the rubblized sections. Observing that sections three and four consistently had the highest levels of distress, raises questions about the possible causes for their elevated levels.

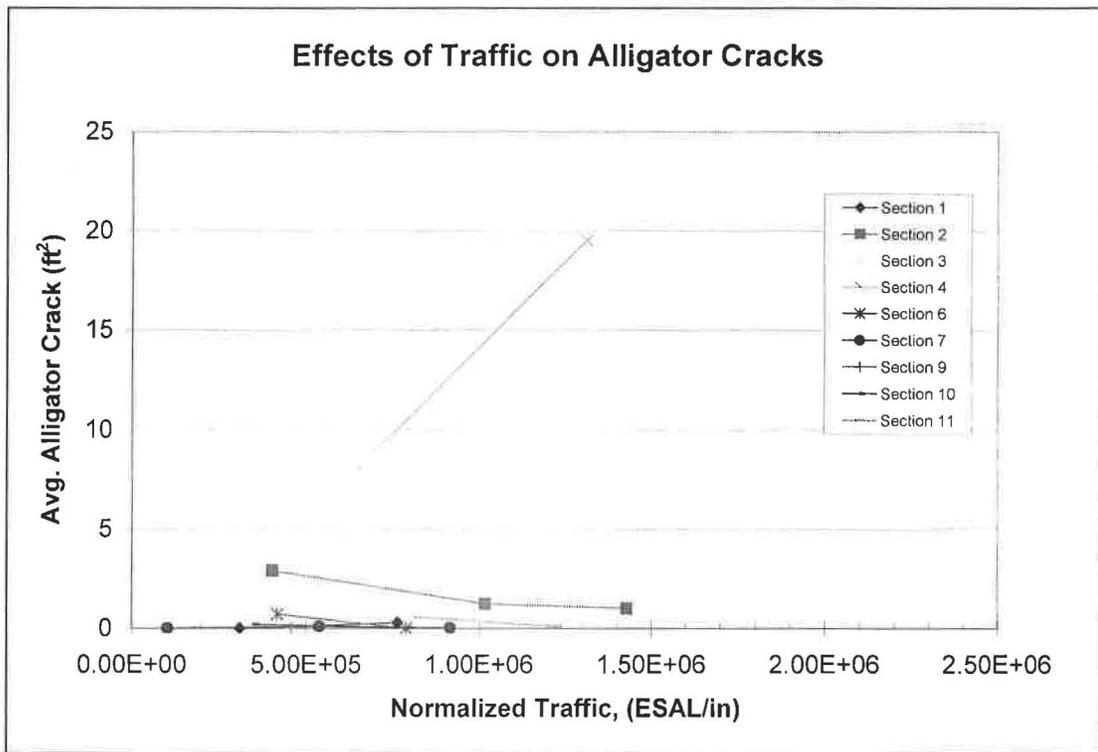
**Figure 5.9 Average Alligator Cracking vs. Normalized Traffic.**
