# PERFORMANCE OF RUBBLIZED PAVEMENT SECTIONS IN ALABAMA

**Final Report**

**Highway Research Center**

**Auburn University**

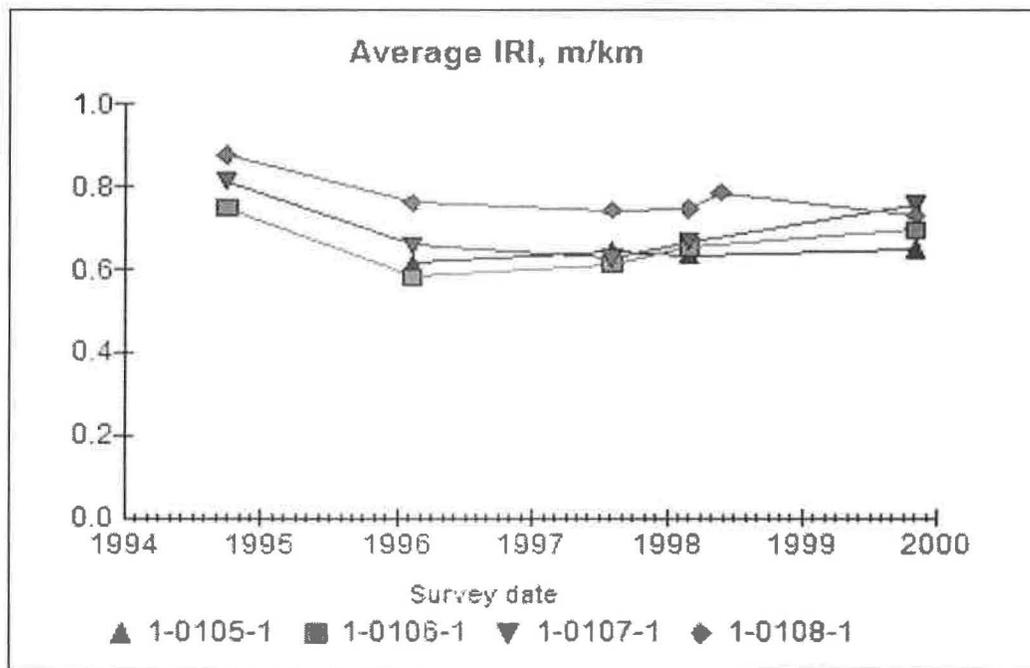
Figure 5.10 IRI vs. Survey Date for Highway 280.

pavement seating from increased traffic loading. This trend is also shown in Figure 5.10 where the distress data from Highway 280 are presented. The second point to be made about Figure 5.7 is that sections three and four, the two CRCP, are among the sections exhibiting the highest levels IRI distress.

LTPP database. This was included to illustrate the decrease in IRI levels. This decrease was also observed in the IRI levels in the above-mentioned rubblized pavements. Table 5.3 is shown below Figure 5.10 for a direct comparison of the two different measurement systems.
