Research Report No. 2F for ALDOT Project 930-601

**REPAIR OF CRACKED PRESTRESSED  
CONCRETE GIRDERS, I-565,  
HUNTSVILLE, ALABAMA**

**JULY 2011**

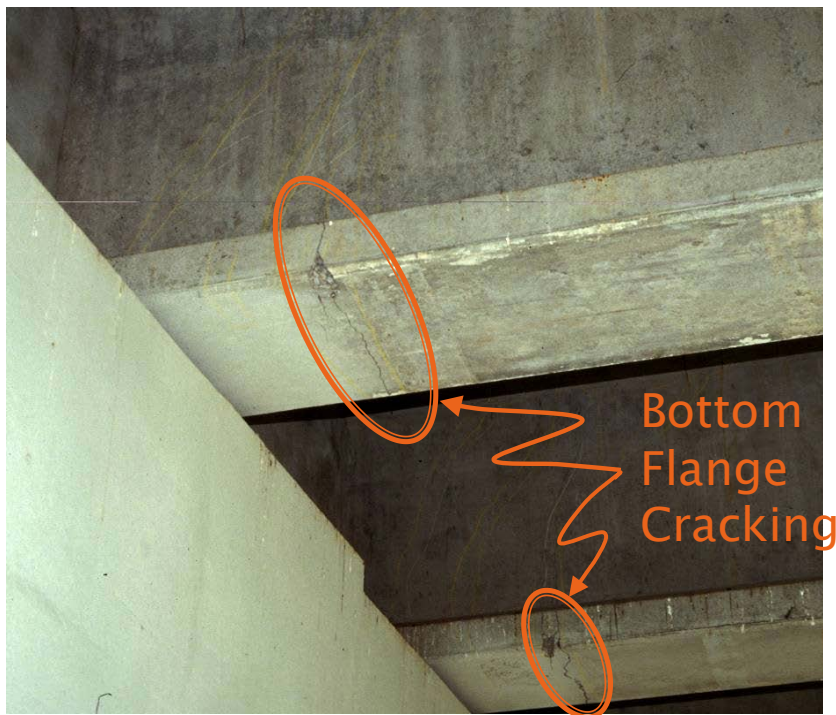
Spans of the elevated portion of interstate highway I-565 in Huntsville, Alabama were constructed to be multi-span continuous structures for post-construction loads. Elevated portions of the interstate are shown in Figures 1.1 and 1.2. In 1992, shortly after construction was completed, large and unexpected cracks were discovered at the continuous end of many prestressed concrete bulb-tee girders within these spans. Cracking of two adjacent prestressed concrete girders of I-565 is shown in Figure 1.3.

**Figure 1.3: Cracked pre-tensioned bulb-tee girders of I-565 (Barnes et al. 2006)**

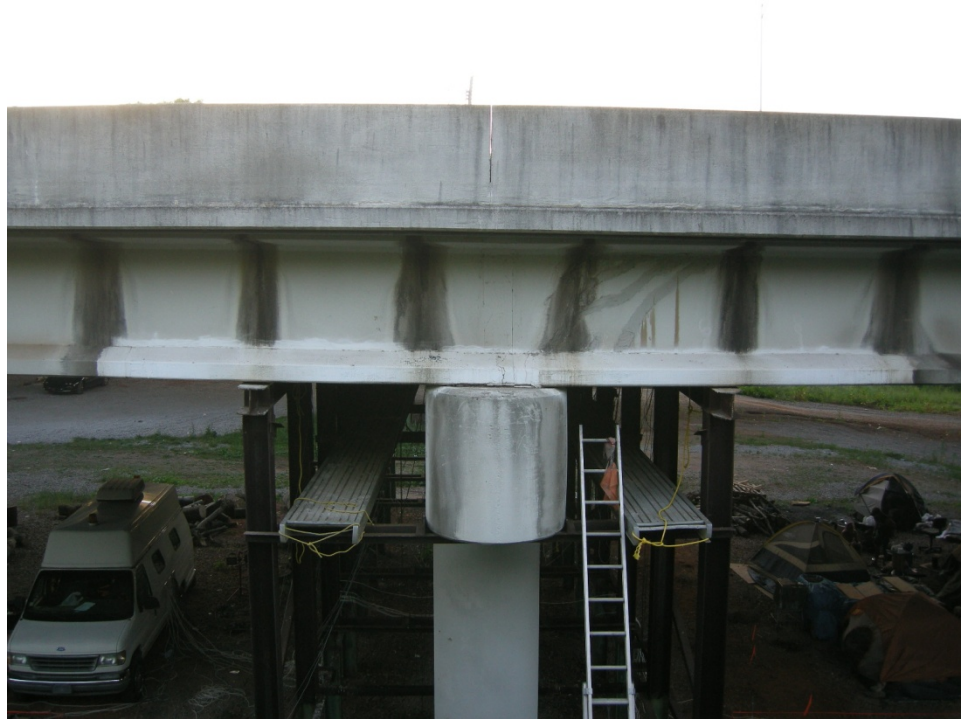
**Figure 1.4: Girder 9 of Northbound Spans 10 and 11—repaired**

desirable to develop a repair solution for these conditions that would require minimal traffic disruption or delay during repair. The proposed FRP reinforcement system, which was installed on Northbound Spans 10 and 11 of I-565 in Huntsville in December of 2007, provides an unobtrusive repair solution, but this solution required verification through testing before further implementation could confidently be recommended. Girders repaired with FRP reinforcement are shown in Figures 1.4 and 1.5.

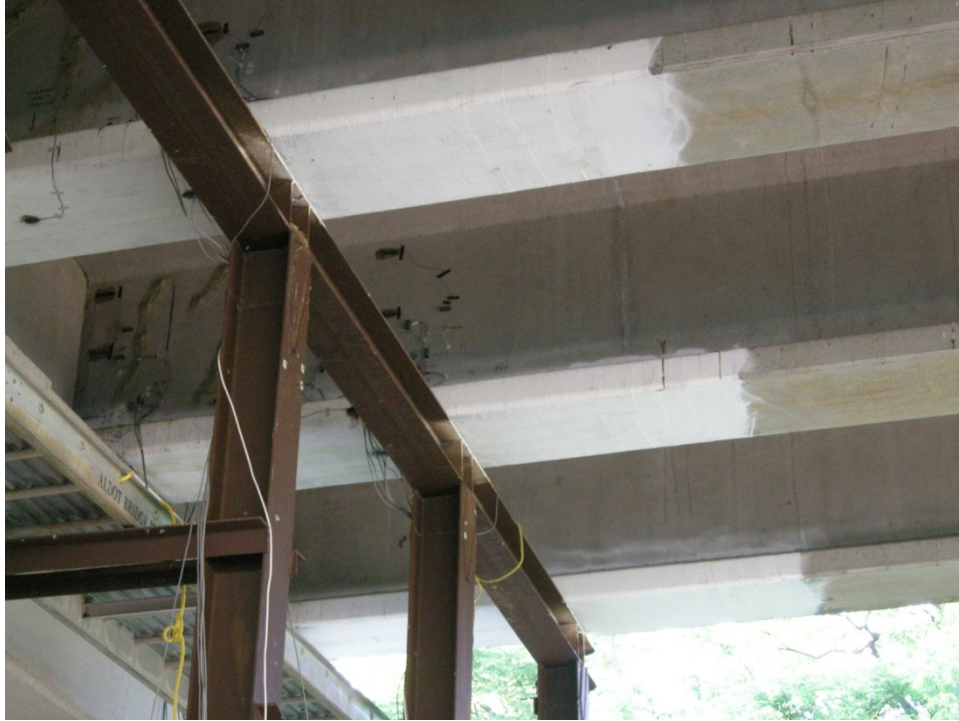
**Figure 1.5: Girders 7, 8, and 9 of Northbound Span 10—repaired**

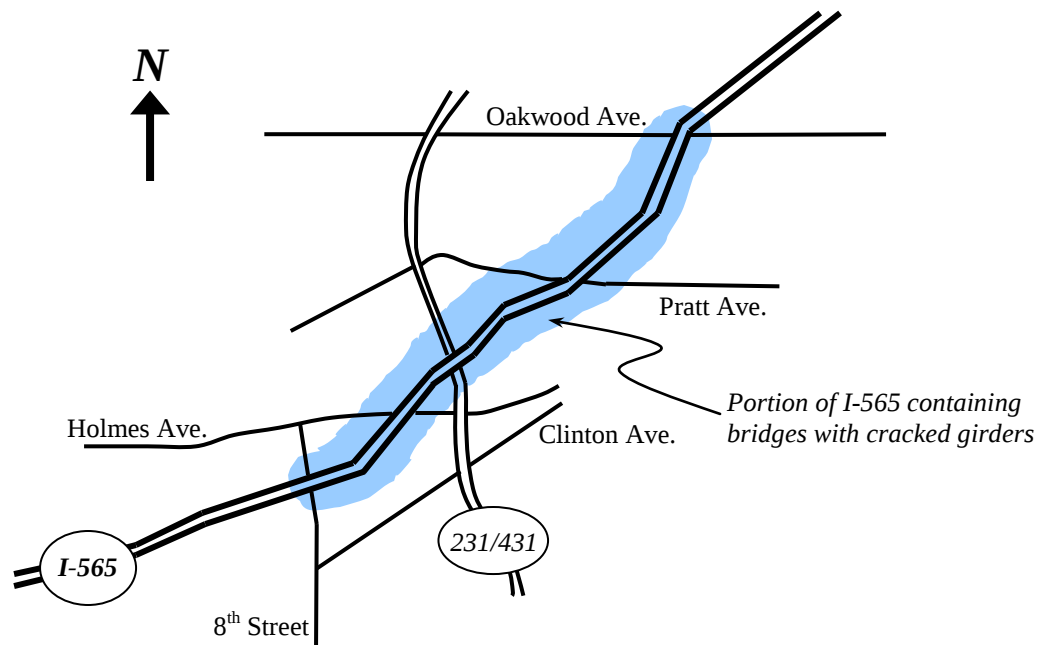
Cracked girders were found at ten different sites between Eighth Street and Oakwood Avenue (ALDOT 1994). The portion of I-565 containing cracked bridge girders is illustrated in Figure 2.15. The pattern of cracking found in one BT-54 girder of Span 5 is illustrated in Figure 2.16. The inclined web cracks were limited to approximately 0.06 in. (1.5 mm) due to the transverse reinforcement that the cracks intersected. The vertical bottom-flange cracks only crossed the longitudinal prestressed strands and crack widths were not controlled by transverse reinforcement. Some of the larger bottom-flange cracks with widths up to 0.25 in. (6 mm) were visible from the ground in 1994, as shown in Figure 1.3.

Figure 2.15: Portion of I-565 containing cracked bridge girders (Swenson 2003)

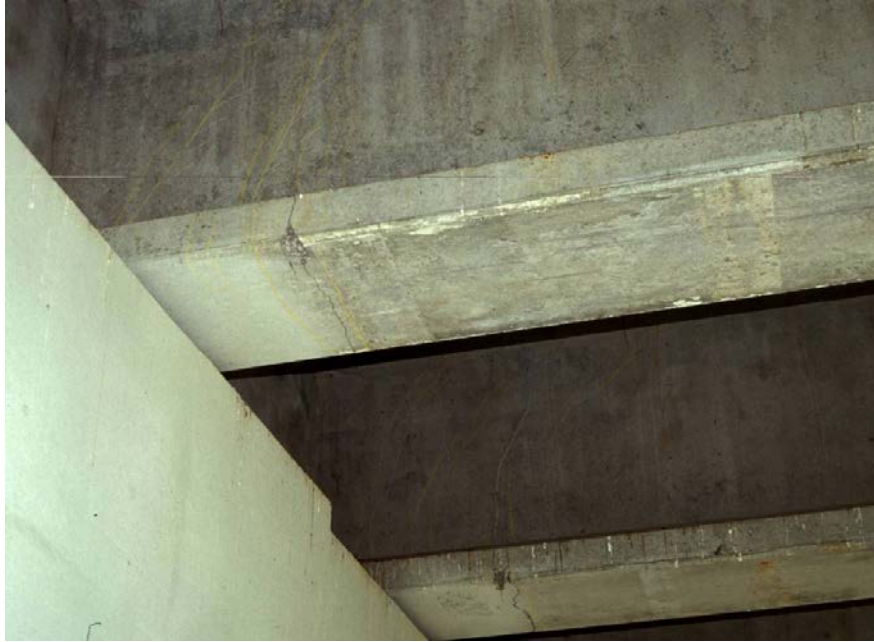
**Figure 2.17: Cracked pre-tensioned bulb-tee girders (Barnes et al. 2006)**

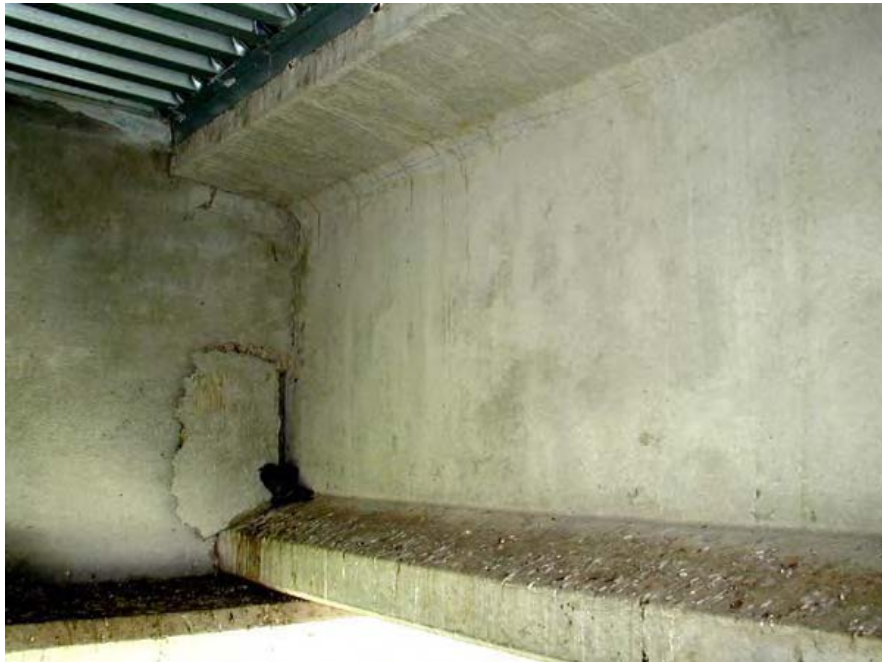
The 1994 investigation also resulted in the discovery of continuity diaphragm cracking. The two types of cracks present in some of the continuity diaphragms were face cracks and end cracks. An example of a typical continuity diaphragm face crack can be seen in Figure 2.18, and an example of a typical diaphragm end crack can be seen in Figure 2.19. Approximately 57 percent of bents supporting bulb-tee girders contain diaphragm face cracks, and roughly 85 percent of bent contain diaphragm end cracks. All interior bents in two-span continuous structures constructed with BT-54 girders exhibit diaphragm end cracks (ALDOT 1994).

**Figure 2.18: Typical diaphragm face crack (Swenson 2003)**

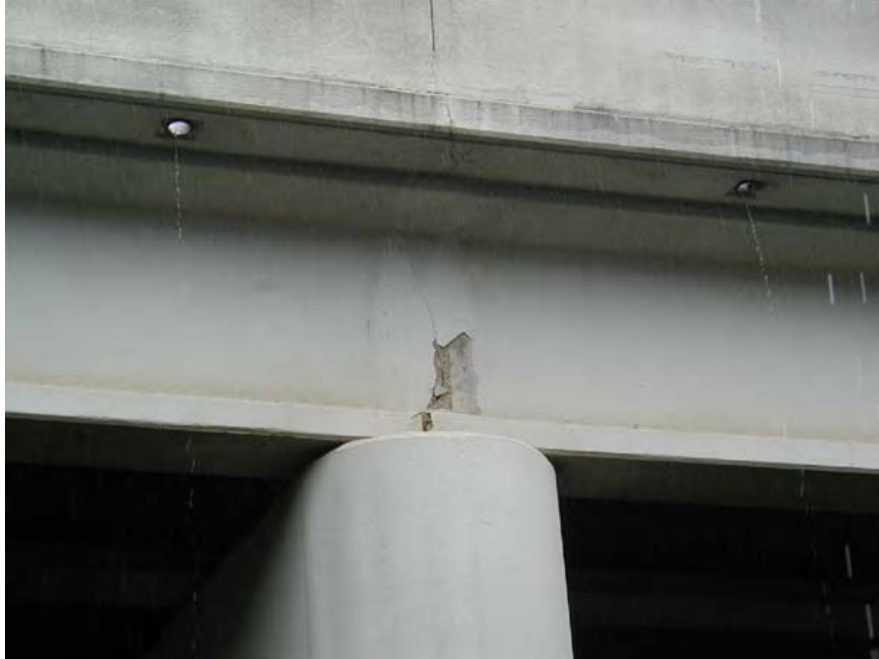
**Figure 2.19: Typical diaphragm end crack (Swenson 2003)**

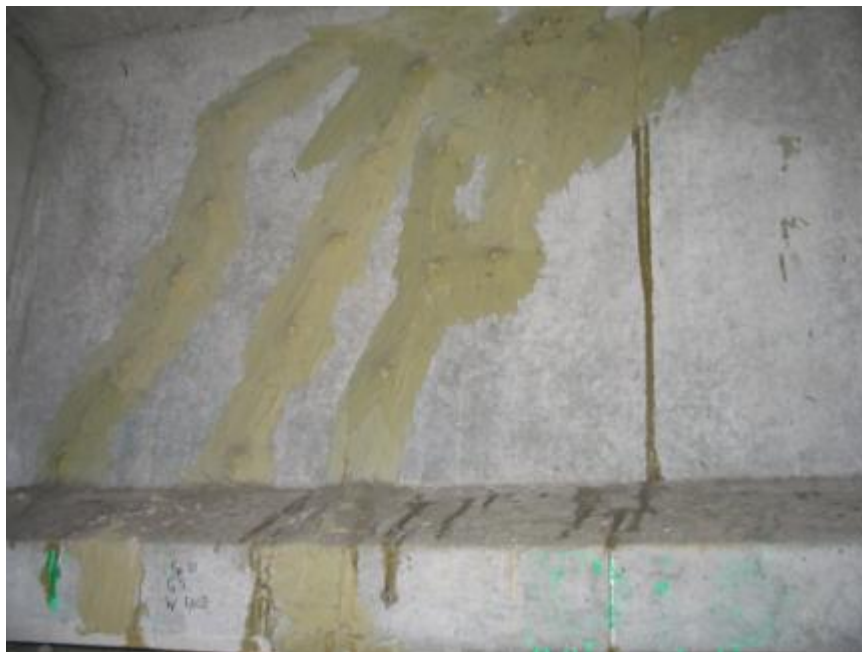
**Figure 2.20: Cracks injected with epoxy (Fason 2009)**

The severity of the cracks required immediate attention, and ALDOT personnel responded to the situation accordingly. The initial repair technique involved injecting the cracks with a structural epoxy, as shown in Figure 2.20, in an attempt to seal existing cracks and prevent future crack growth. However, new cracks often formed near the epoxy-injected cracks, and many epoxy-injected cracks reopened, indicating that this repair technique was ineffective. Other safety measures had to be implemented before a more effective repair method could be determined.

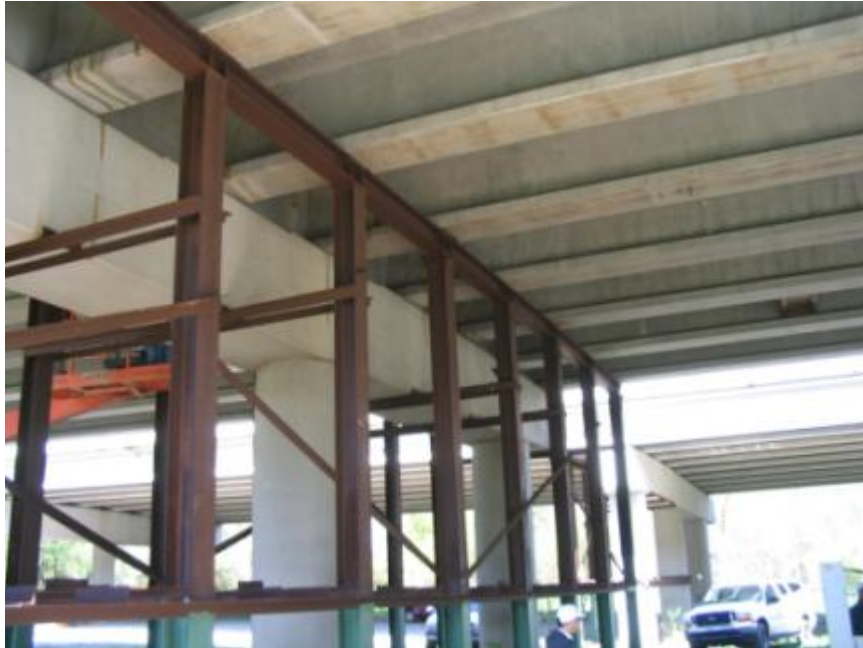
**Figure 2.21: Steel frame false supports (Fason 2009)**

Steel frame false supports, as shown in Figure 2.21, were installed near all bents that were associated with girders containing cracked end regions. The false supports were positioned slightly beyond the cracked regions. The false supports were also installed with clearance of roughly 1 in. between the top of the false support and the bottom of the girder. Elastomeric bearing pads were installed between the false supports and each girder bottom to allow the false supports to carry loads, if necessary, while limiting impact forces that could result in damage to the girders or false supports. Although the bearing pads were installed to limit impact-related damage, it was undesirable for bearing pads to remain in contact with bridge girders. An installed bearing pad with proper space between the pad and girder is shown in Figure 2.22. A bearing pad that is in contact with a girder and transferring loads through the false support is shown in Figure 2.23.

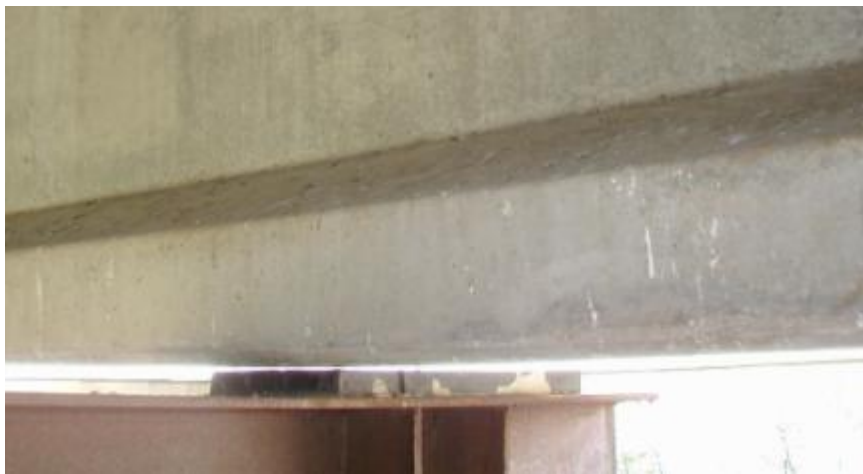
**Figure 2.22: False support bearing pad with gap between pad and girder (Fason 2009)**

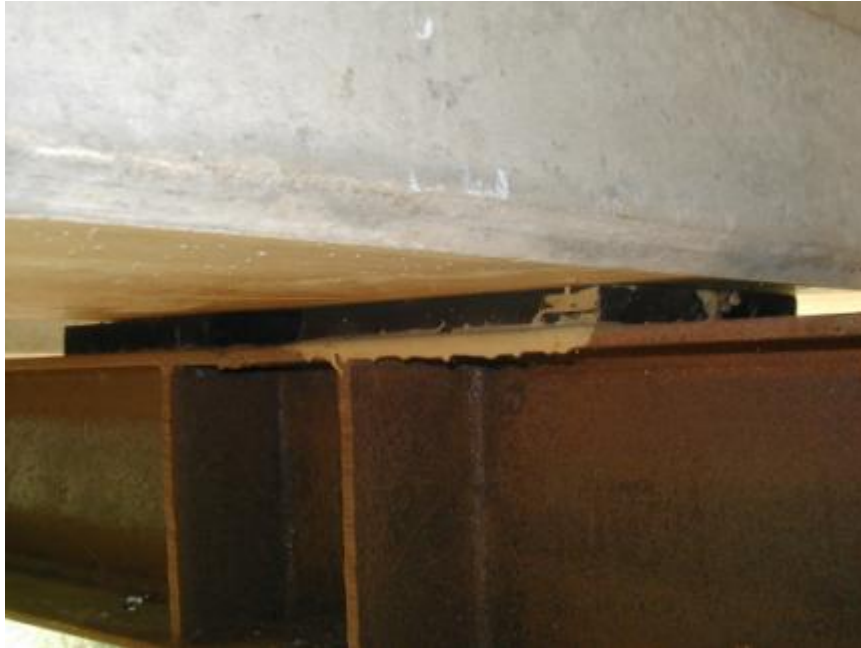
**Figure 2.23: False support bearing pad in contact with girder (Fason 2009)**

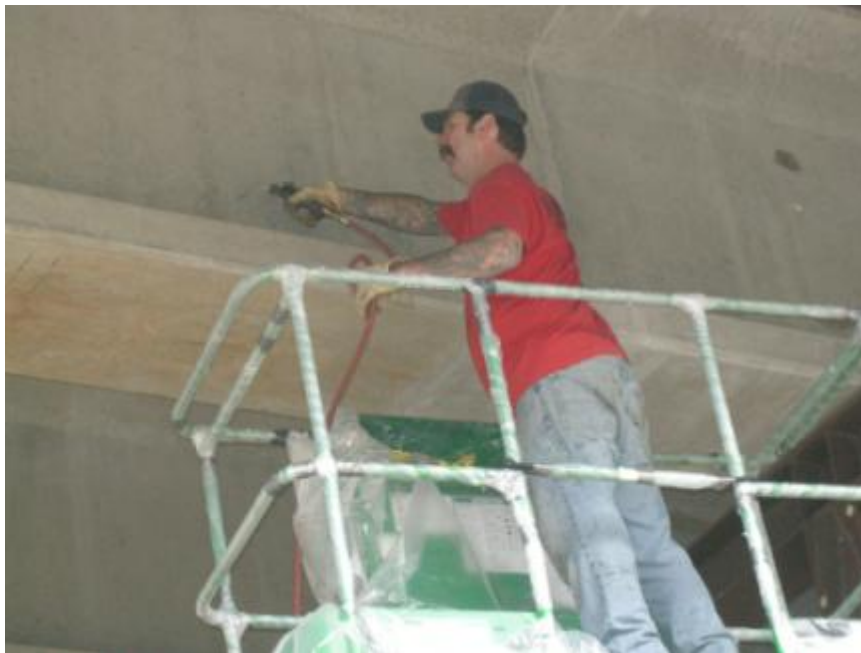
**Figure 2.29: Surface cleaning—final removal of dust and debris**

Prior to FRP fabric installation, the contractor was required to prepare the surface to ensure adequate contact between the FRP and concrete. Surface preparation procedures were conducted in accordance with the ALDOT Special Provision regarding the use of fiber-reinforced polymer reinforcement for girder repair. Surface preparation techniques included surface grinding of irregularities such as excess crack-injected epoxy, surface patching of unacceptable voids and depressions, light surface roughening for improved bond quality, and final surface cleaning to remove dust and all other bond-inhibiting material. The use of compressed air for final cleaning is shown in Figure 2.29.

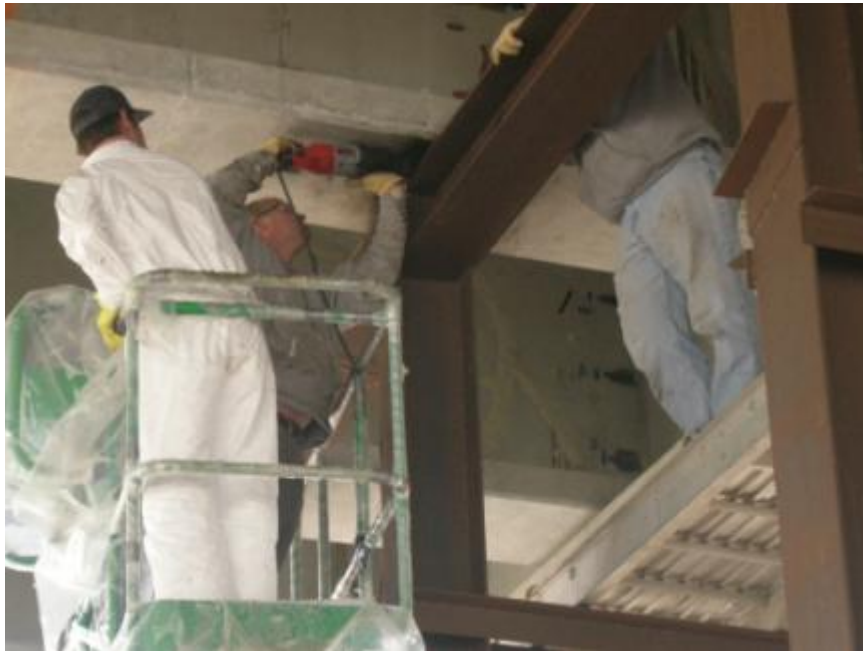
**Figure 2.30: Use of saw for bearing pad removal**

bearing pads under Span 11 were, in general, more difficult to remove than the bearing pads under Span 10. Initially, the contractor attempted to remove each bearing pad by punching it out of place using a chisel and hammer. When a bearing pad was under enough pressure to prevent removal, the contractor then used a reciprocating saw on the pad to alleviate some of that pressure, as shown in Figure 2.30. In some cases, saw cutting alone was not effective at alleviating enough pressure for successful bearing pad removal. In these cases, a propane torch was used to soften the rubber and allow for a more effective sawing process, which is shown in Figure 2.31. After successful pressure alleviation, the bearing pad was removed using the initial chisel-and-hammer removal method, as shown in Figure 2.32. An example of a bearing pad that required extensive removal efforts is shown in Figure 2.33.

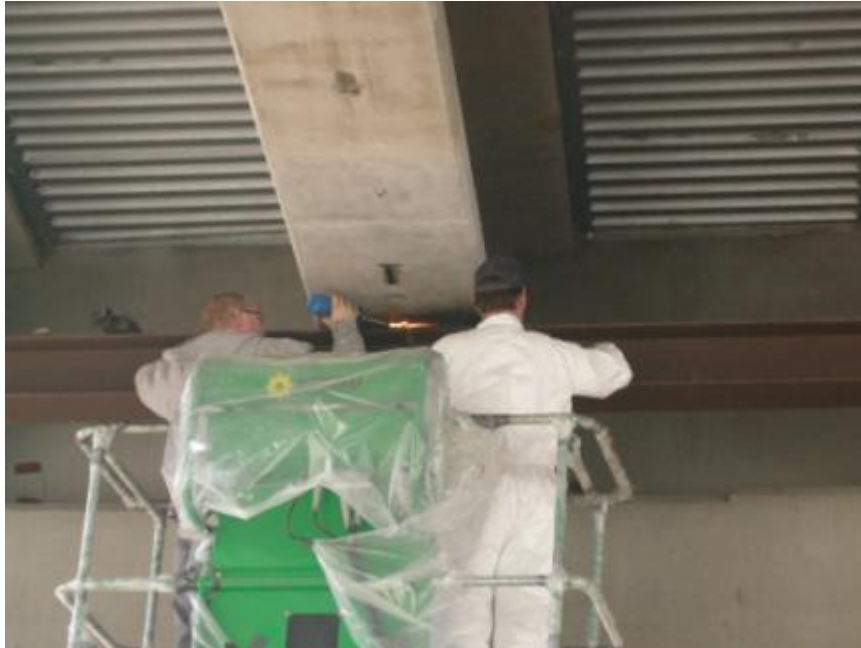
**Figure 2.31: Use of torch for bearing pad removal**

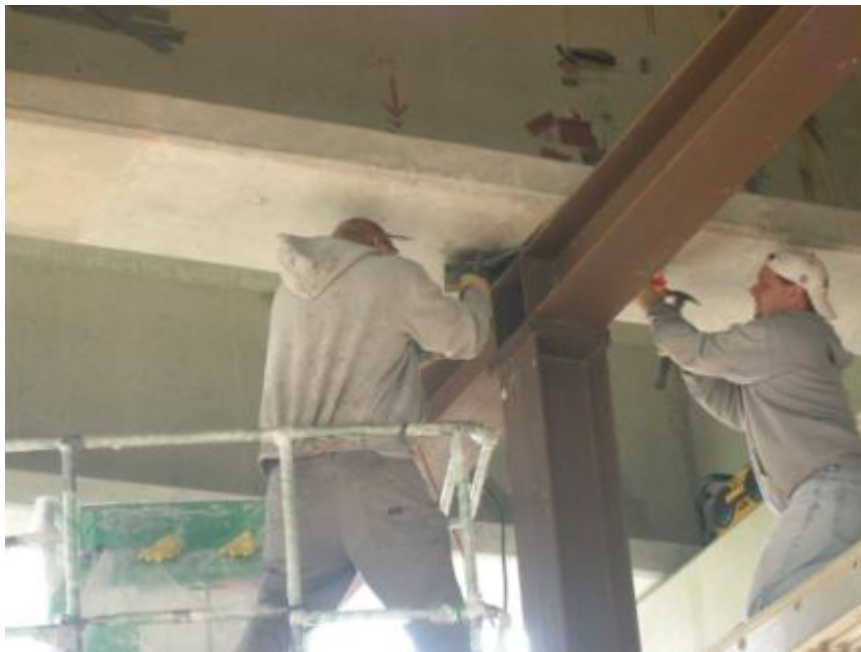
**Figure 2.32: Successful removal of bearing pad**

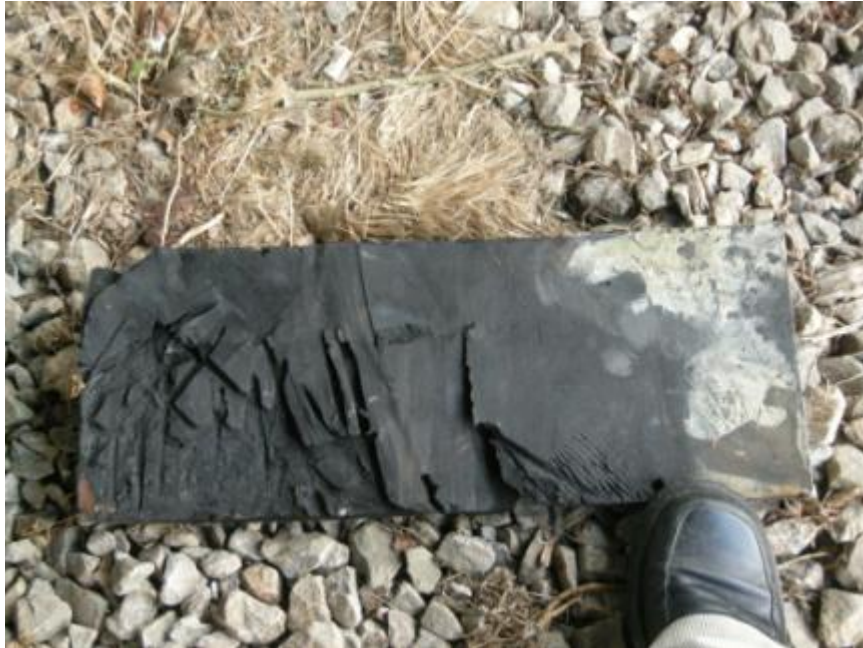
**Figure 2.33: Bearing pad after forceful removal**

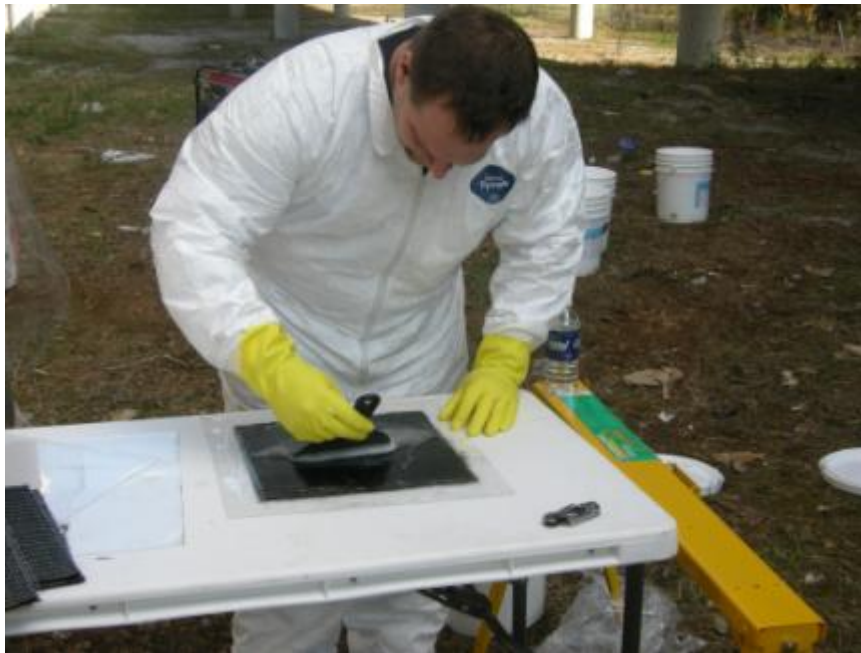
reinforcement was installed. A testing sample, prepared as shown in Figures 2.36 and 2.37, was to consist of two 12 in. by 12 in. panels representative of the four-layer FRP and epoxy composite. However, the contractor fabricated each panel with only two plies of fabric, interpreting this as “representative” of the four-ply system. The samples were sent to a testing laboratory accredited in accordance with ISO/IEC 17025. The required testing procedures are presented in ASTM D3039. The tensile strength, ultimate tensile strain, and tensile modulus of elasticity were tested in a minimum of five sample batches.

**Figure 2.36: Preparation of sample for tension testing**

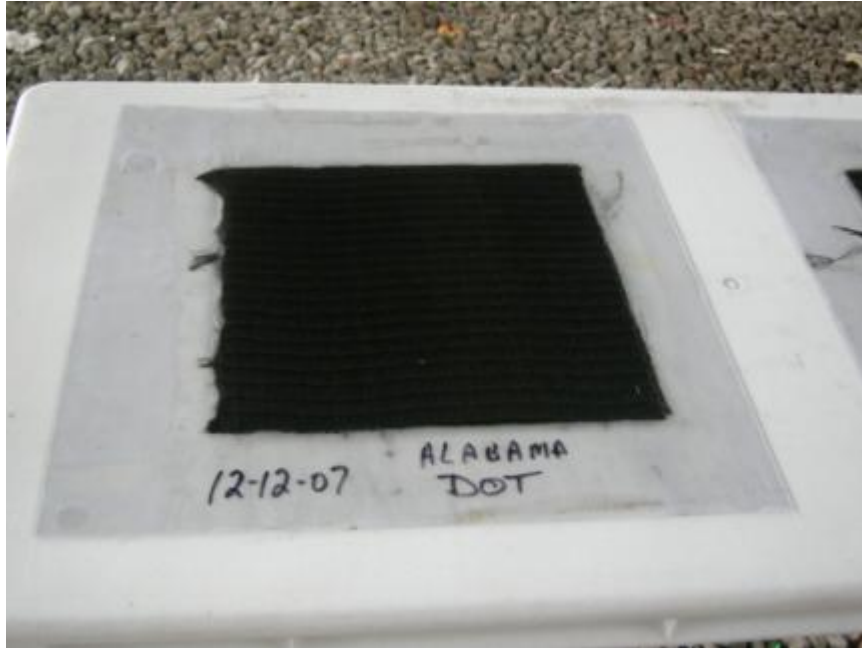
**Figure 2.37: Representative sample for tension testing**

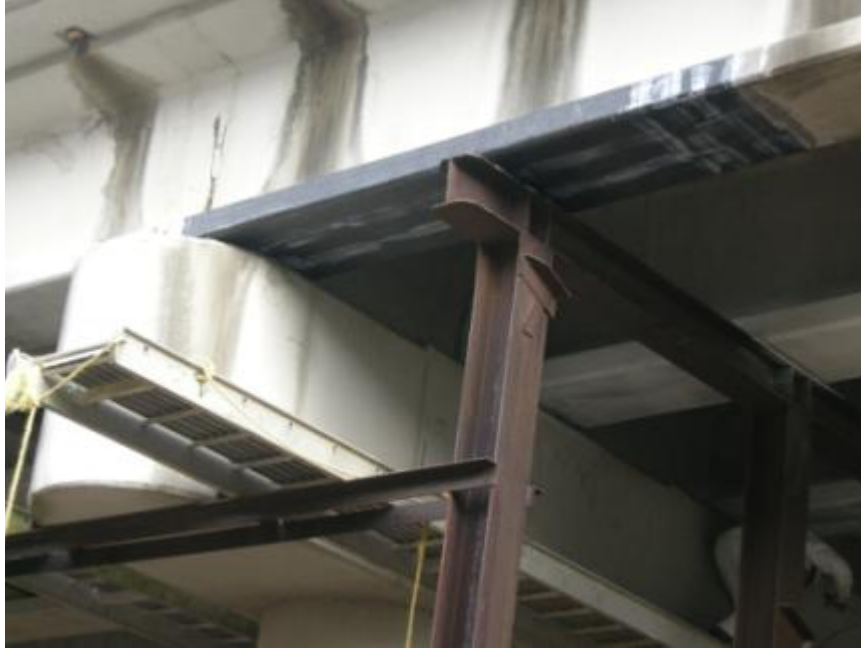
**Figure 2.42: Four layers of installed FRP fabric**

Each sheet of FRP fabric was cut to size and then saturated with epoxy. The typical fabric cutting and epoxy saturation procedures are shown in Figures 2.38 and 2.39. Epoxy was also applied to the surface of the girders prior to application of the first layer of FRP fabric, as shown in Figure 2.40. The first layer of FRP fabric was then installed as shown in Figure 2.41. Successive layers of FRP and epoxy were then applied, and an example of a typical four-layer installation is shown in Figure 2.42.

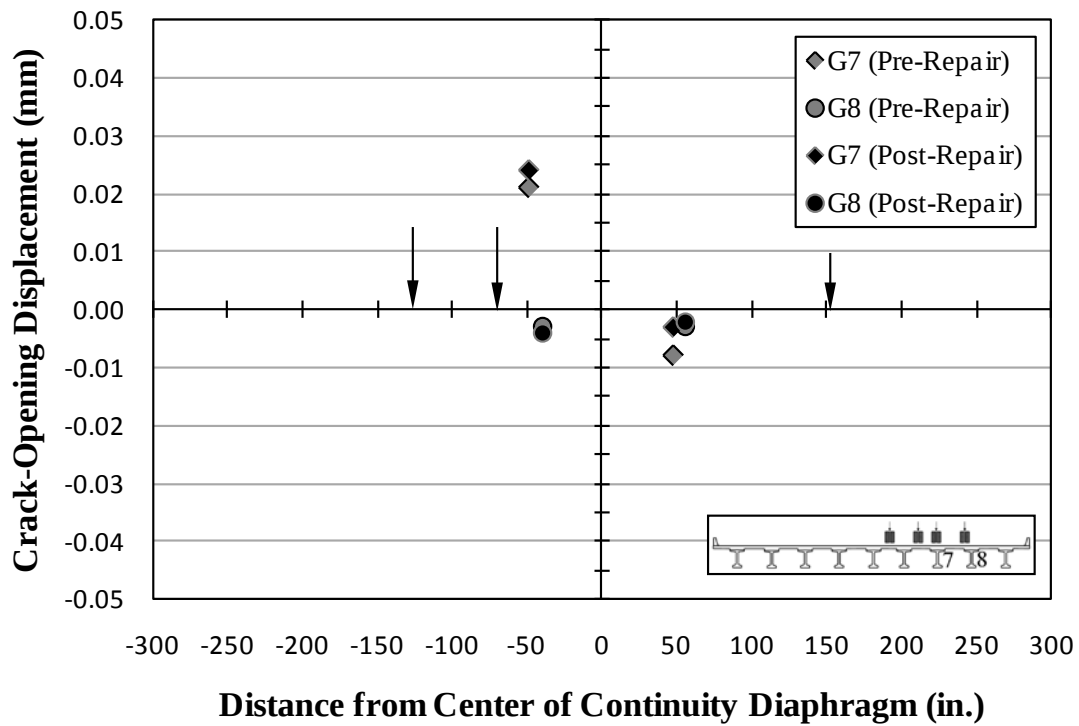
The comparison of crack-opening displacements from the pre- and post-repair tests in response to the same truck positions is one behavior that indicates that the bearing pads had a significant effect on the pre-repair measurements. Stop positions that resulted in crack openings were analyzed. Stop position locations are described in Section 4.4 of this report. During both the pre- and post-repair tests, Stop Position 4 had the greatest effect on the Span 10 crack

openings, and Stop Position 7 had the greatest effect on the Span 11 crack openings. The pre- and post-repair crack-opening displacement measurements for Stop Positions A4, A7, C4, and C7 are presented in Figures 5.1–5.4 and Table 5.1. The arrows in the figures represent the position of the wheel loads on the bridge.

Figure 5.1: Crack-opening displacements—pre- and post-repair—A4

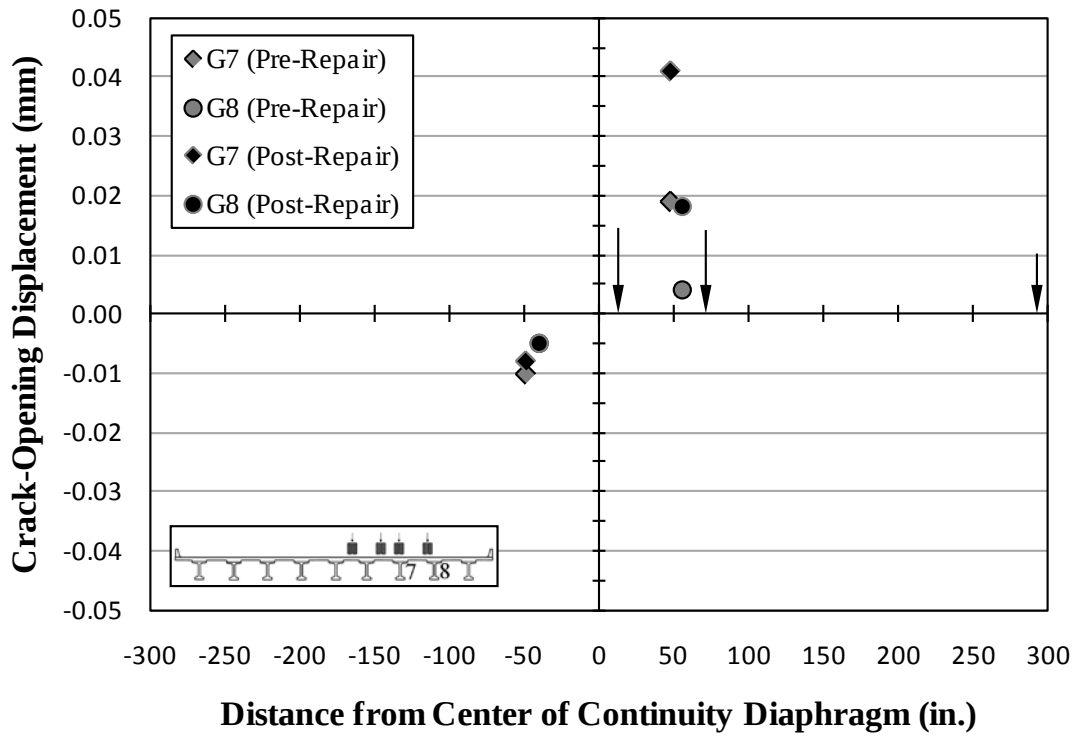
Figure 5.2: Crack-opening displacements—pre- and post-repair—A7

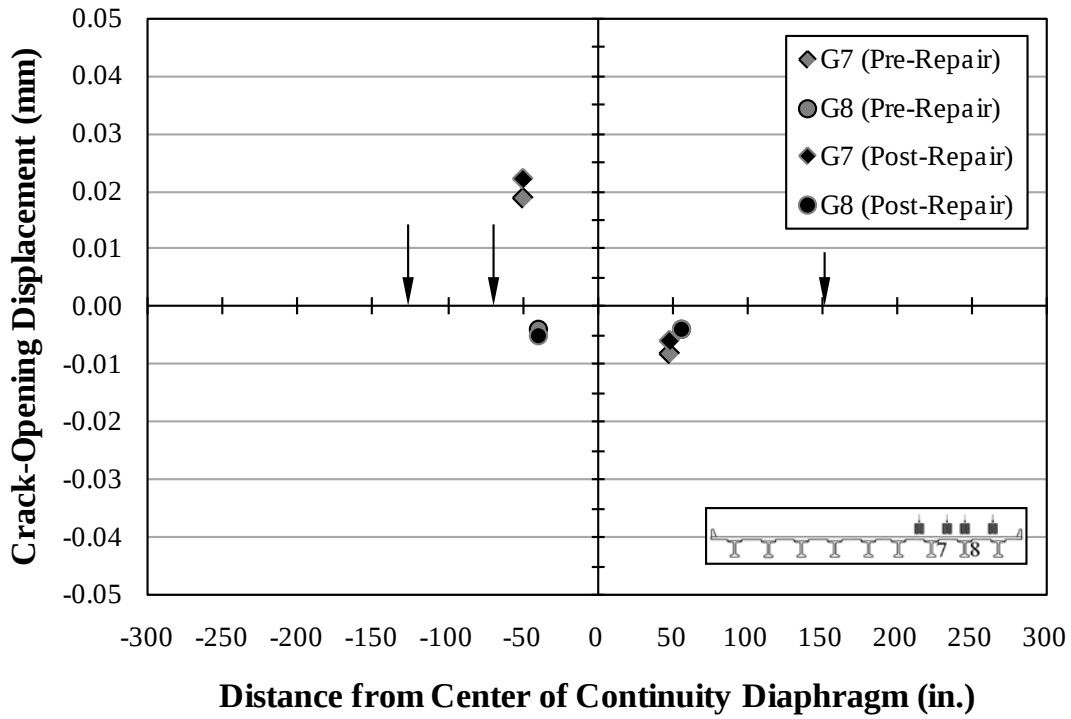
Figure 5.3: Crack-opening displacements—pre- and post-repair—C4

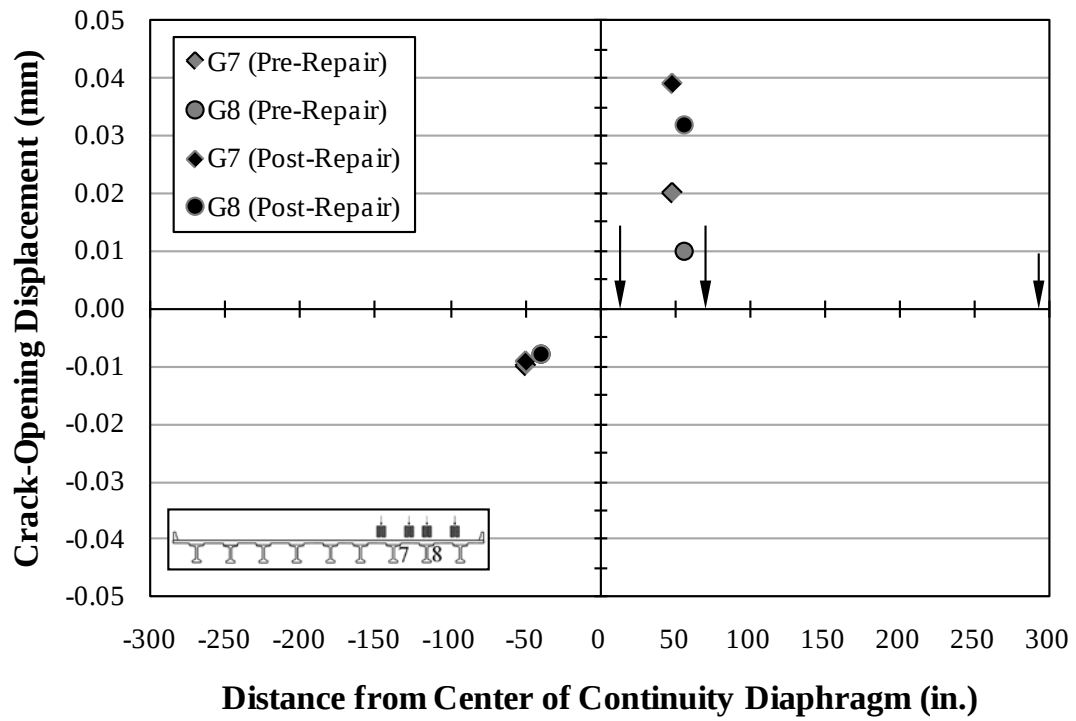
**Figure 5.4: Crack-opening displacements—pre- and post-repair—C7**

The crack-opening displacements measured in Span 10 were similar for both pre- and post-repair testing, but the crack-opening displacements measured in Span 11 in response to the Stop Position 7 load condition of the post-repair test increased in comparison to the crack-opening displacements measured in response to the same load condition during pre-repair testing. This behavior corresponds with the Span 10 bearing pads being partially removed prior to pre-repair testing, and the Span 11 bearing pads being under enough pressure to prevent any removal prior to pre-repair testing. It is apparent that girder contact with the false support bearing pads under Span 11 resulted in additional support conditions that affected pre-repair measurements. This conclusion is further supported by the other comparisons that are located in Appendix K.

Due to the apparent effects that the bearing pads had on the pre-repair tests, direct comparisons of the pre- and post-repair measured behavior cannot be used to accurately gauge the effectiveness of the FRP repair. Analysis of the post-repair measurements, independent of the pre-repair measurements, is required to assess the post-repair behavior of the overall structure and the FRP reinforcement.

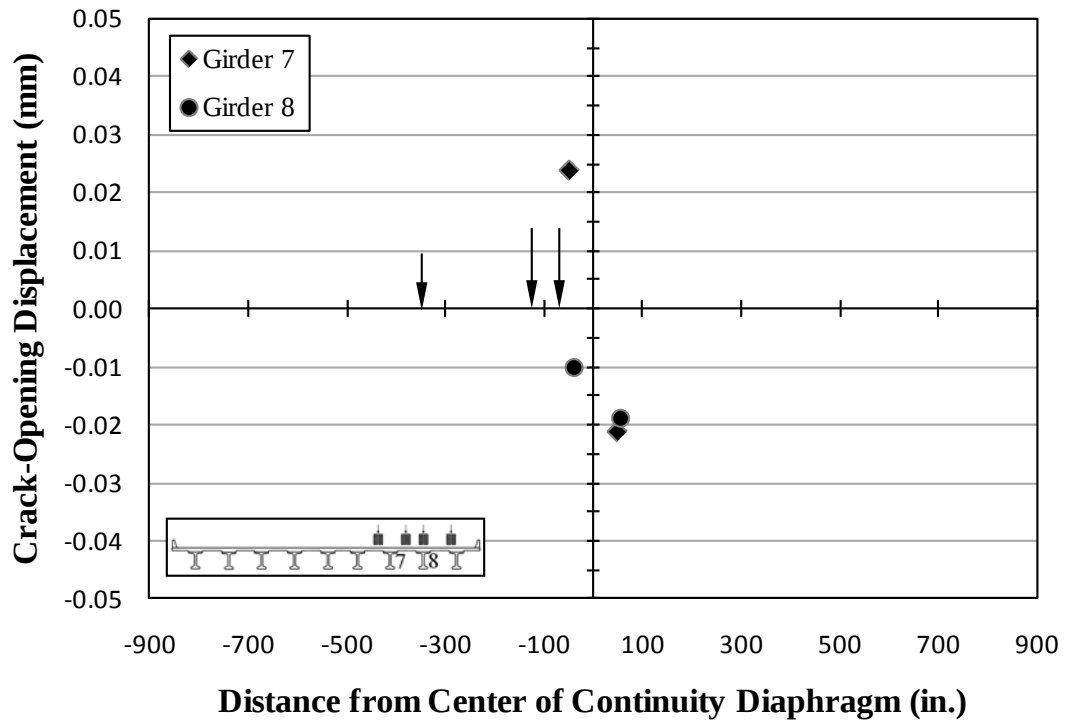
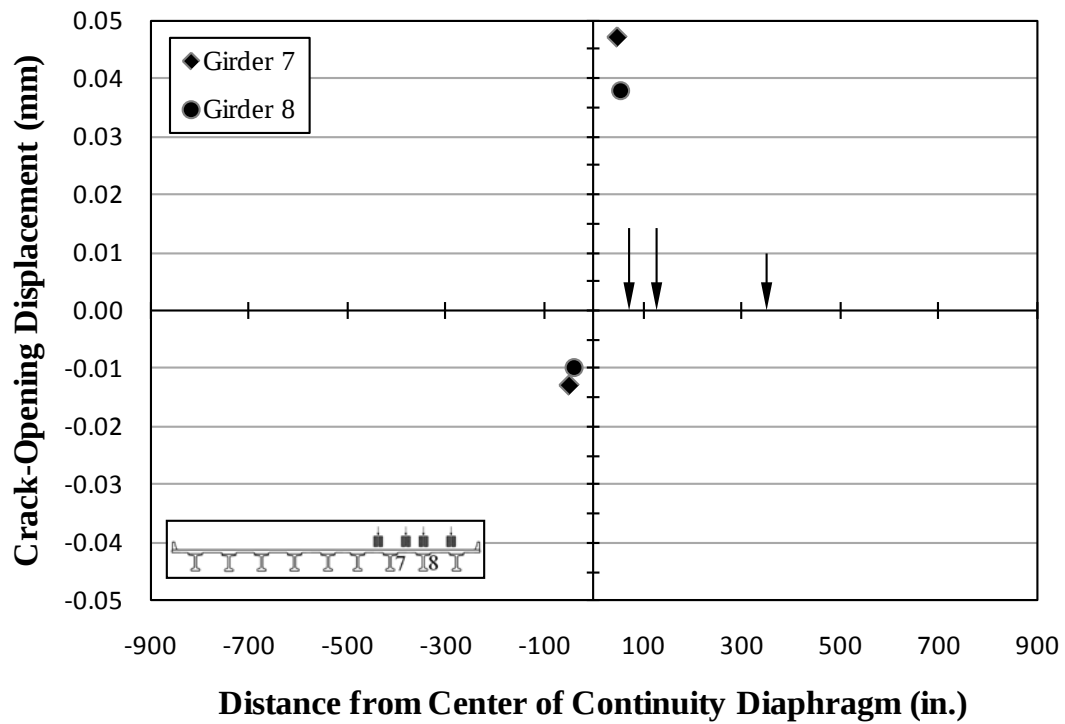
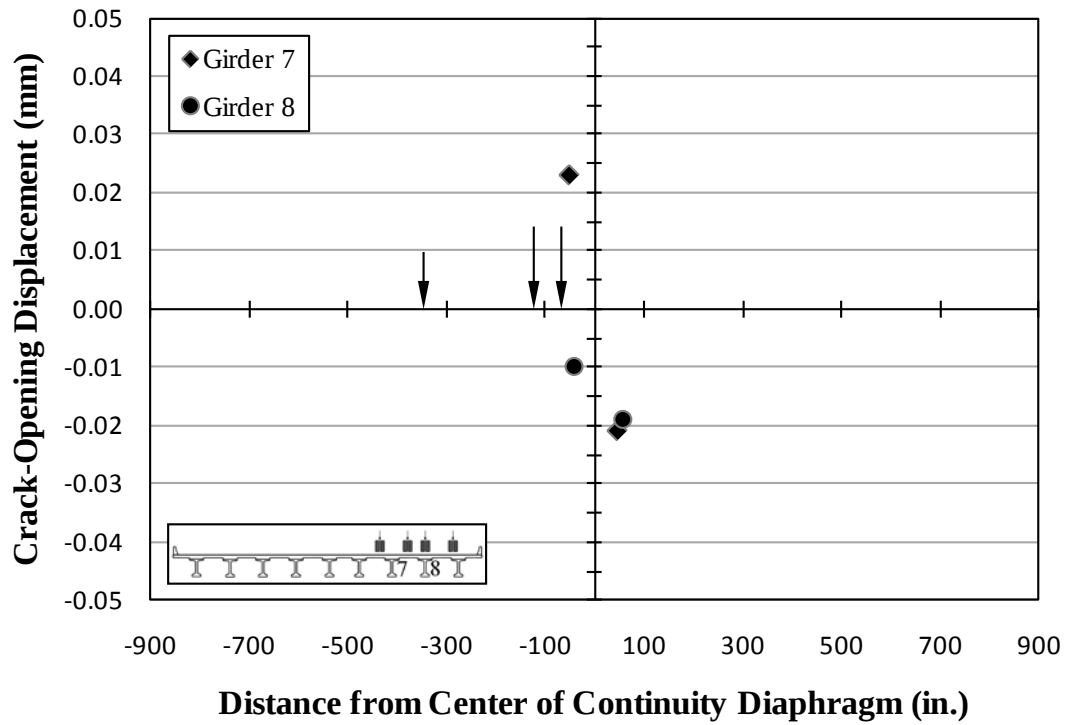
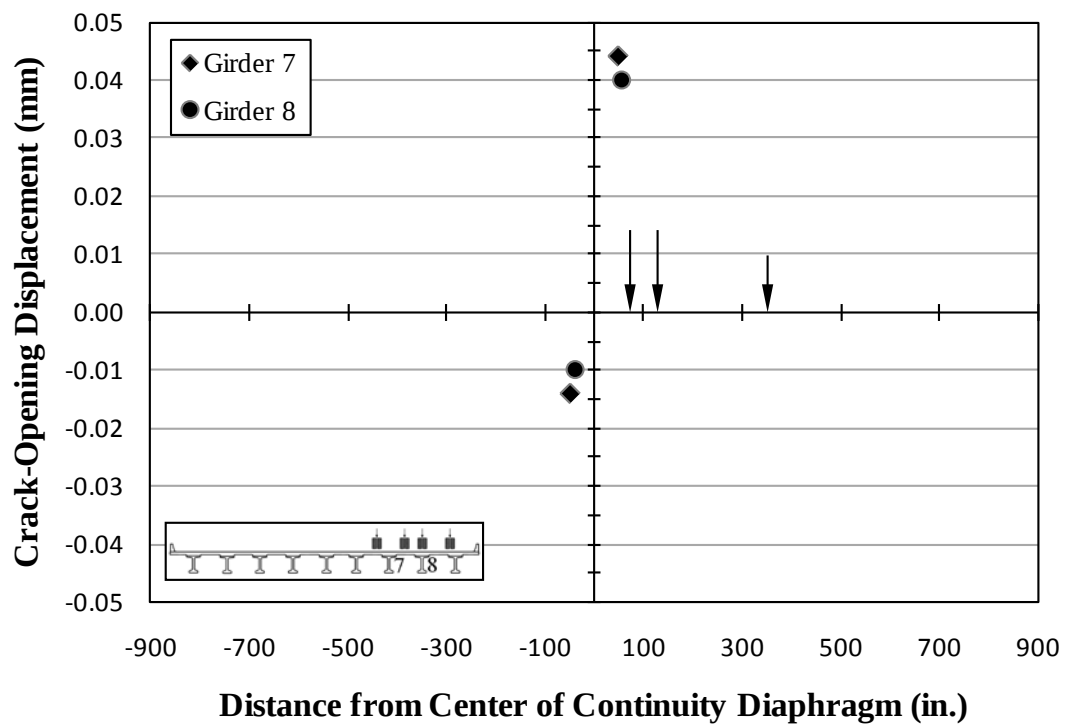
Figure 5.11: AE Span 10 truck position—crack-opening displacements—LC-6.5

Figure 5.12: AE Span 11 truck position—crack-opening displacements—LC-6.5

Figure 5.13: AE Span 10 truck position—crack-opening displacements—LC-6

Figure 5.14: AE Span 11 truck position—crack-opening displacements—LC-6

A maximum crack opening of 0.047 mm ( $1.83 \times 10^{-3}$  in.) was measured by the COD gage on the east face of Girder 7 in Span 11 in response to the AE Span 11 static position. A maximum crack closure of 0.021 mm ( $0.84 \times 10^{-3}$  in.) was measured by the same COD gage on the east face of Girder 7 in Span 11 but in response to the Span 10 static position. The COD gage on the west face of Girder 8 in Span 10 did not measure a crack opening due to any of the AE static positions.

The crack openings measured on the instrumented girders of Span 11 due to the Span 11 static position were of greater magnitude than the Span 10 crack openings due to the Span 10 static position. Similarly, the crack closures measured on the instrumented girders of Span 11 due to the Span 10 static position were of greater magnitude than the Span 10 crack closures due to the Span 11 static position. In response to trucks with consistent load-block configurations, the maximum range of crack-opening displacements on an instrumented Span 11 crack was 0.068 mm ( $2.67 \times 10^{-3}$  in.) measured by the COD gage on Girder 7 of Span 11. The maximum range of crack-opening displacements on an instrumented Span 10 crack was 0.037 mm ( $1.47 \times 10^{-3}$  in.) measured by the COD gage on Girder 7 of Span 10.

The crack-opening displacements measured for the instrumented crack on Girder 8 of Span 10 exhibited behavior that was inconsistent with the other three instrumented cracks.

Similar behavior measured at the COD gage location on Girder 8 of Span 10 during both pre- and post-repair AE testing is an indication that the pre-repair crack-opening displacement behavior measured at this location was related to something other than the bearing pad under Girder 8 of Span 10 being the only bearing pad completely removed prior to pre-repair testing. If the complete removal of only one bearing pad is not the reason for the COD gage on Girder 8 of Span 10 to behave differently, then the gage may be measuring a response to out-of-plane bending as suggested by Fason (2009).
