Research Report No. 2F for ALDOT Project 930-601

**REPAIR OF CRACKED PRESTRESSED  
CONCRETE GIRDERS, I-565,  
HUNTSVILLE, ALABAMA**

**JULY 2011**

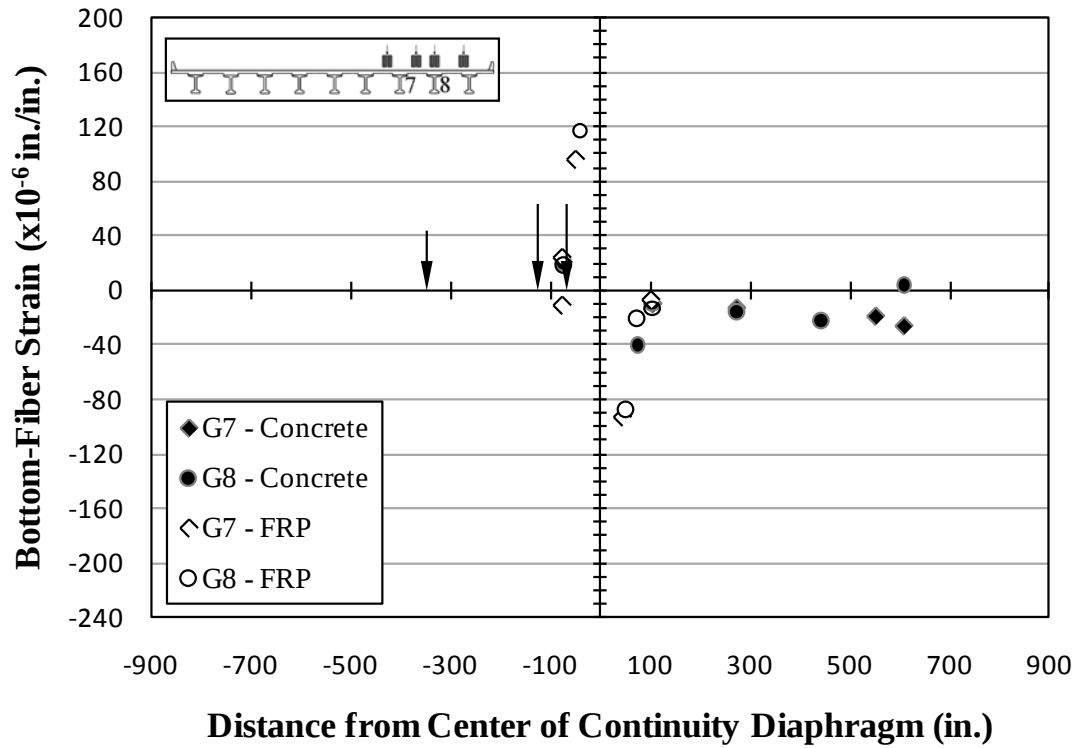
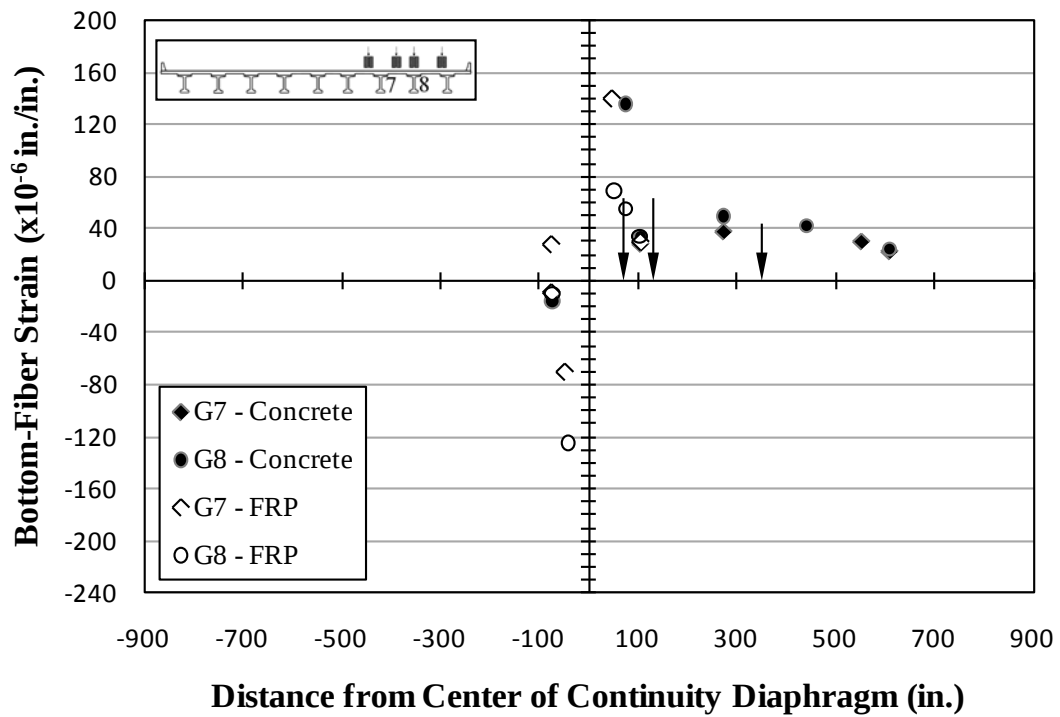
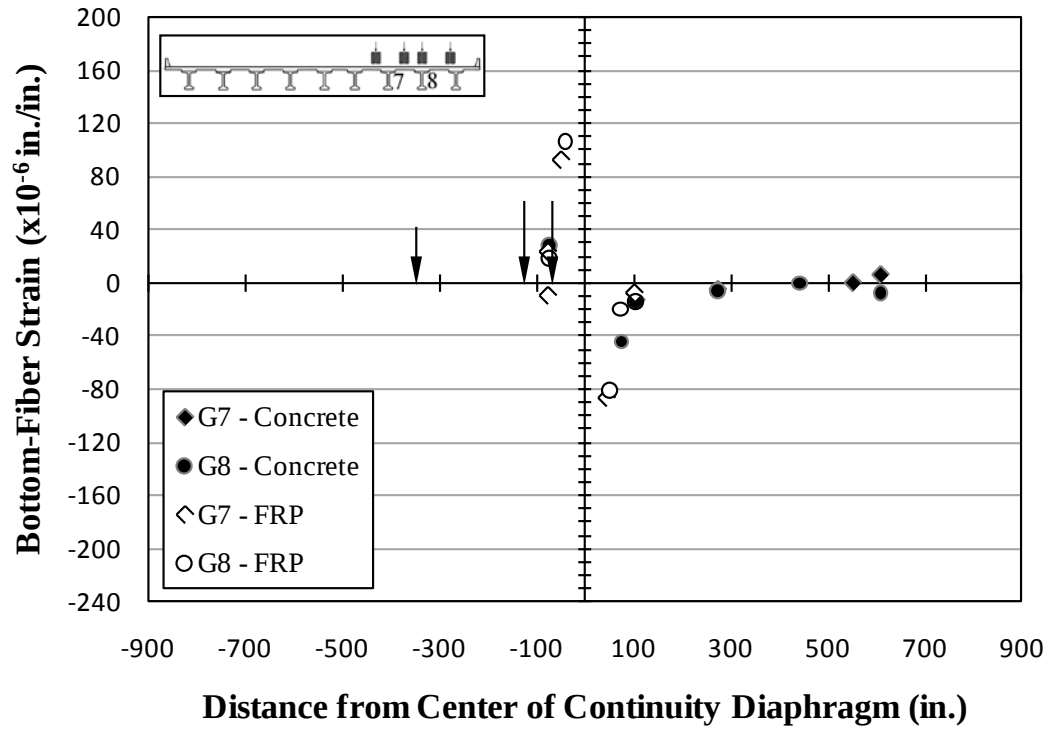
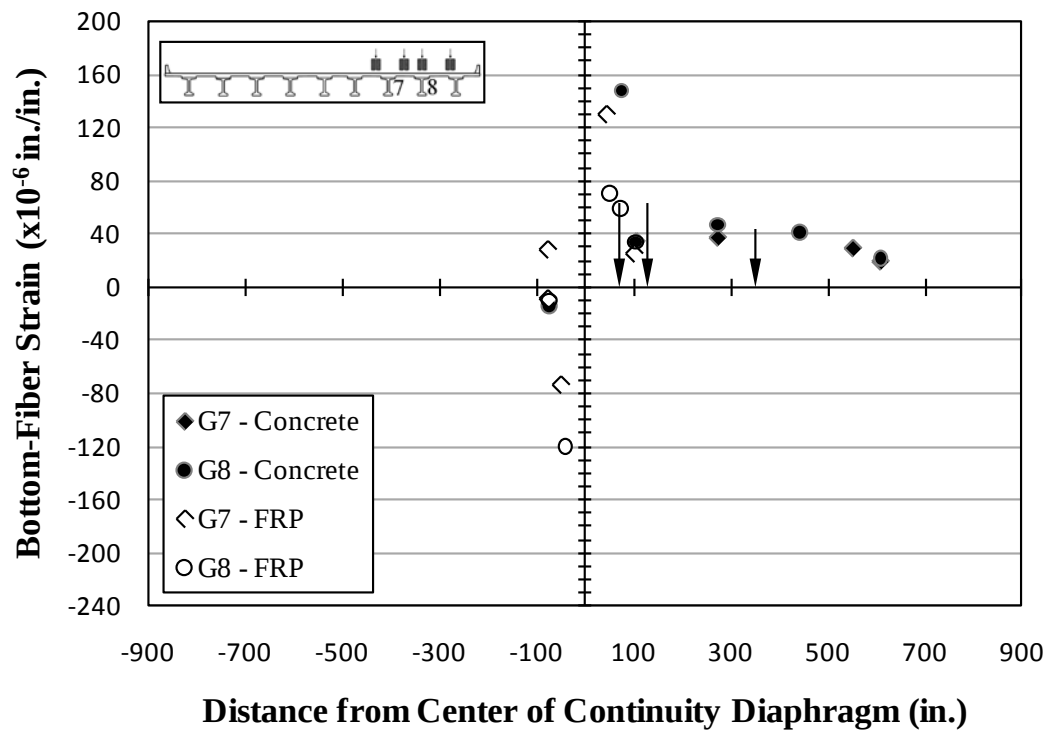
Figure 5.15: AE Span 10 truck position—bottom-fiber strains—LC-6.5

Figure 5.16: AE Span 11 truck position—bottom-fiber strains—LC-6.5

Figure 5.17: AE Span 10 truck position—bottom-fiber strains—LC-6

Figure 5.18: AE Span 11 truck position—bottom-fiber strains—LC-6

A maximum bottom-fiber near-crack FRP reinforcement tensile strain of  $140 \times 10^{-6}$  in./in. was measured 47 in. from the center of the continuity diaphragm at the crack on Girder 7 of Span 11 in response to the Span 11 static position. A maximum bottom-fiber near-crack FRP reinforcement compressive strain of  $125 \times 10^{-6}$  in./in. was measured 41 in. from the center of the continuity diaphragm at the crack on Girder 8 of Span 10 in response to the Span 11 static position.

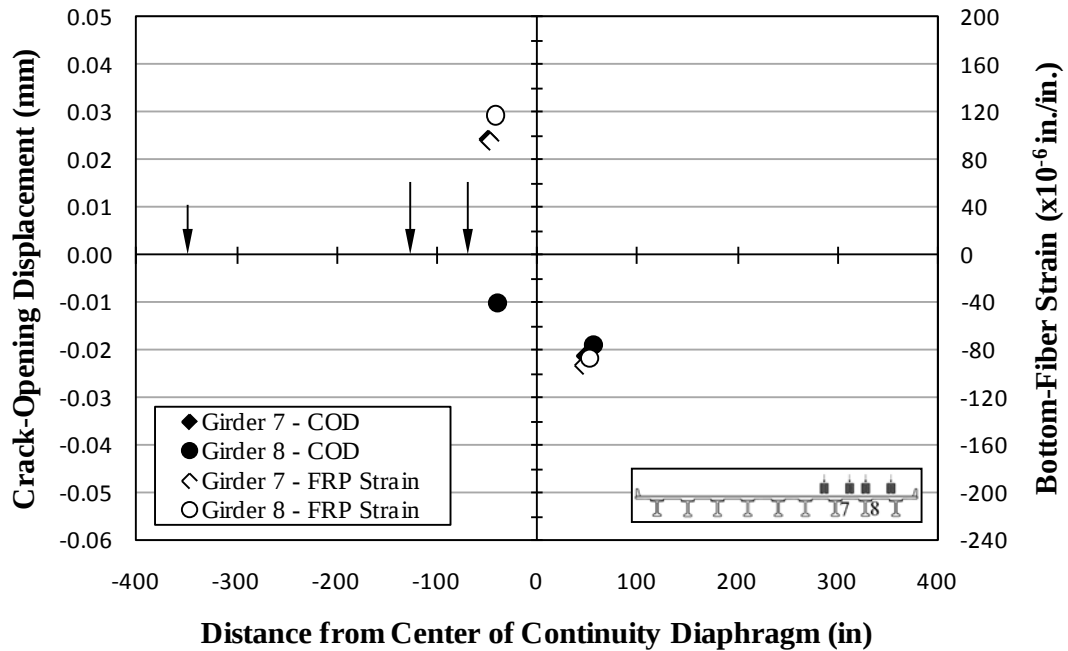
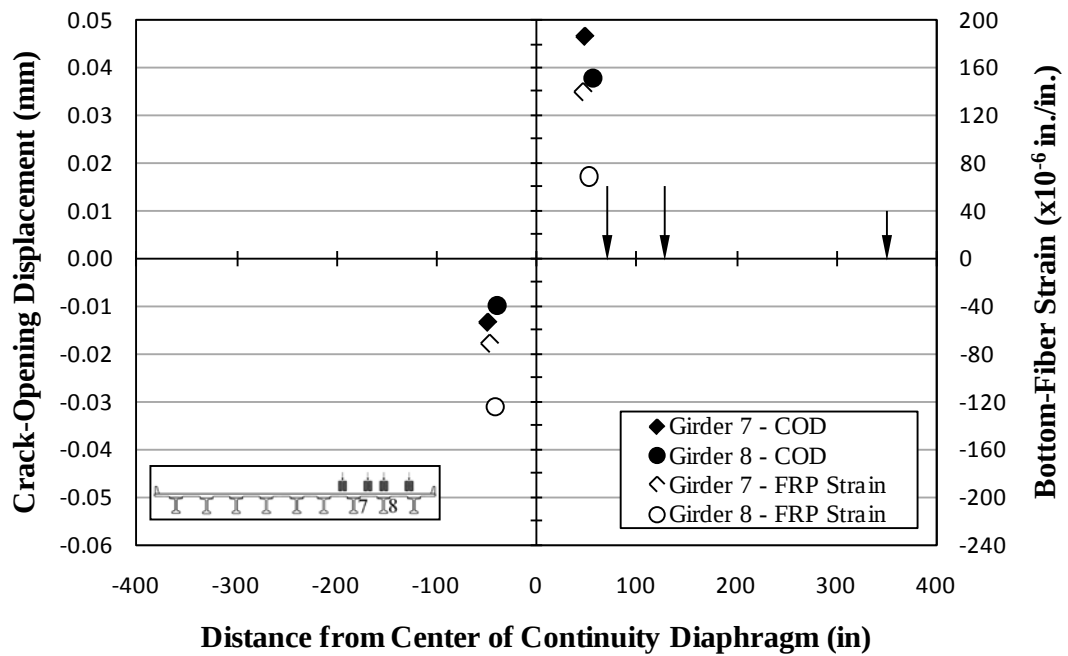
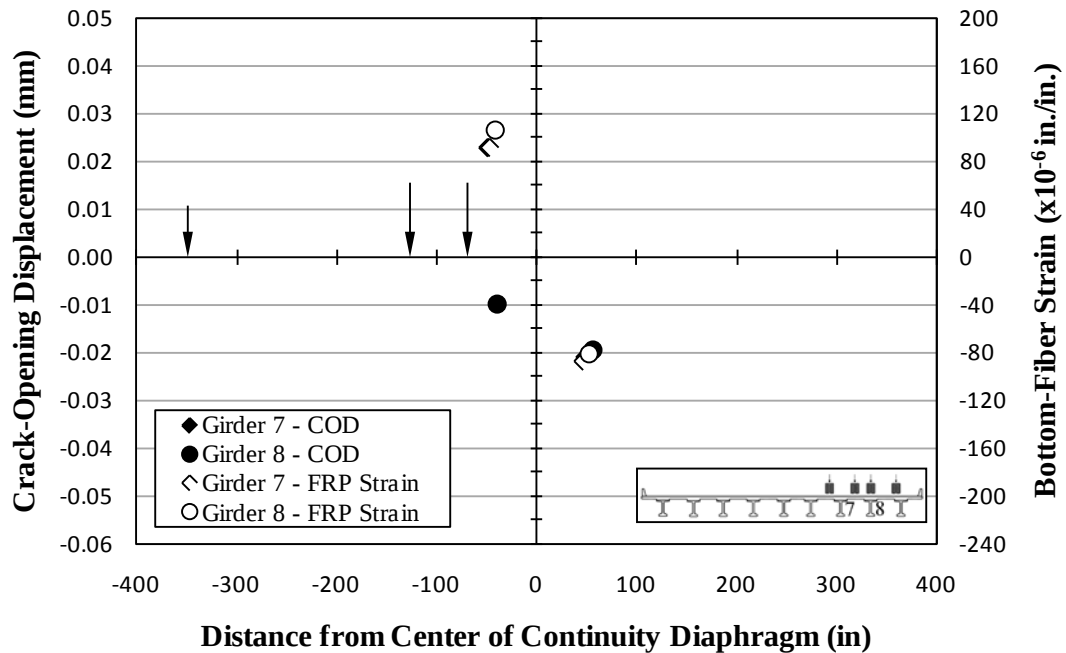
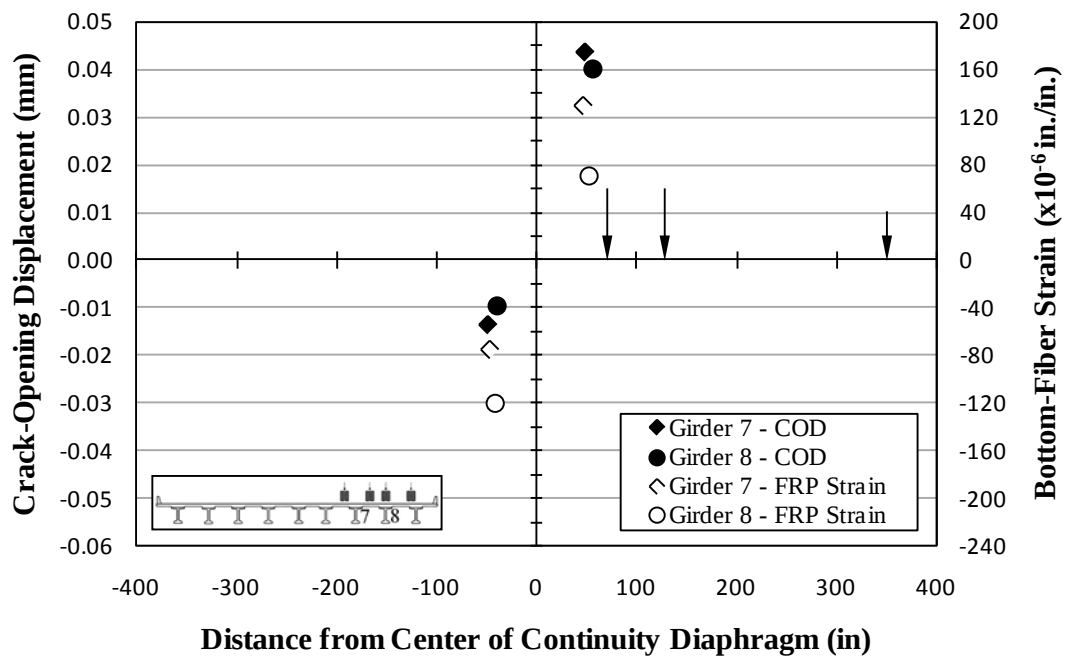
Figure 5.19: COD and bottom-fiber strain comparisons—LC-6.5—AE Span 10

Figure 5.20: COD and bottom-fiber strain comparisons—LC-6.5—AE Span 11

Figure 5.21: COD and bottom-fiber strain comparisons—LC-6—AE Span 10

Figure 5.22: COD and bottom-fiber strain comparisons—LC-6—AE Span 11

The COD and near-crack bottom-fiber strain measurements of Girder 8 in Span 10 exhibited contradicting behavior. Crack closure was measured in response to the Span 10 load condition while a near-crack bottom-fiber tensile strain was measured. The tensile strain measured at the Girder 8-Span 10 near-crack strain gage location was similar to the tensile strain

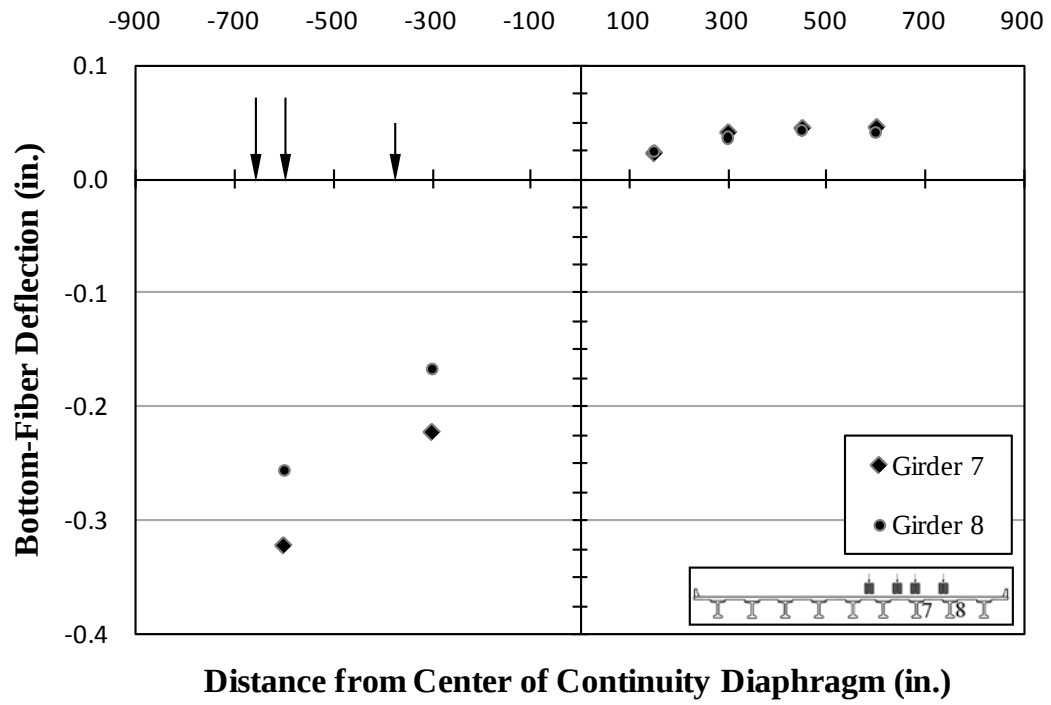
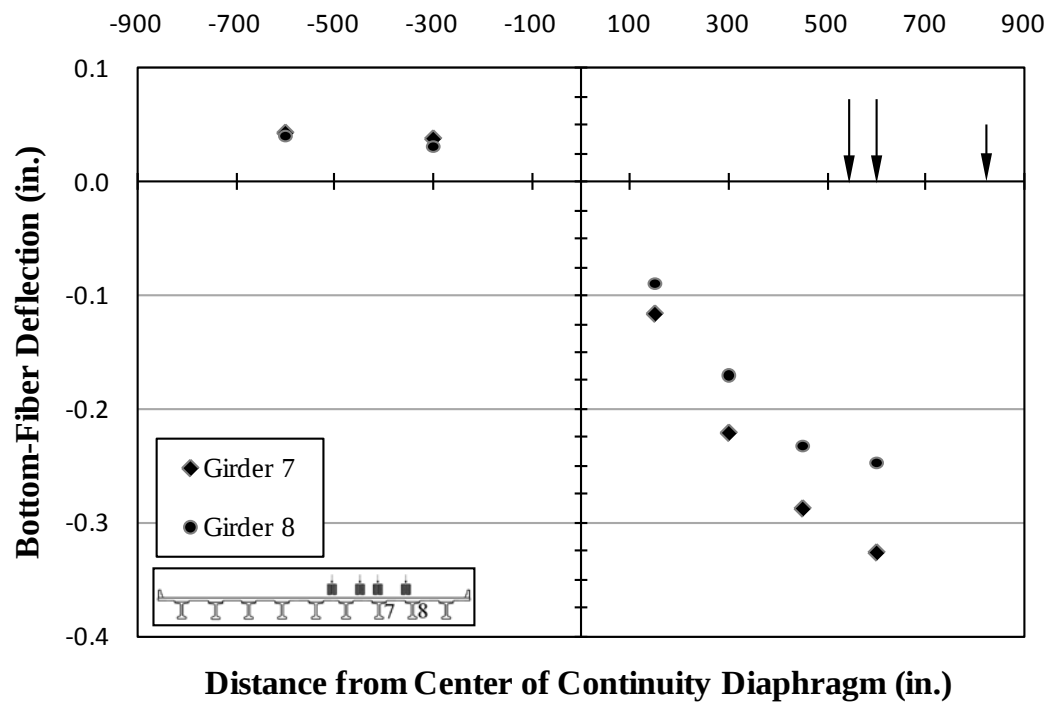
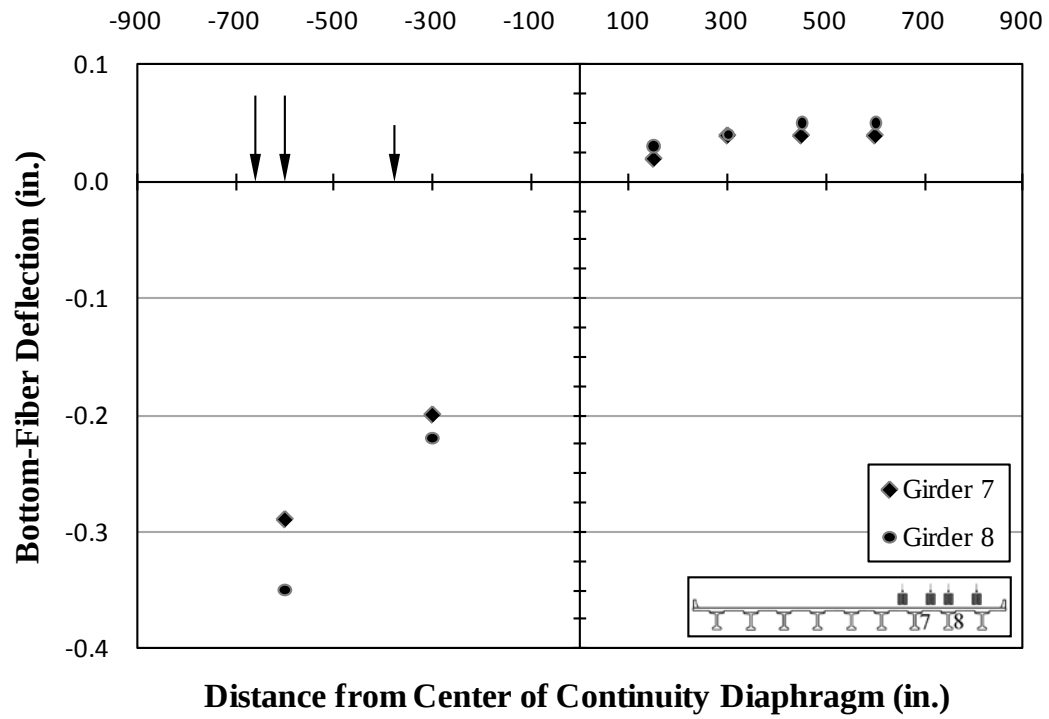
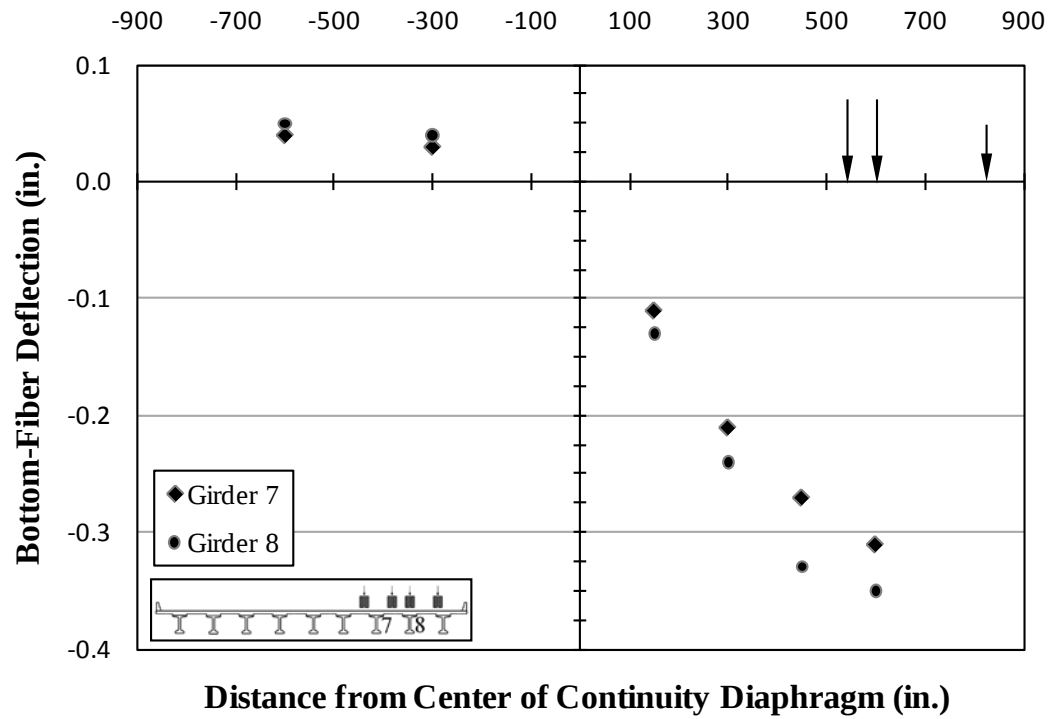
Deflections measured during post-repair multiposition load testing exhibit continuous behavior for the bridge structure. This behavior is evident due to the upward deflections measured within the non-loaded span. The maximum deflections were measured in response to the midspan load conditions. The deflections measured in response to load trucks traversing Lanes A and C and stopping at the midspan stop positions (Stop Positions 1 and 9) are presented graphically in Figures 5.23–5.26. The summary of deflection measurements due to the midspan static positions is presented in Table 5.6.

Figure 5.23: Deflections—A1

Figure 5.24: Deflections—A9

Figure 5.25: Deflections—C1

Figure 5.26: Deflections—C9

A maximum downward deflection of 0.35 in. was measured at the midspan location of Span 11 due to the Span 11 midspan load condition. A maximum upward deflection of 0.05 in. was measured at three different locations due to separate load conditions. The upward deflections due to live loads are an indicator that partial continuity has been preserved.

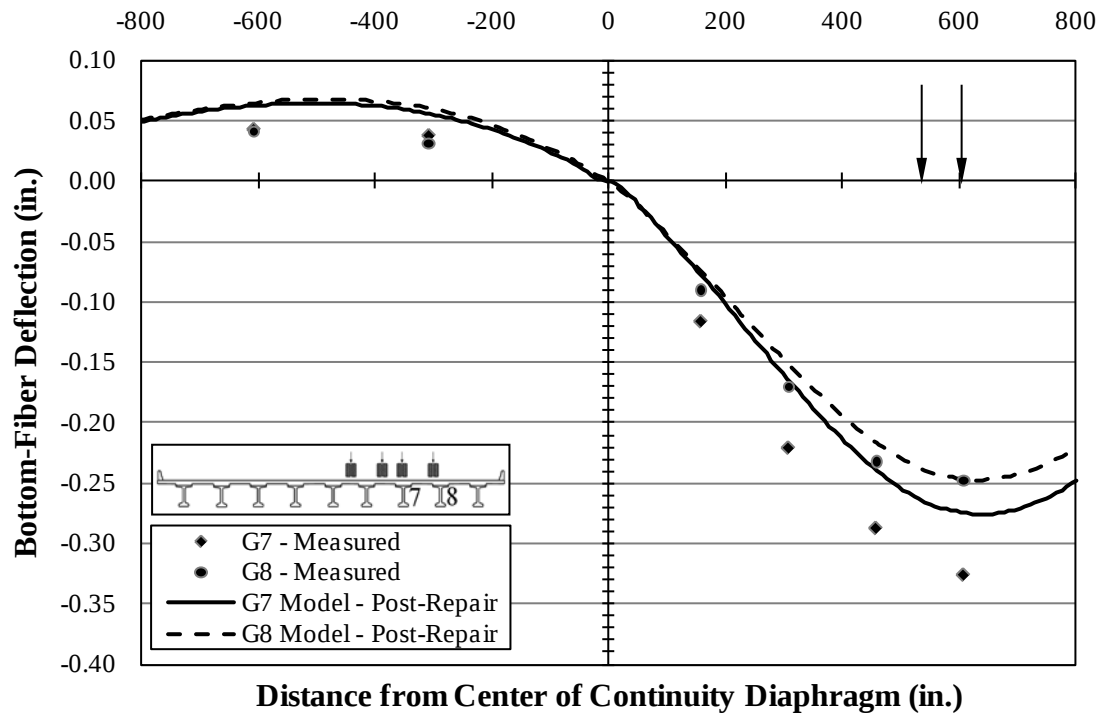
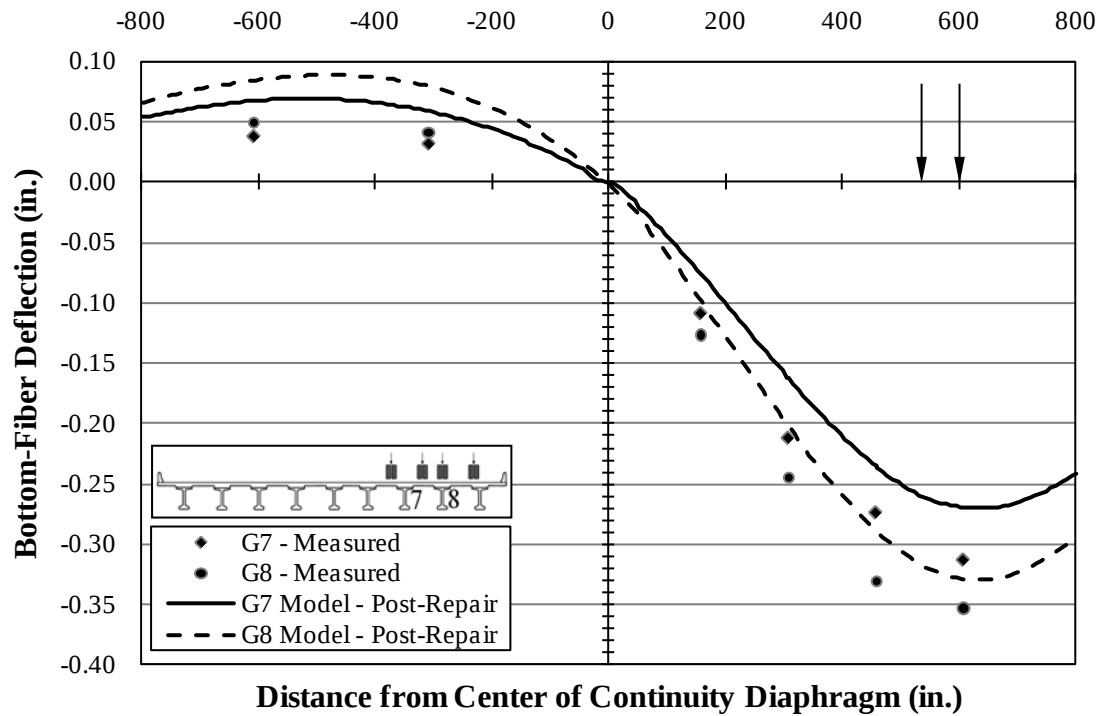
Figure 5.27: Deflections—post-repair—measurements and predictions—A9

Figure 5.28: Deflections—post-repair—measurements and predictions—C9

Post-repair deflection measurements are an indication that the *modeled* post-repair structure exhibits more apparent stiffness and continuity than the *actual* post-repair structure. The downward deflections measured in the loaded span were greater than the downward deflections predicted. The upward deflections measured in the non-loaded span were less than the upward deflections predicted.

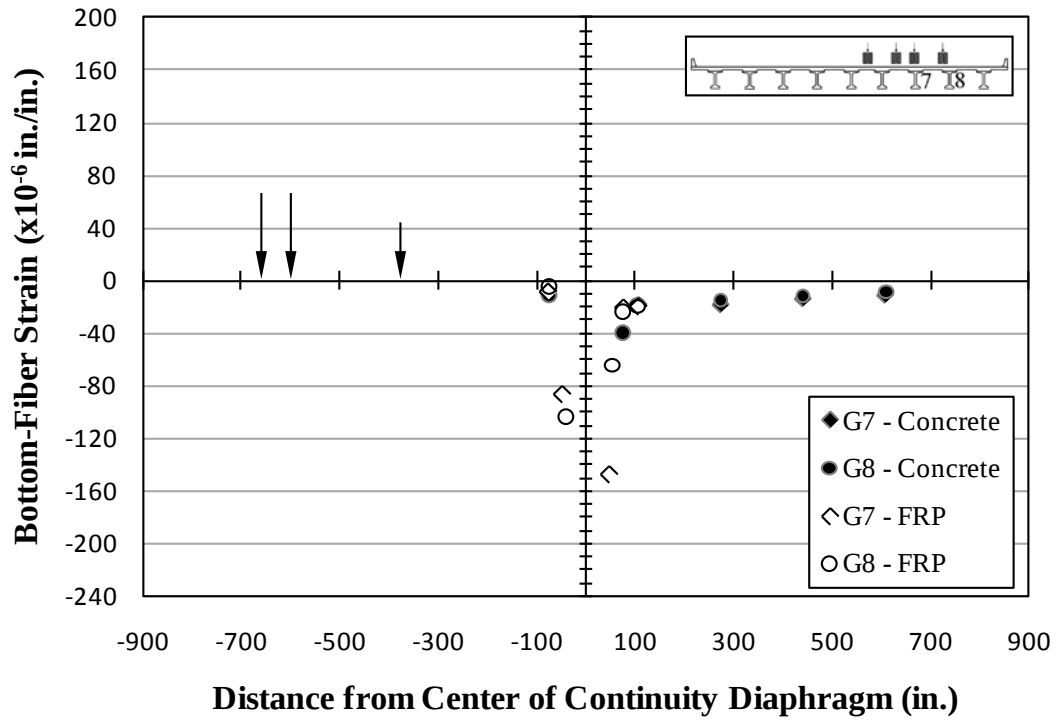
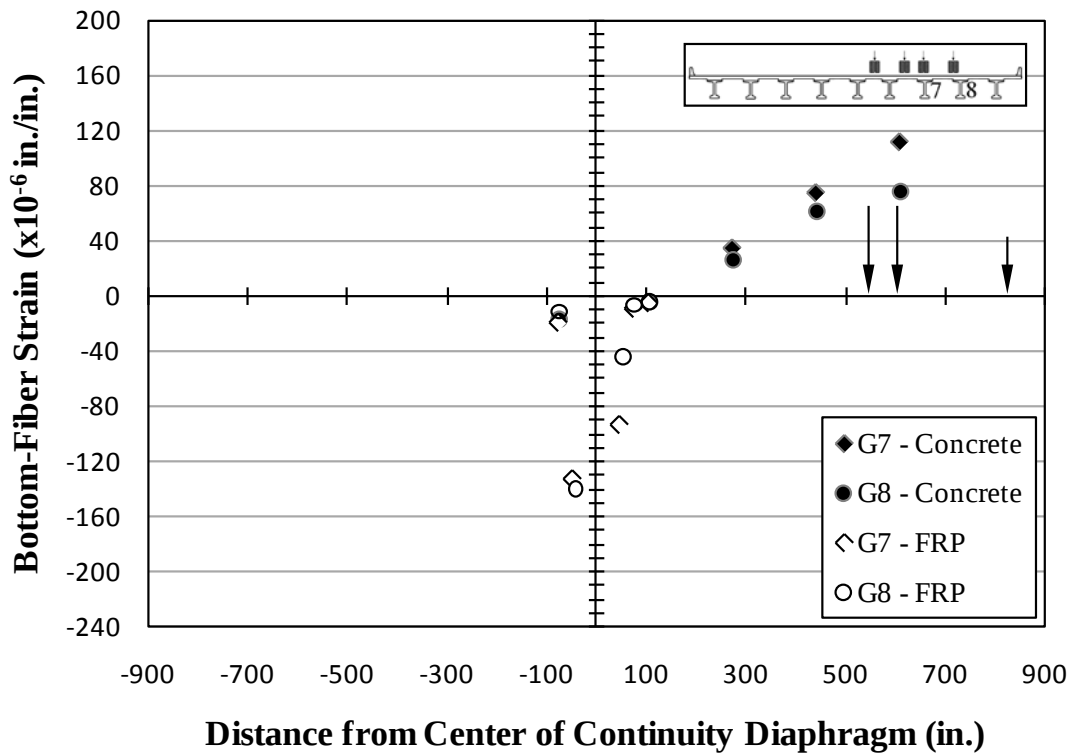
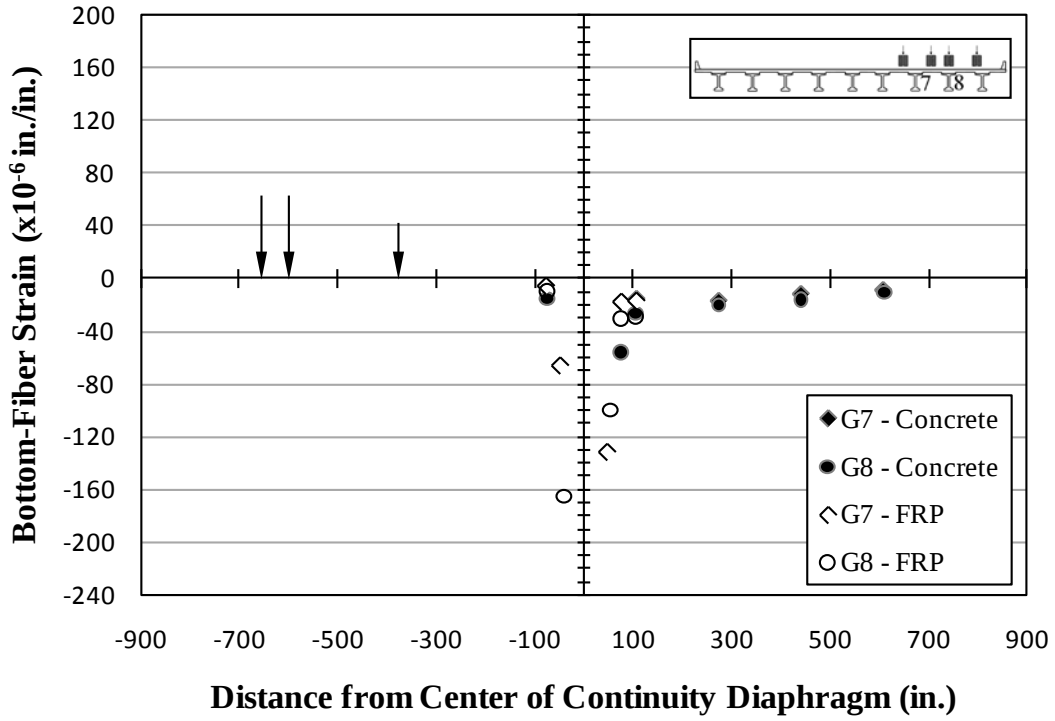
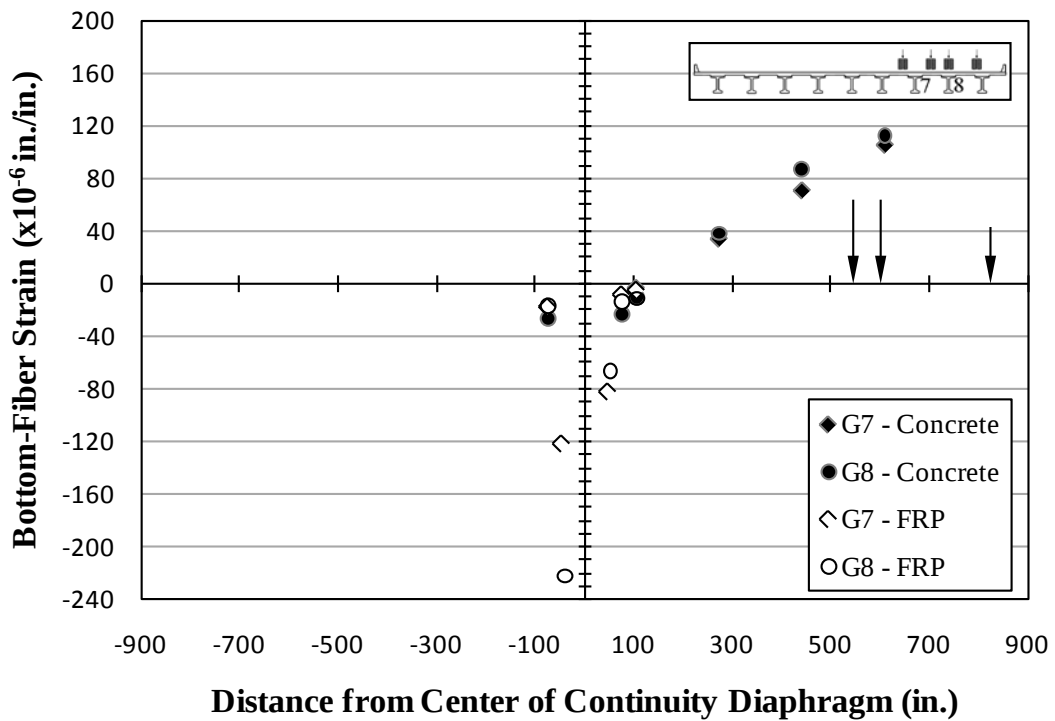
Figure 5.29: Bottom-fiber strain—A1

Figure 5.30: Bottom-fiber strain—A9

Figure 5.31: Bottom-fiber strain—C1

Figure 5.32: Bottom-fiber strain—C9

The maximum bottom-fiber compressive strain measured during the post-repair static load test was  $222 \times 10^{-6}$  in./in. at the FRP reinforcement near the crack location of Girder 8 in Span 10 due to the Lane C midspan static position of Span 11. This bottom-fiber compressive response in the non-loaded span is a sign of continuous behavior.

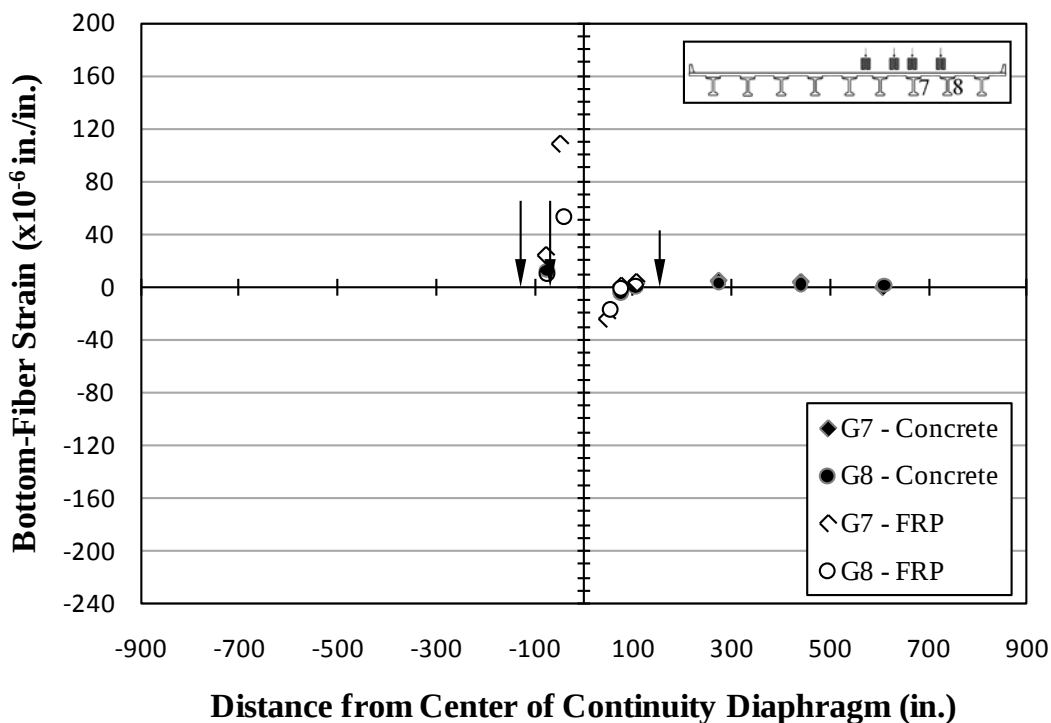
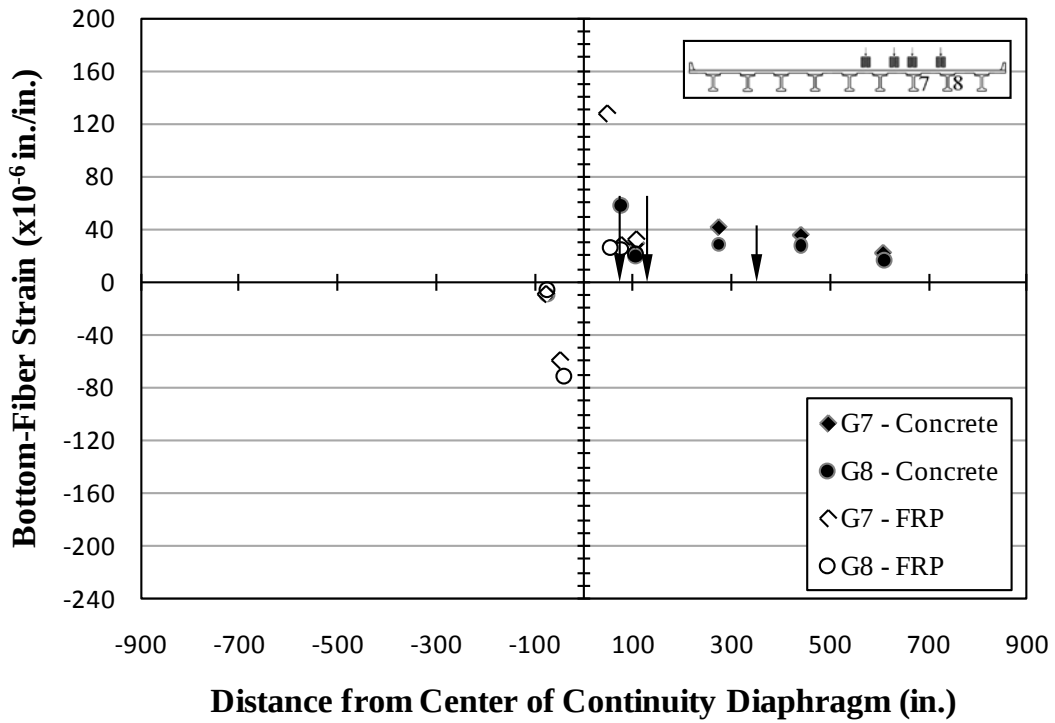
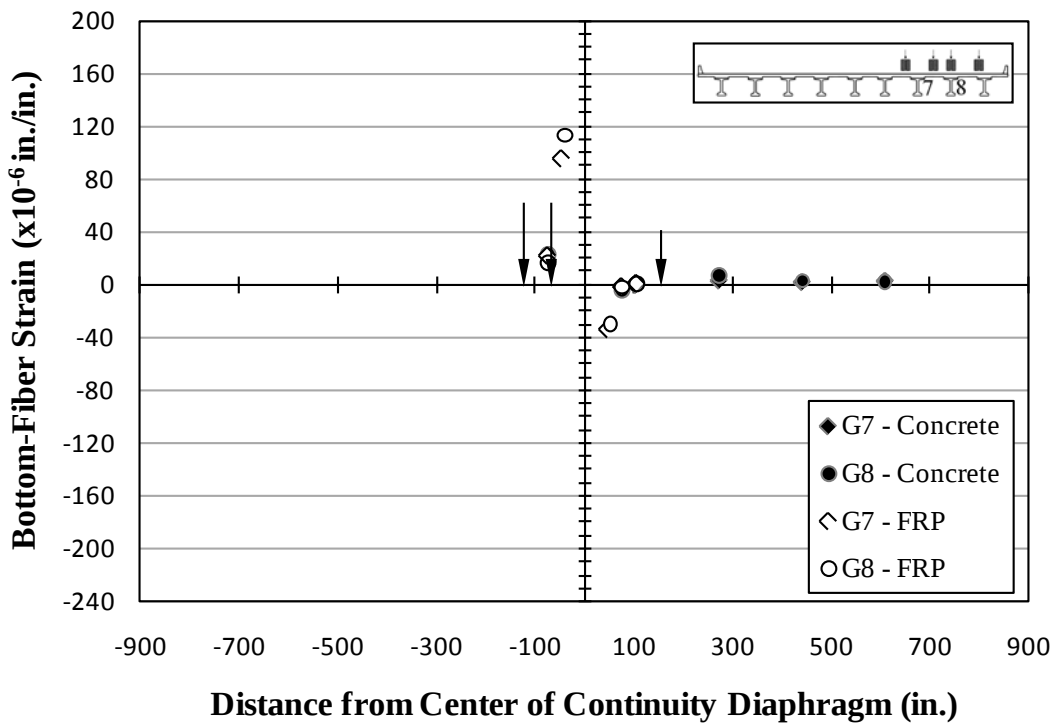
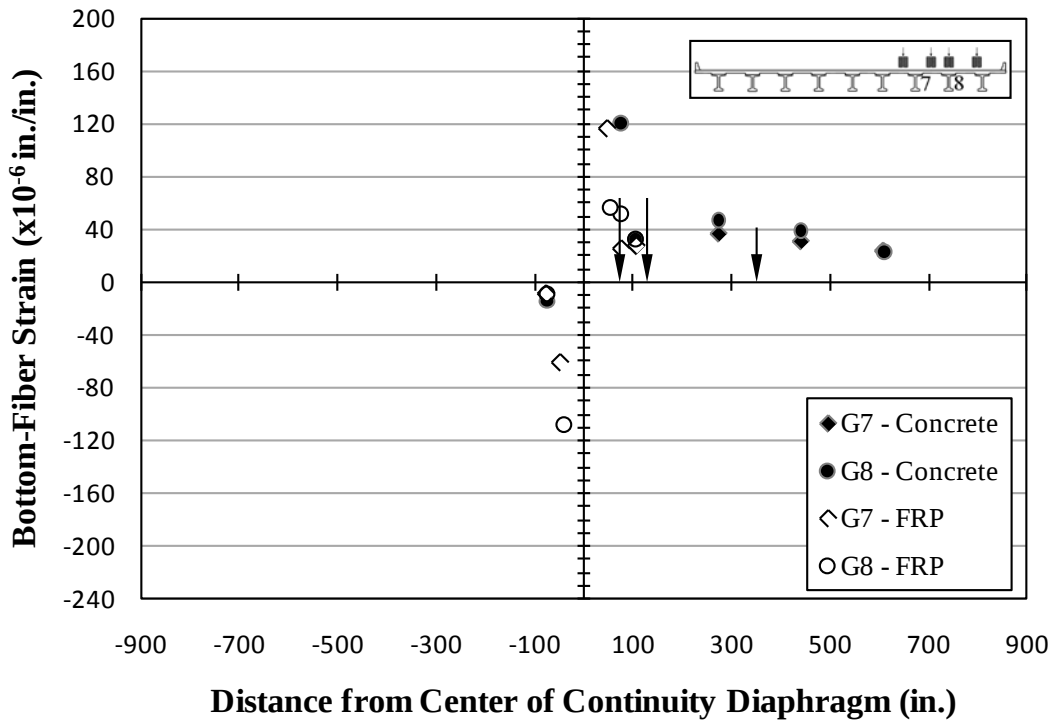
Figure 5.33: Bottom-fiber strain—A4

Figure 5.34: Bottom-fiber strain—A7

Figure 5.35: Bottom-fiber strain—C4

Figure 5.36: Bottom-fiber strain—C7

The maximum bottom-fiber tensile strain measured in response to the eighteen post-repair traversing-load-test truck positions was  $128 \times 10^{-6}$  in./in. near the crack location 47 in. from the continuity diaphragm along Girder 7 of Span 11 in response to trucks aligned with Lane A and positioned near the damaged section (A7). A bottom-fiber tensile strain of  $28 \times 10^{-6}$  in./in. was measured 74 in. from the continuity diaphragm along the same girder and in response to the same load condition. This bottom-fiber tensile response near the continuity diaphragm is a sign of local behavior that decreases the overall continuity of the bridge structure.

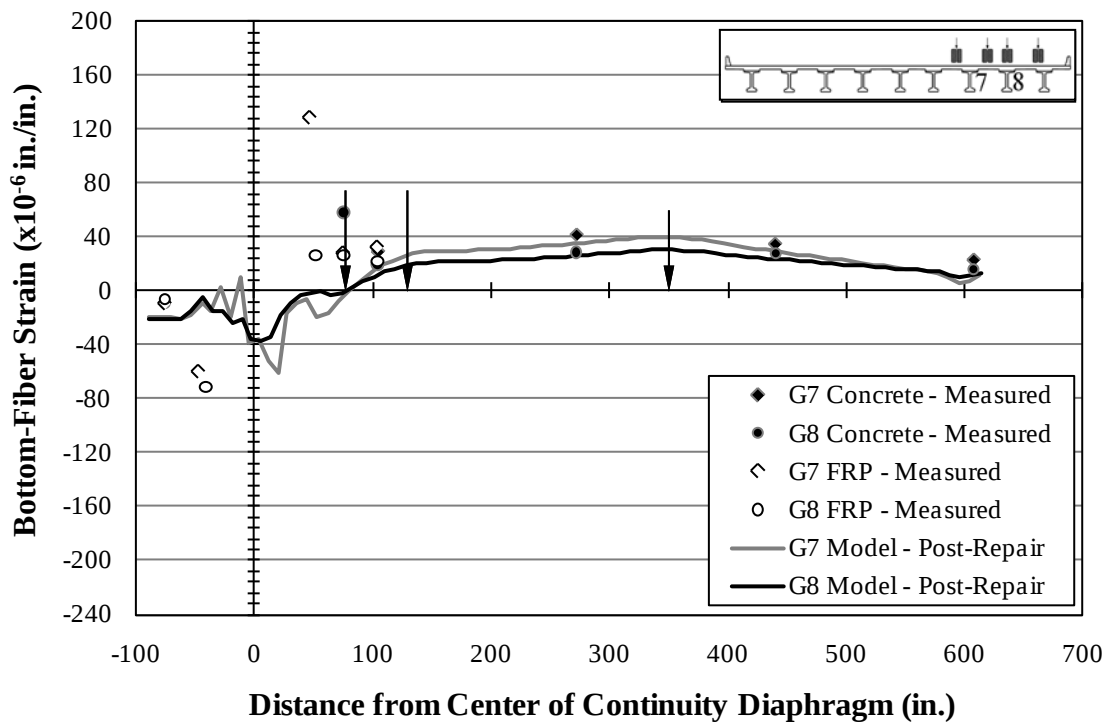
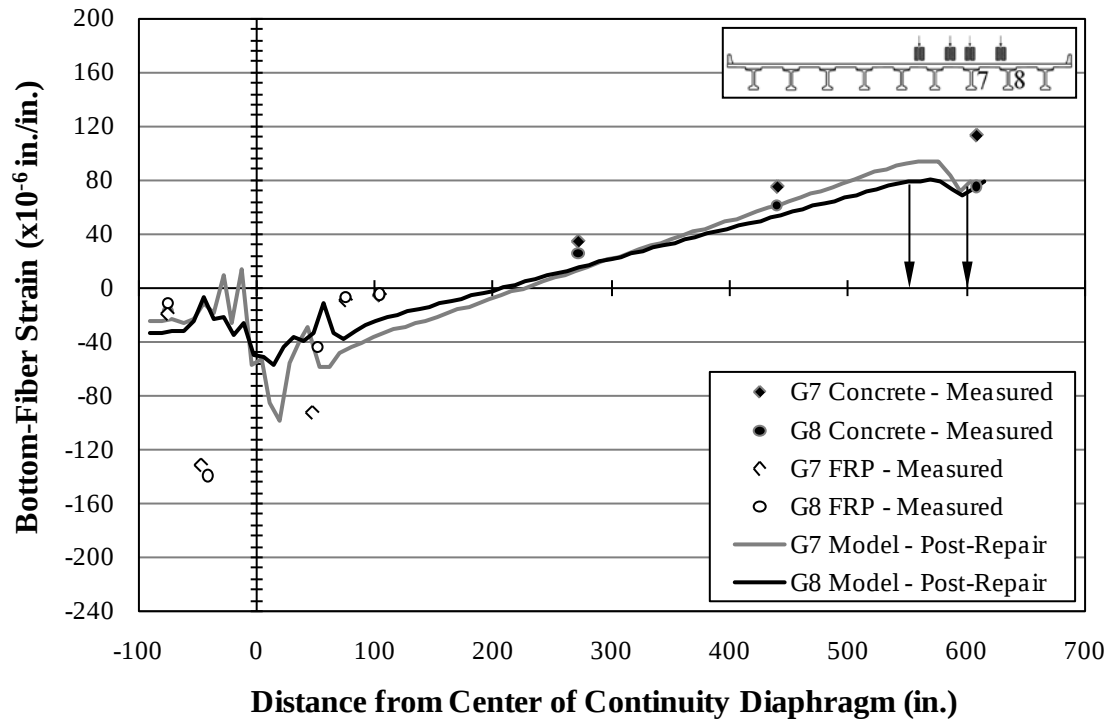
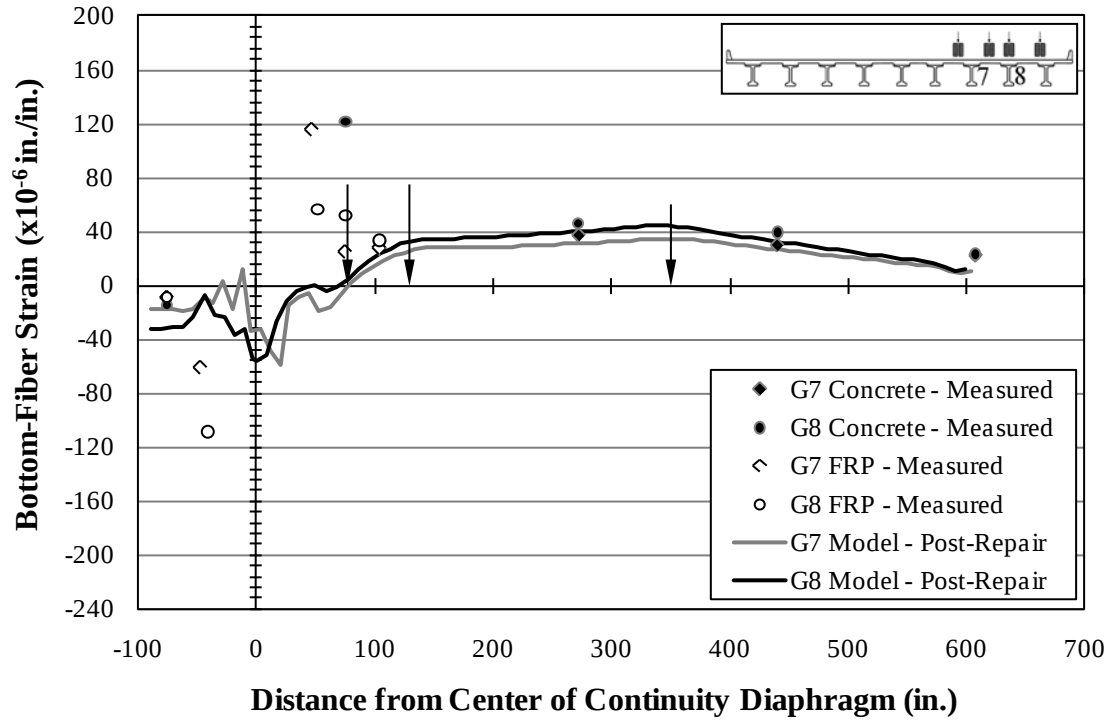
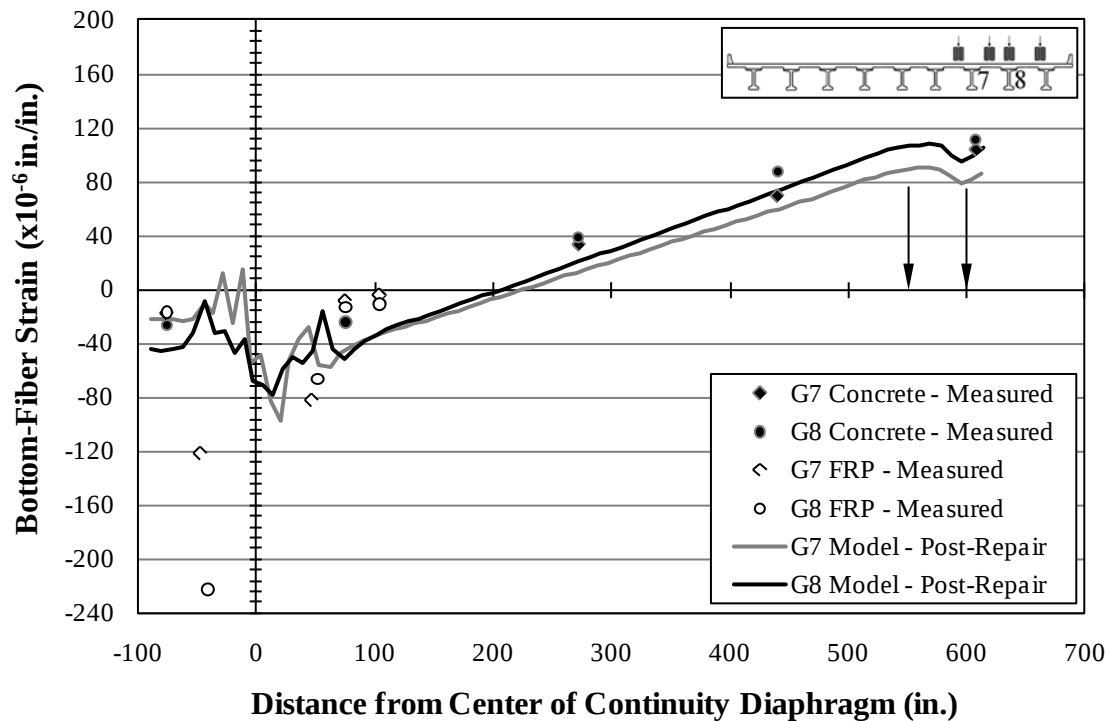
**Figure 5.37: Bottom-fiber strain—post-repair—measurements and predictions—A7**

Figure 5.38: Bottom-fiber strain—post-repair—measurements and predictions—A9

Figure 5.39: Bottom-fiber strain—post-repair—measurements and predictions—C7

**Figure 5.40: Bottom-fiber strain—post-repair—measurements and predictions—C9**

Bottom-fiber strains measured beyond the damaged regions were similar to the predicted strains, but they were slightly more tensile. This is an indicator that the bridge structure is behaving continuously, but with slightly less apparent stiffness than modeled. The measured bottom-fiber strains near the damaged region were not similar to the predicted strains. When the trucks were positioned near the damaged regions of Span 11, the bottom-fiber strains measured near the crack locations of Span 11 were more tensile than predicted. When the trucks were positioned near midspan of Span 11, the bottom-fiber strains measured near the crack locations of Span 10 were more compressive than predicted.
