Research Report No. 2F for ALDOT Project 930-601

**REPAIR OF CRACKED PRESTRESSED  
CONCRETE GIRDERS, I-565,  
HUNTSVILLE, ALABAMA**

**JULY 2011**

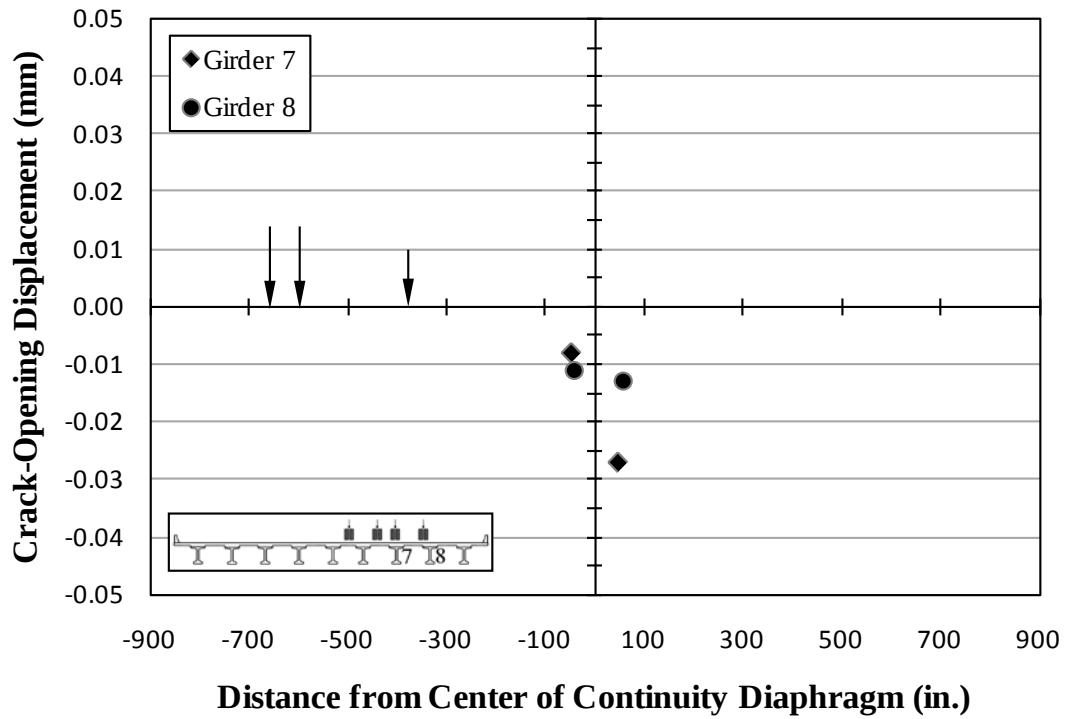
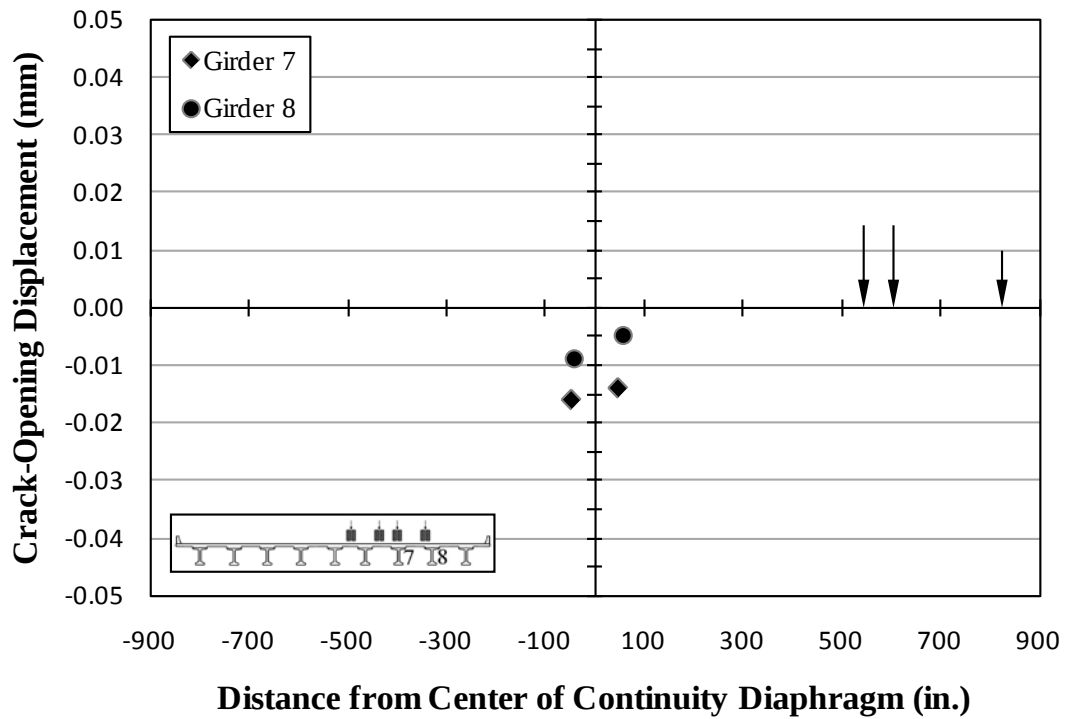
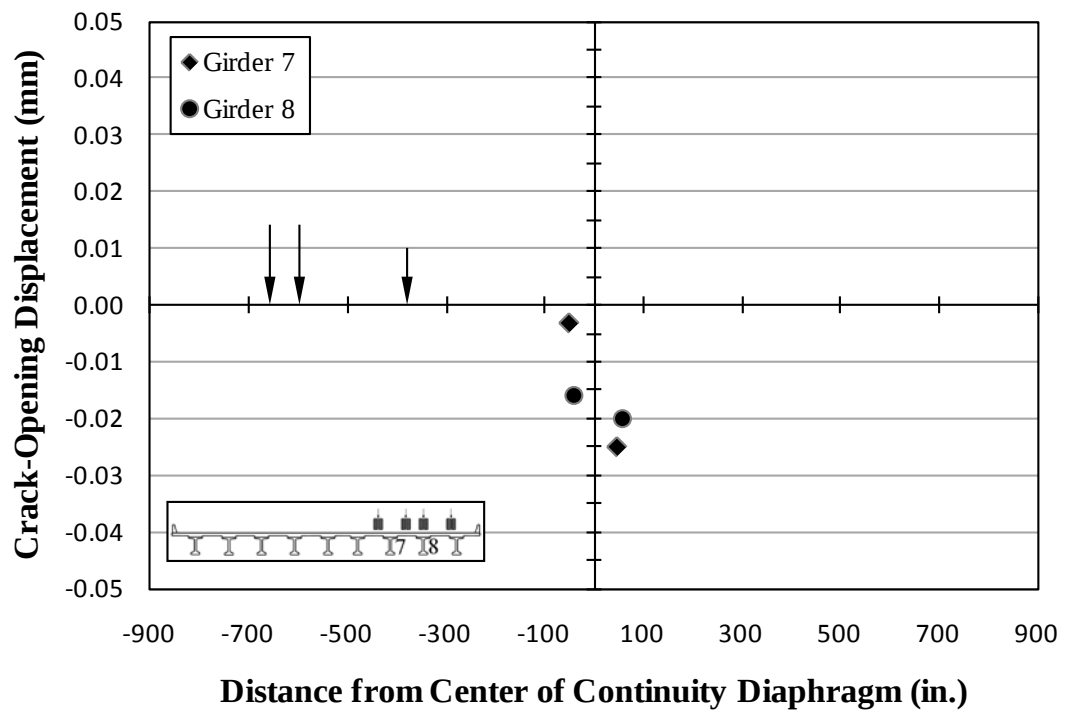
Crack closures measured near the continuity diaphragm, particularly within a non-loaded span, are an indicator of continuous behavior. The maximum post-repair crack closures were

**Figure 5.41: Midspan truck positions—crack-opening displacements—A1**

Figure 5.42: Midspan truck positions—crack-opening displacements—A9

Figure 5.43: Midspan truck positions—crack-opening displacements—C1

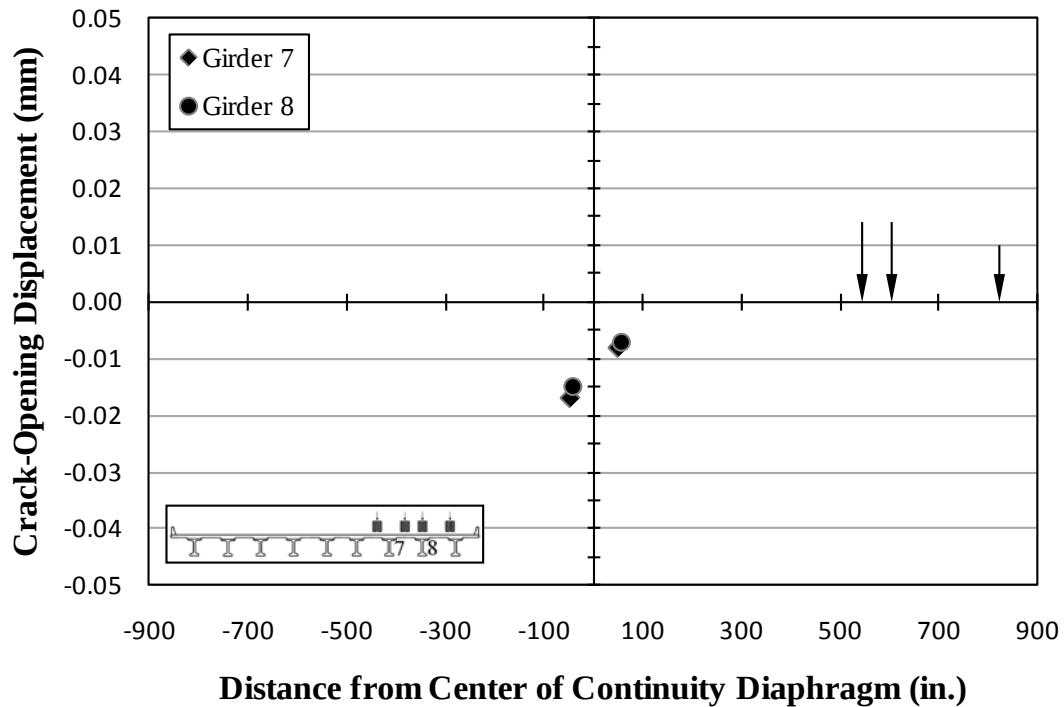
Figure 5.44: Midspan truck positions—crack-opening displacements—C9

Crack closures were measured at all of the COD gage locations in response to all four midspan truck positions of the post-repair traversing load test. The maximum crack closure measured during the post-repair traversing load test was 0.027 mm ( $1.08 \times 10^{-3}$  in.) at the crack location of Girder 7 in Span 11 in response to the Lane A midspan load condition of Span 10 (A1). The maximum crack closure of Span 10 was 0.017 mm ( $0.65 \times 10^{-3}$  in.) at the crack

location of Girder 7 in response to the Lane C midspan load condition of Span 11 (C9). Crack closures measured at damaged regions of both spans in response to midspan truck positions are signs of continuous behavior being partially preserved as well as decreased local apparent stiffness.

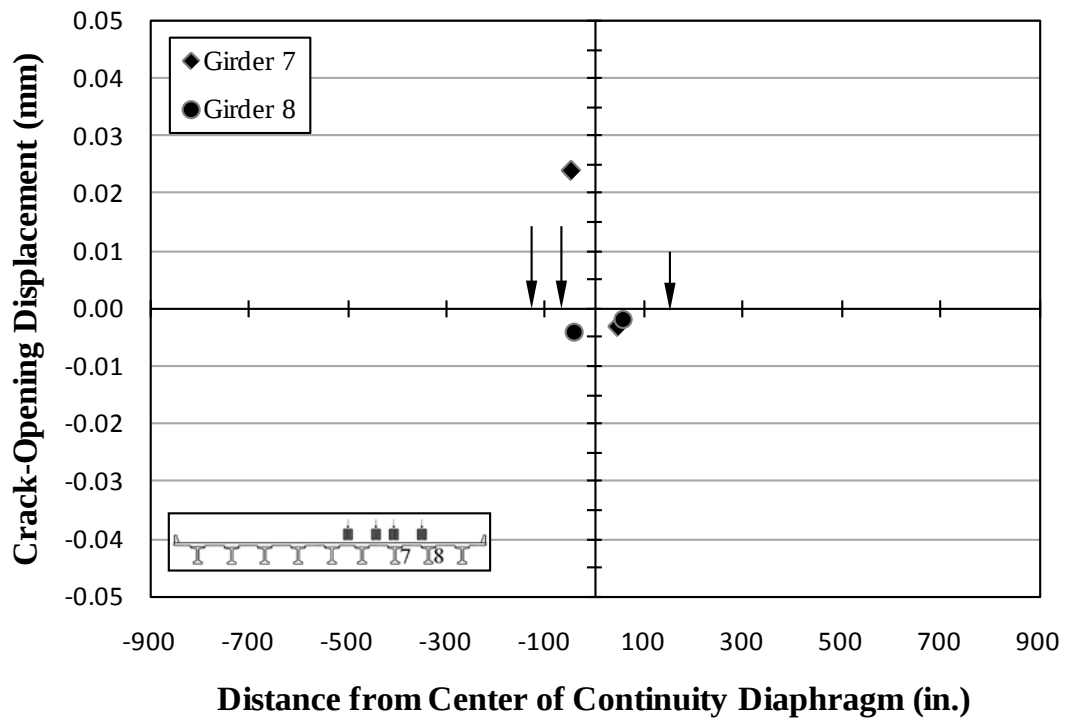
Figure 5.45: Damaged region truck positions—crack-opening displacements—A4

The maximum crack opening measured during the post-repair traversing load test was 0.041 mm ( $1.62 \times 10^{-3}$  in.) at the crack location of Girder 7 in Span 11 in response to the Lane A load condition with trucks near the Span 11 damaged sections (A7). The maximum Span 10 crack opening measured was 0.024 mm ( $0.95 \times 10^{-3}$  in.) at the crack location of Girder 7 in Span 10 in response to the Lane A load condition with trucks near the Span 10 damaged sections

(A4). Crack openings measured within a loaded span are also signs of decreased apparent stiffness within damaged regions.

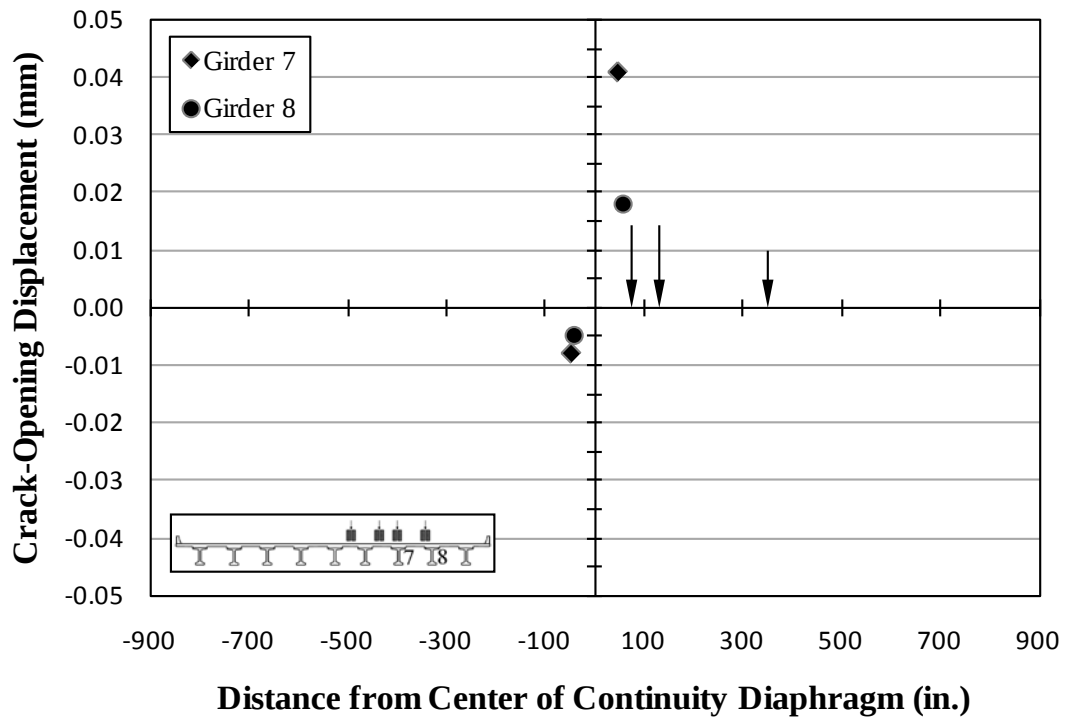
Figure 5.46: Damaged region truck positions—crack-opening displacements—A7

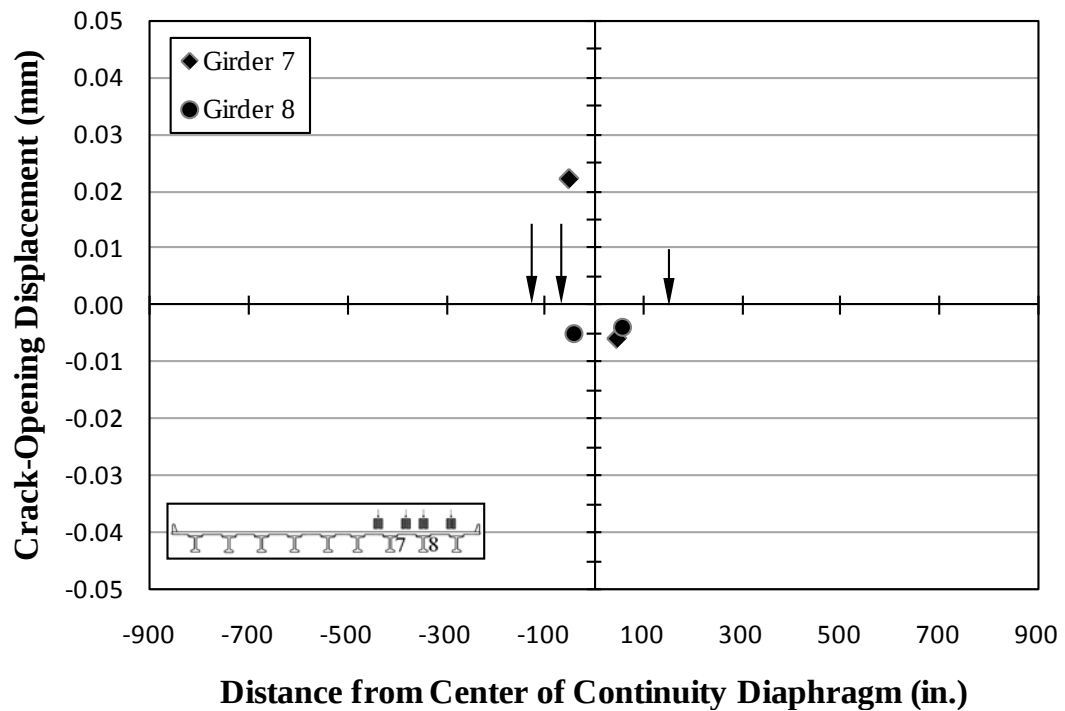
Figure 5.47: Damaged section truck positions—crack-opening displacements—C4

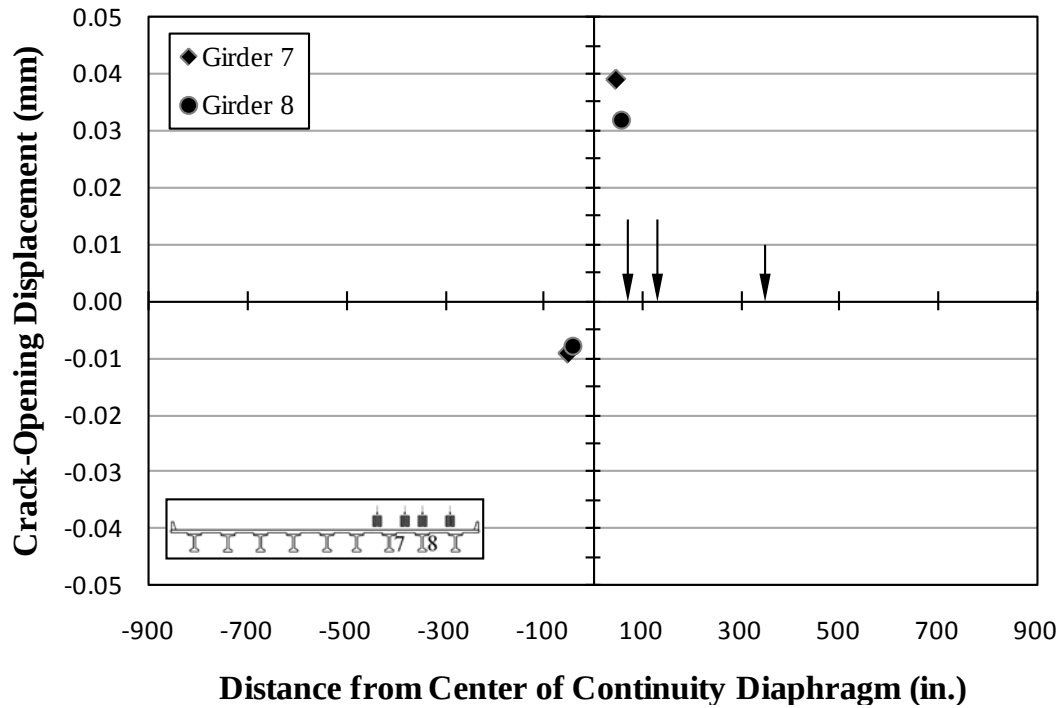
Figure 5.48: Damaged region truck positions—crack-opening displacements—C7

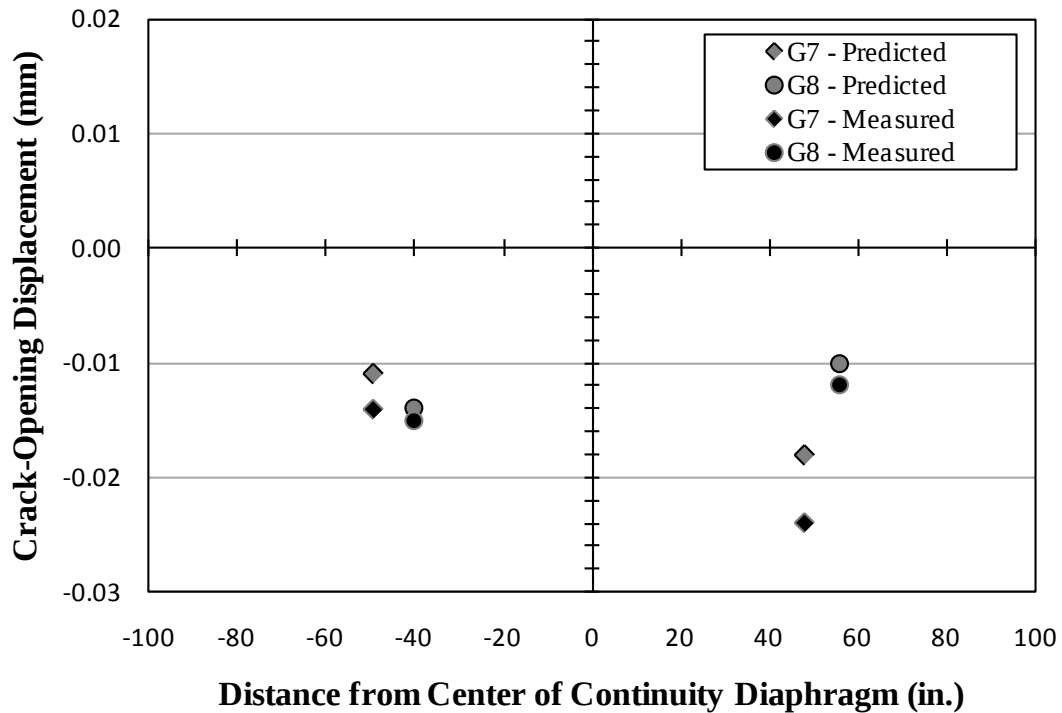
The predicted and measured superposition crack-opening displacements are illustrated in Figure 5.50. The differences between the predicted and measured superposition crack-opening displacements are presented in Table 5.14.

Figure 5.50: Superposition—crack-opening displacements—predicted and measured

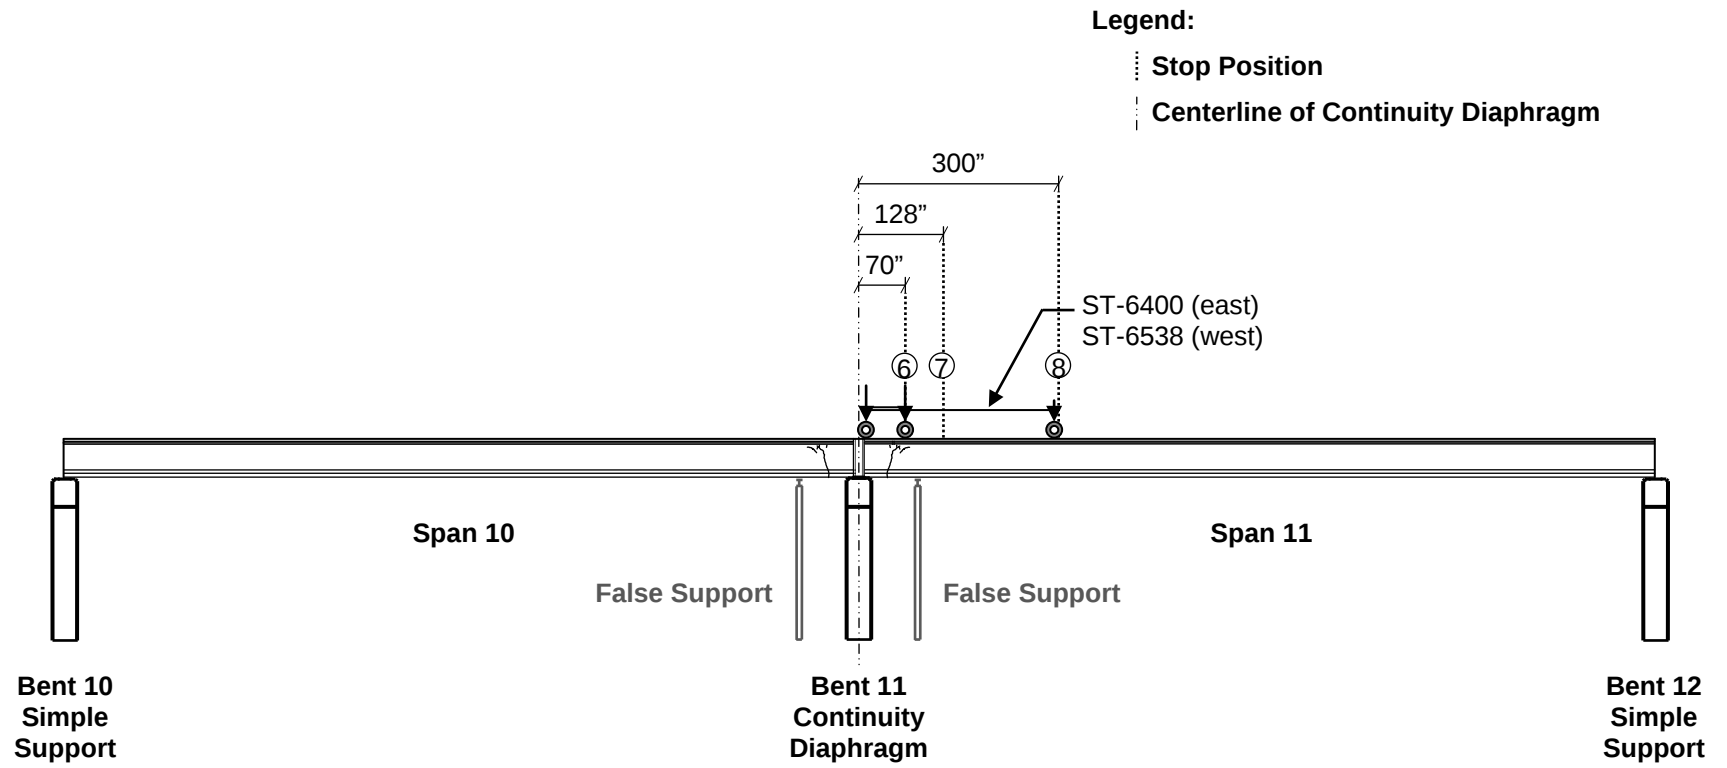
Figure 5.52: Longitudinal truck positions—C6

When the trucks are at Static Position C6, the back axles of each truck straddle the damaged region. The middle axle is positioned 70 in. from the center of the continuity diaphragm, and the rear axle is approximately 13 in. from the center of the diaphragm, as shown in Figure 5.52. The distance between the rear axle and middle axle is 57 in. for the standard ALDOT load truck.

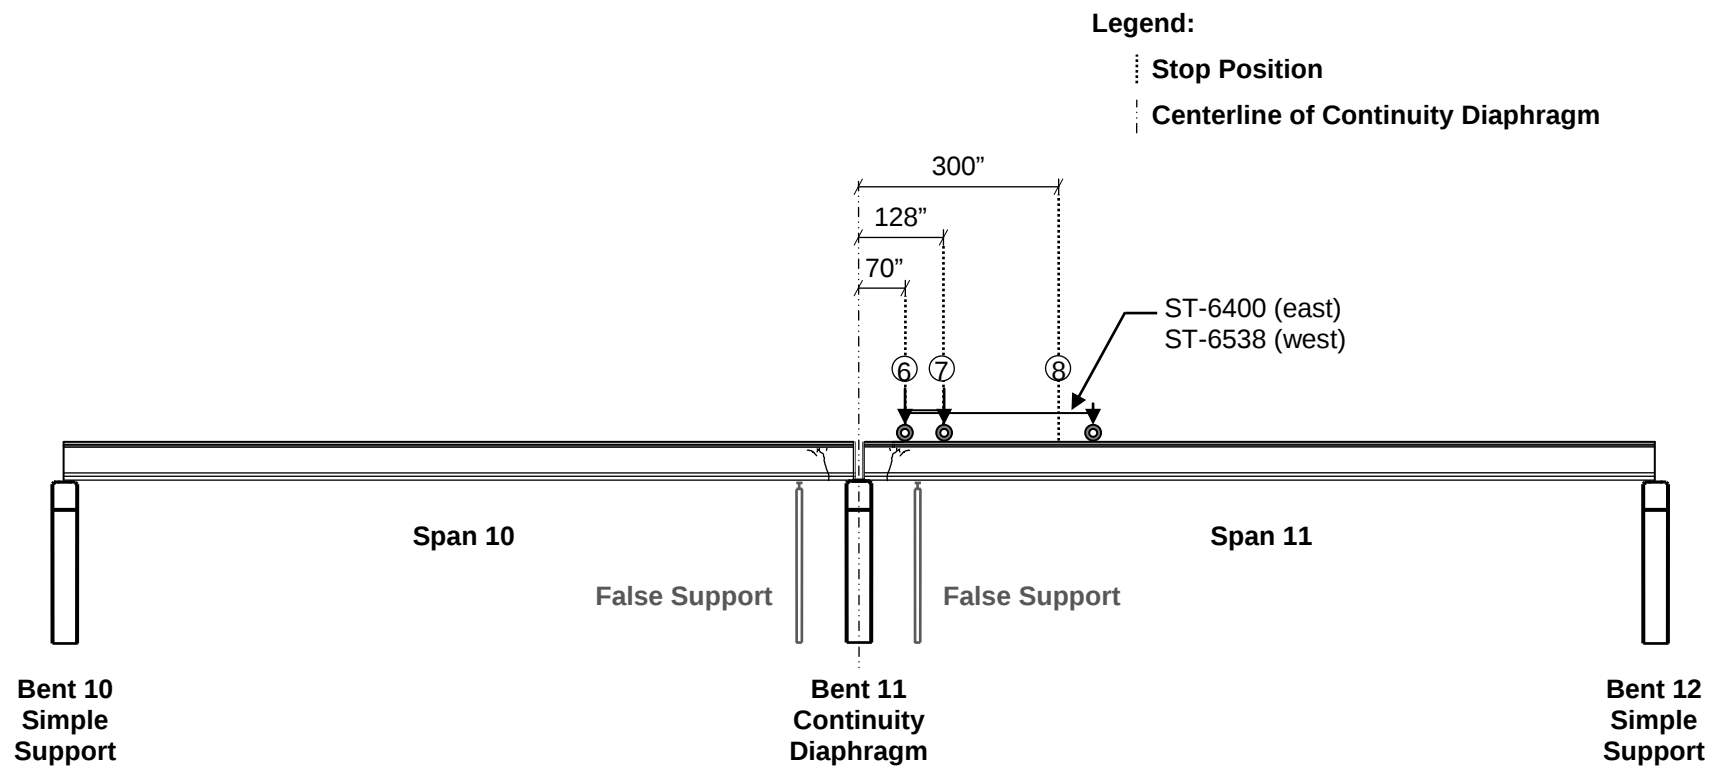
Figure 5.53: Longitudinal truck positions—AE LC-6 Span 11 and C7

The Span 11 static position of the AE tests is similar to Static Position C7 of the multiposition load-tests. These stop positions are similar enough to be presented as one stop position, as shown in Figure 5.53, however, there is a slight difference between the two truck positions. Truck positioning for AE testing was based on aligning the rear axle, and truck positioning for the multiposition tests was based on aligning the middle axle. For the AE Span 11 static position, the rear axle is positioned 70 in. from the center of the continuity diaphragm, and the middle axle is approximately 127 in. from the center of the diaphragm. When the trucks are at Static Position C7, the middle axle is positioned 128 in. from the center of the continuity diaphragm, and the rear axle is approximately 71 in. from the center of the diaphragm.

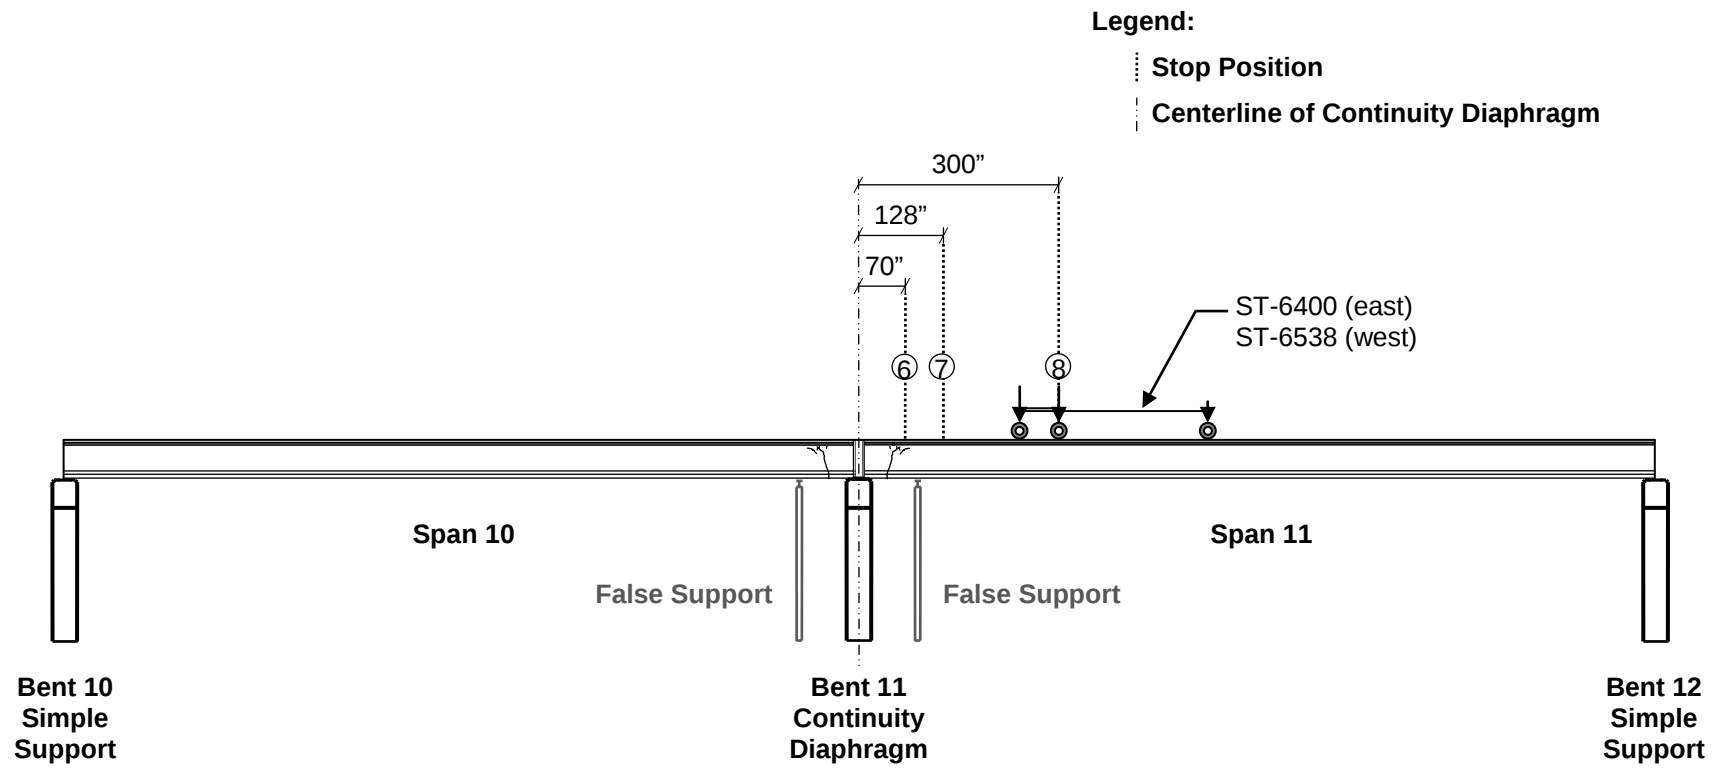
Figure 5.54: Longitudinal truck positions—C8

When the trucks are at Static Position C8, all truck axles are beyond the damaged region. The middle axle is positioned 300 in. from the center of the continuity diaphragm, and the rear axle is approximately 243 in. from the center of the diaphragm, as shown in Figure 5.54.

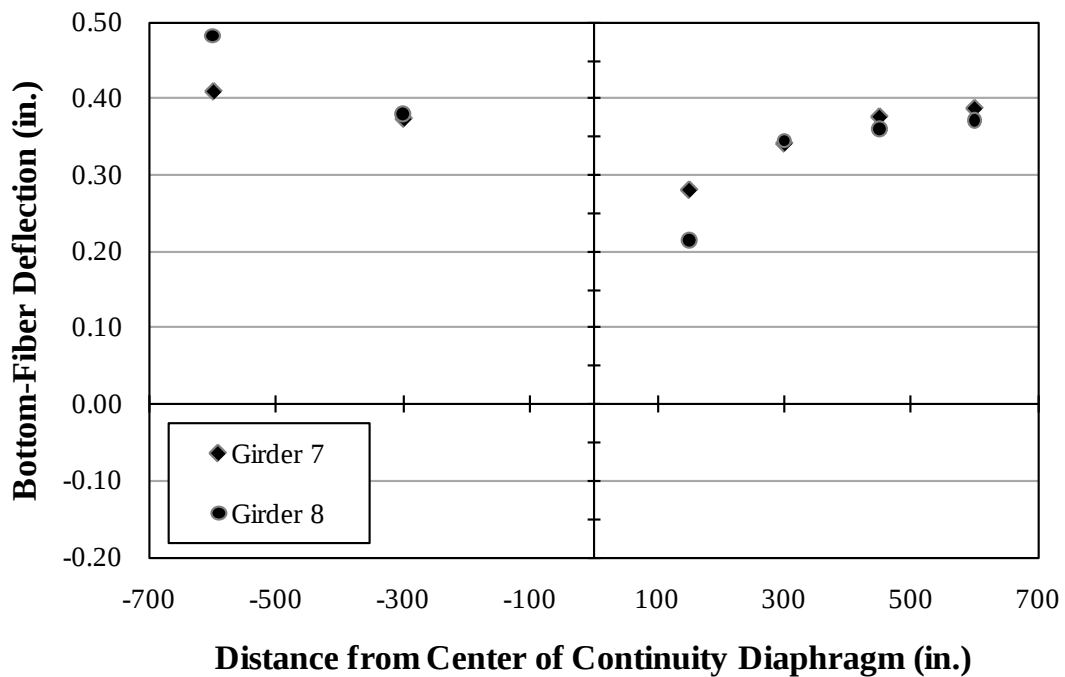
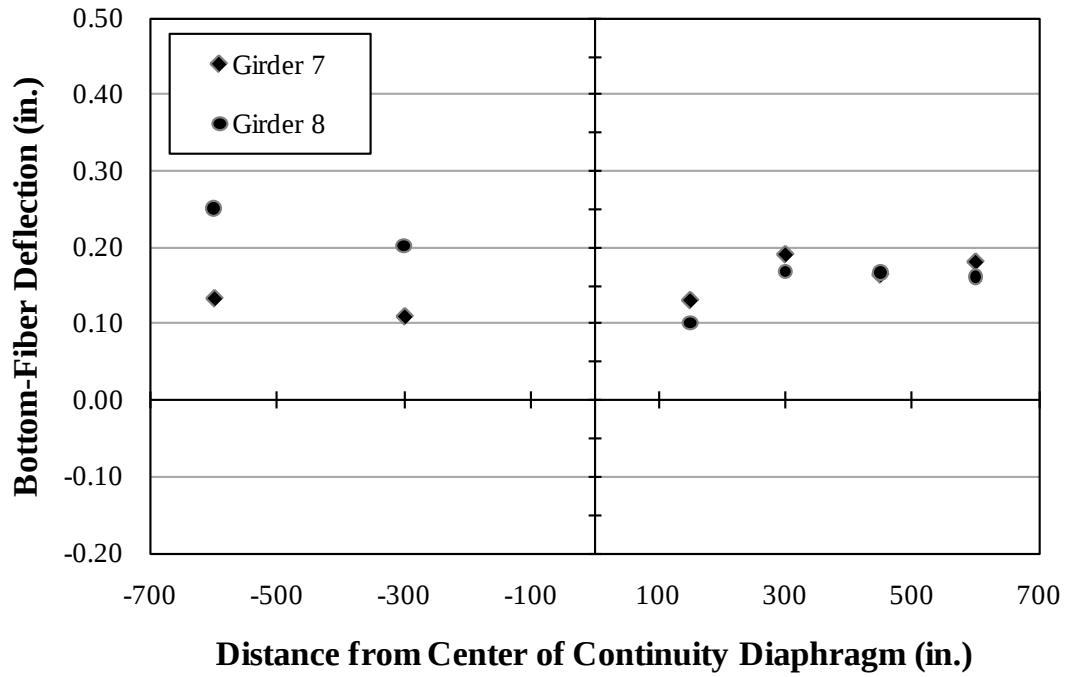
Figure 5.73: Deflections—4:30 p.m.

Figure 5.74: Deflections—8:30 p.m.

The deflections measured at 4:30 p.m. and 8:30 p.m. result in deflected shapes that are similar to the deflected shape expected of a continuous structure subjected to a thermal gradient as shown in Figure 5.69. However, additional measured deflections would be useful for providing clearer evidence of an inflection point in response to restrained thermal effects.

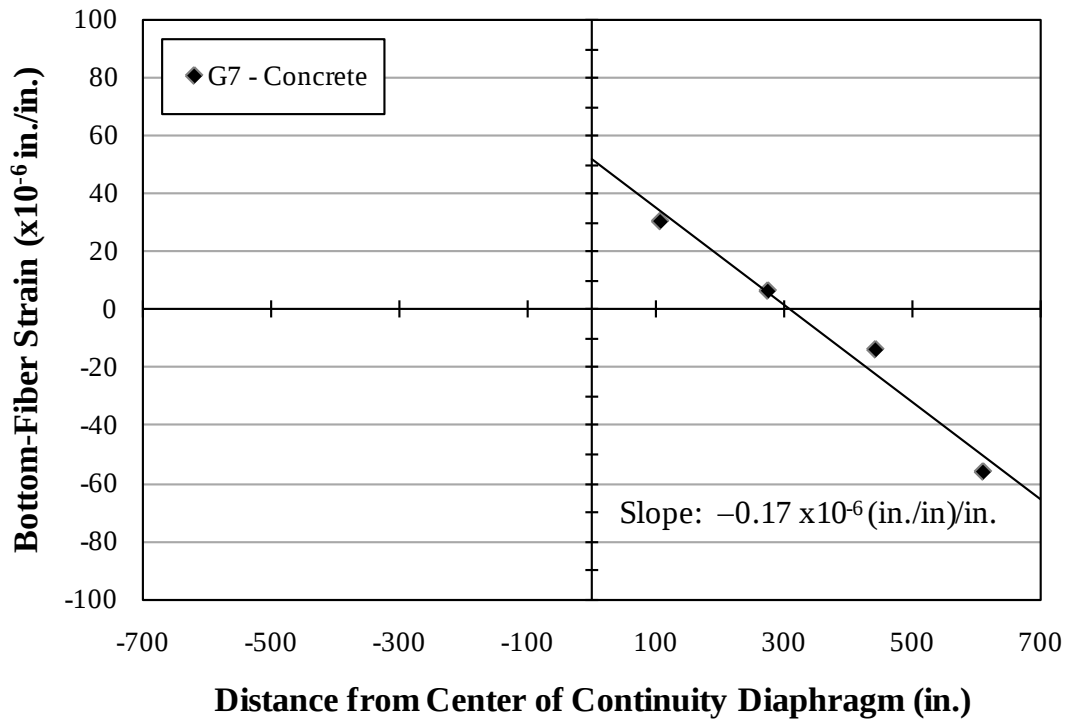
Figure 5.85: Bottom-fiber strains—concrete—Girder 7—4:30 p.m.

The slope of the bottom-fiber strain profile expected due to these conditions is  $-0.24 \times 10^{-6} (\text{in./in.})/\text{in.}$ , which is similar to the  $-0.17 \times 10^{-6} (\text{in./in.})/\text{in.}$  slope of the measured strain profile for Girder 7 in Span 11 at 4:30 p.m. as presented in Figure 5.85. The slope of the measured strain profile is less steep than the slope of the theoretical strain profile, which could be an indication that the girder is not exhibiting fully continuous behavior as theoretically assumed, or that the actual temperature gradient was less than the estimated value. This decrease in continuity exhibited by the slope of the measured strain profile is likely due to the local behavior of the damaged region.

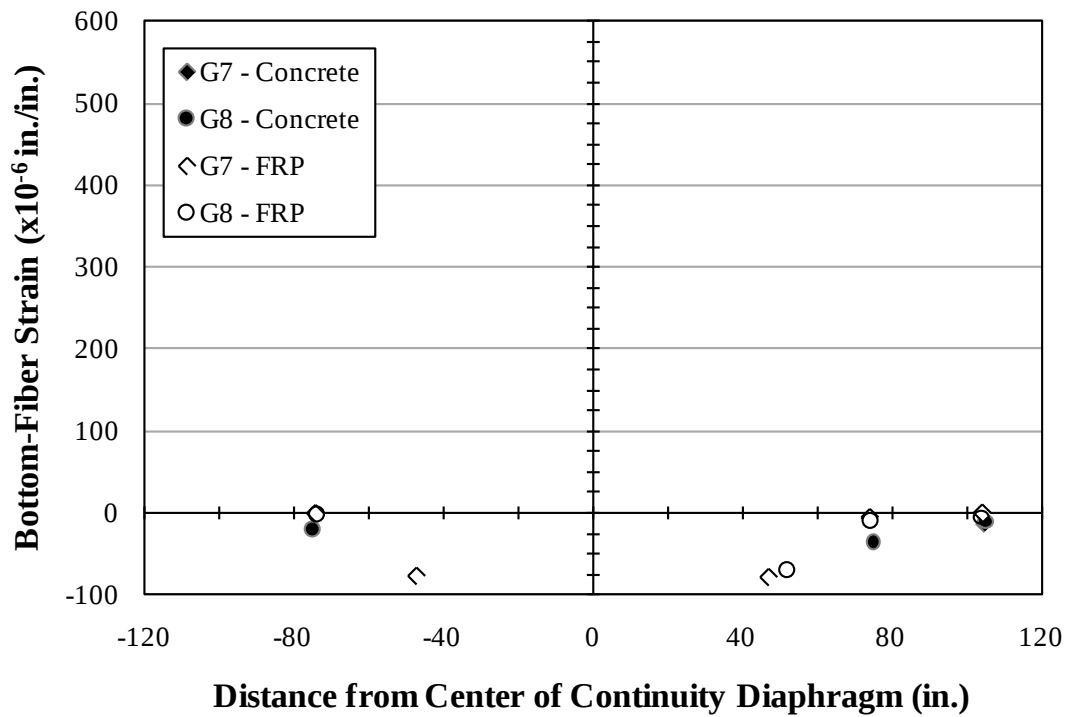
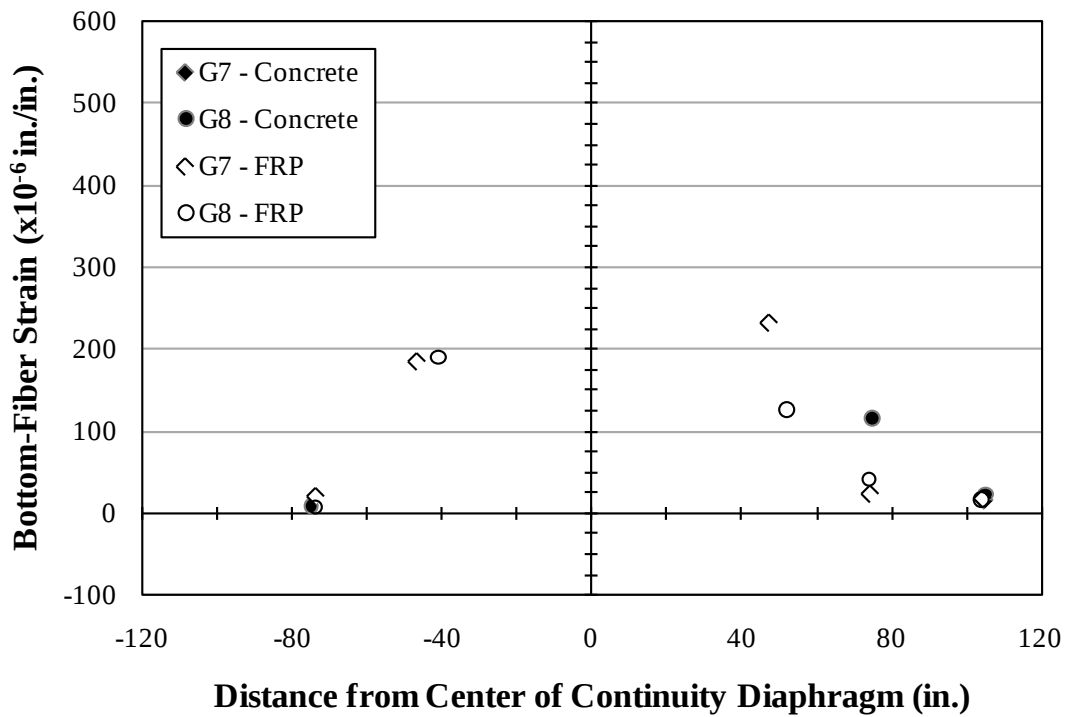
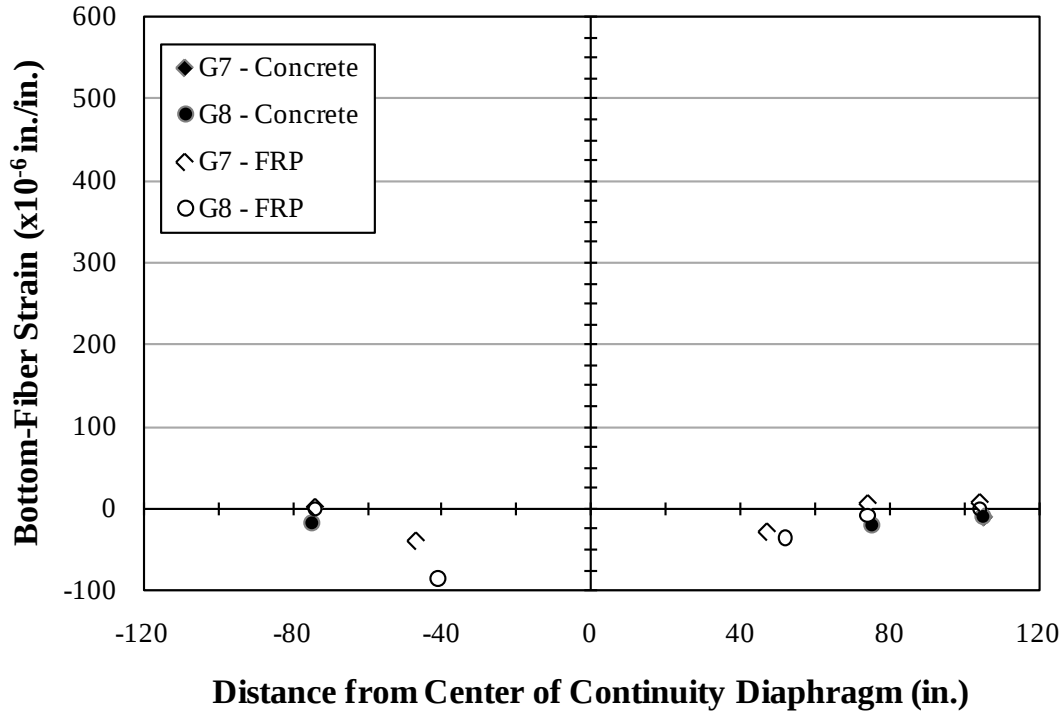
The bottom-fiber strains near the damaged region are shown to be greater than the strains projected by trend lines associated with concrete strains beyond the damaged region. These near damage zone bottom-fiber strains are presented in Figures 5.92–5.95. The

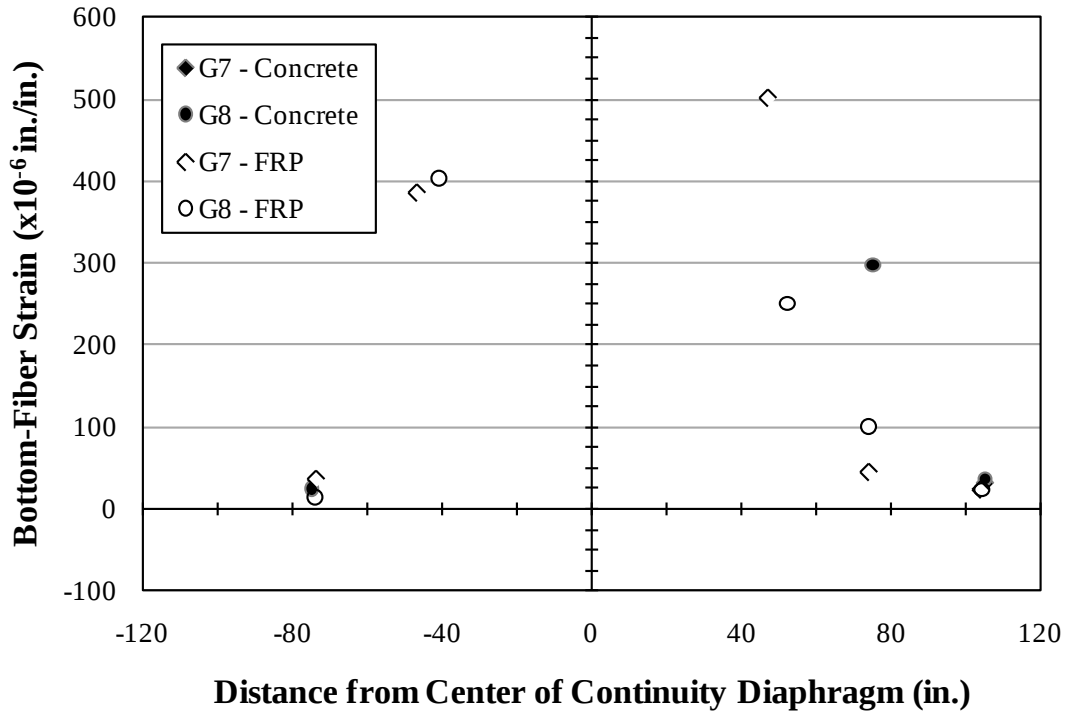
Figure 5.93: Bottom-fiber strains—damaged region—4:30 p.m.

magnitudes of the bottom-fiber tensile strains measured within the damaged region at 4:30 p.m. as shown in Figure 5.93 are an indication that the ambient thermal conditions have a significant effect on the damaged regions.

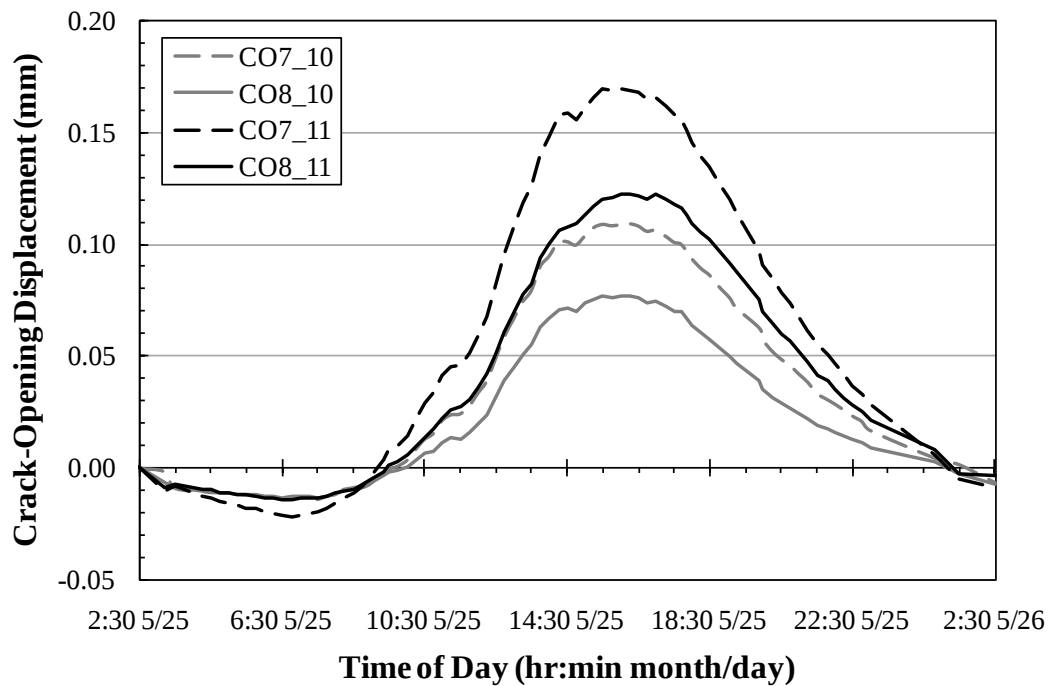
**Figure 5.96: Crack-opening displacements—normal traffic—twenty-four hours**

presented in Table E.1. Graphical presentations of these crack-opening displacements are shown in Figure 5.96.

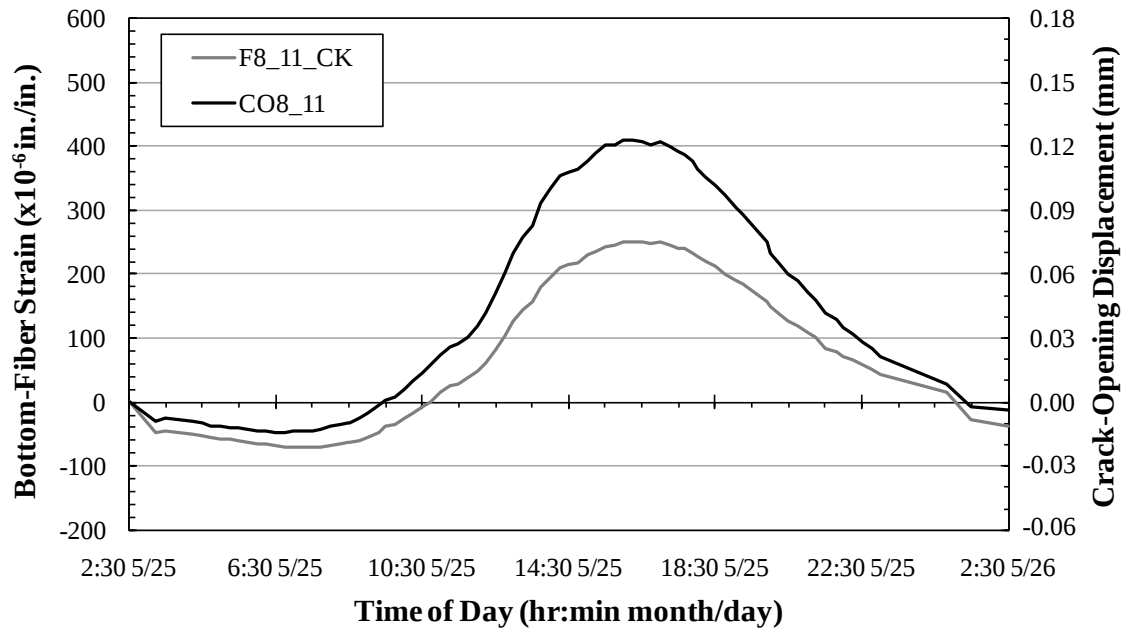
Figure 5.100: Bottom-fiber strain and COD—thermal conditions—Girder 8—Span 11

The FRP strains measured at the crack location of Girder 8 in Span 11 were consistently the least tensile of the four instrumented girders. This behavior is not consistent with the crack-opening displacements measured by the COD gage on the same girder. The relationship shown in Figure 5.100 between the COD measurements and the bottom-fiber FRP strain measurements at the crack location of Girder 8-Span 11 supports the previous conclusion that the bottom-fiber FRP strain gage assigned to that crack location was not accurately installed as close to the actual underlying crack location as the other FRP strain gages assigned to their respective crack locations.

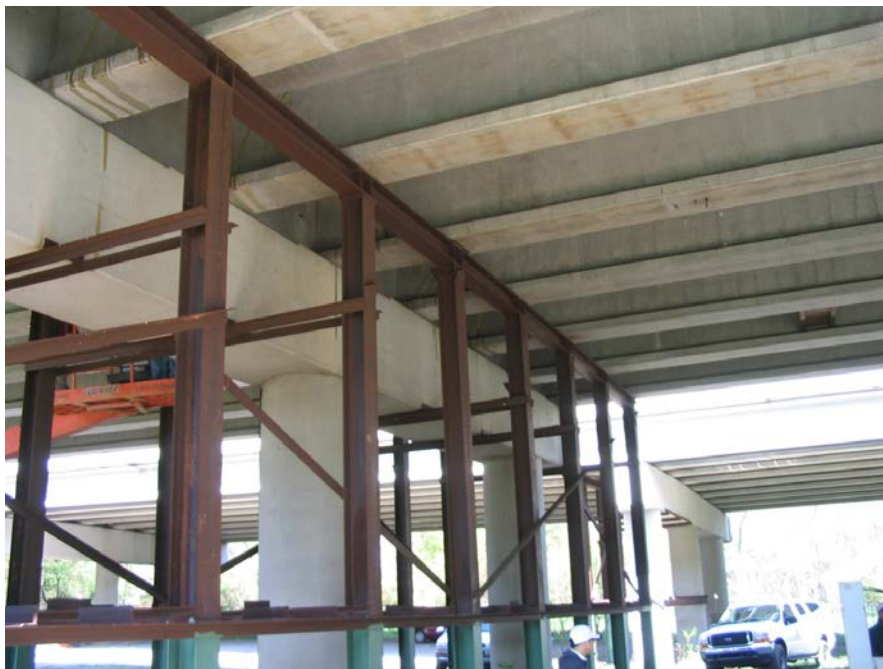
In response to the severity of cracking observed at the continuous ends of prestressed concrete girders of I-565, ALDOT installed steel frame false supports under spans containing damaged girders, as shown in Figure K.1. False supports were installed within ten feet of the bents, allowing the cracked regions of damaged girders to be contained between false supports and the nearest bent.

**Figure K.1: Steel frame false supports**

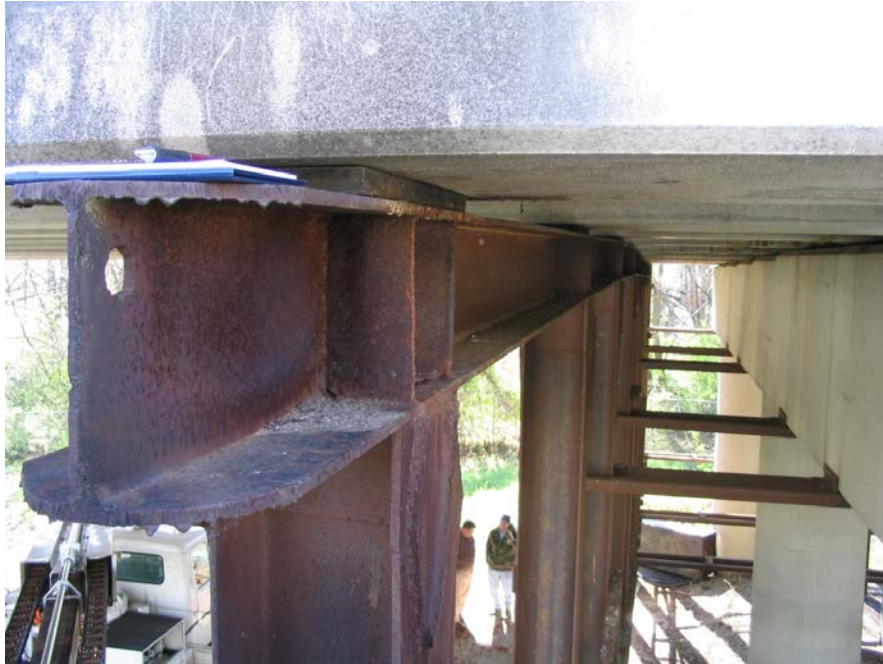
**Figure K.2: Bearing pad between false support and exterior girder**

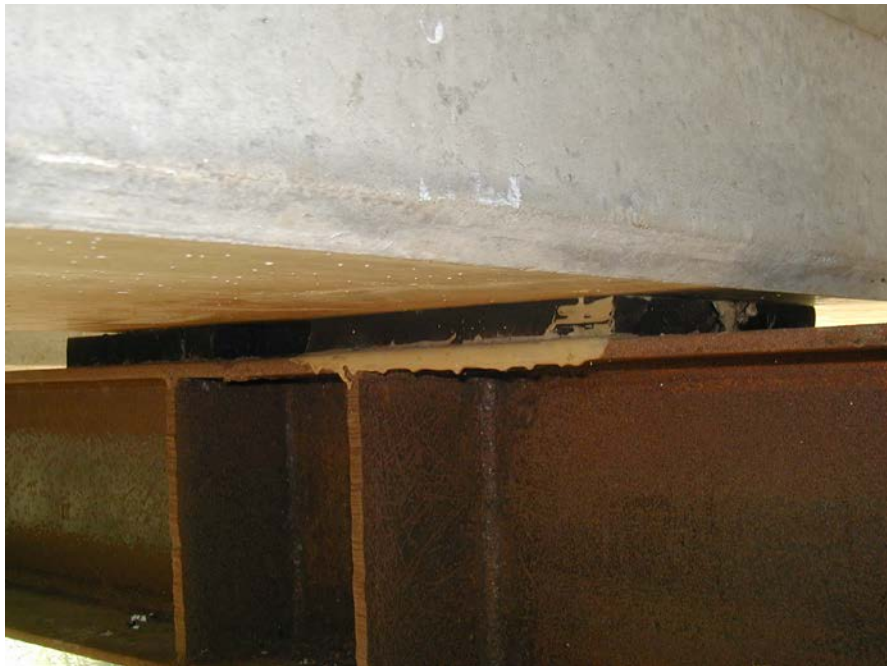
A small gap between the bearing pad and girder bottom remained after false support installation. Bearing pads were installed to prevent catastrophic collapse in case of further deterioration of the bridge girders, but it was undesirable for bearing pads to remain in contact with bridge girders during load testing. An installed bearing pad with space remaining between the pad and girder is shown in Figure K.3. A bearing pad that is in contact with a girder and likely transferring loads through the false support is shown in Figure K.4.

Figure K.4: Bearing pad location *without* space between the bearing pad and girder

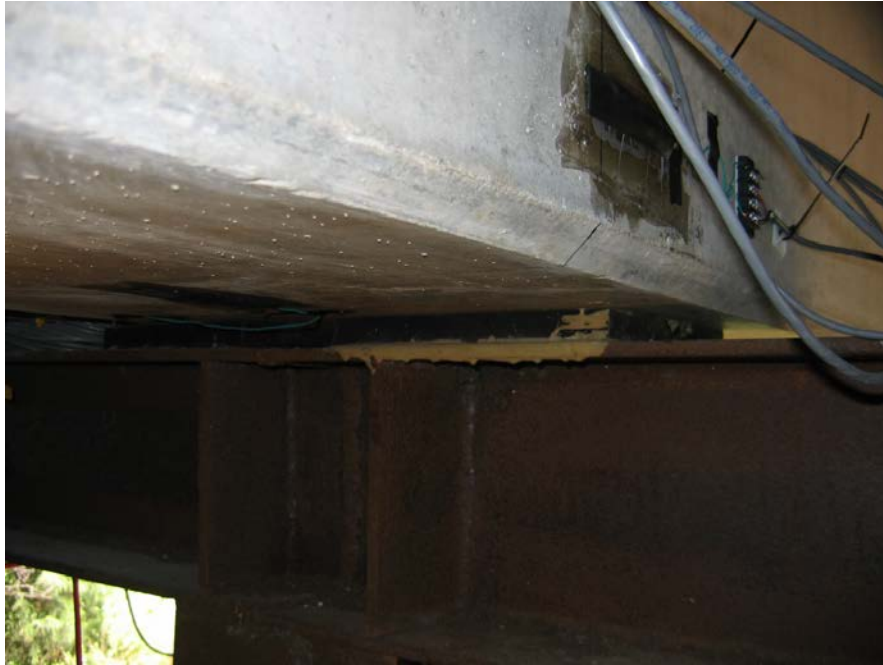
During initial test preparation, it was observed that some of the gaps between bearing pads and false supports had closed, and bearing pads were in contact with instrumented girders, as shown in Figure K.5. The closure of gaps between girders and false support bearing pads was likely due to downward creep deformations of the girders or settlement of the bridge structure.

**Figure K.5: Bearing pad in contact with girder during pre-repair testing**

An attempt was made to remove the bearing pads; however, initial removal attempts were unsuccessful. A surface-mounted strain gage was attached to one column of the false supports to determine if the false supports were supporting normal traffic loads due to the bearing pads being in direct contact with the girders. Due to the measurement of small compressive strains, it was determined that the bearing pads were transmitting some load through the false supports during normal traffic conditions (Fason 2009).

complete removal of all bearing pads would not be possible before conducting pre-repair load tests, holes were drilled in the bearing pads to alleviate pressure and reduce the effective stiffness of the pads (Fason 2009).
