Research Report No. 2F for ALDOT Project 930-601

**REPAIR OF CRACKED PRESTRESSED  
CONCRETE GIRDERS, I-565,  
HUNTSVILLE, ALABAMA**

**JULY 2011**

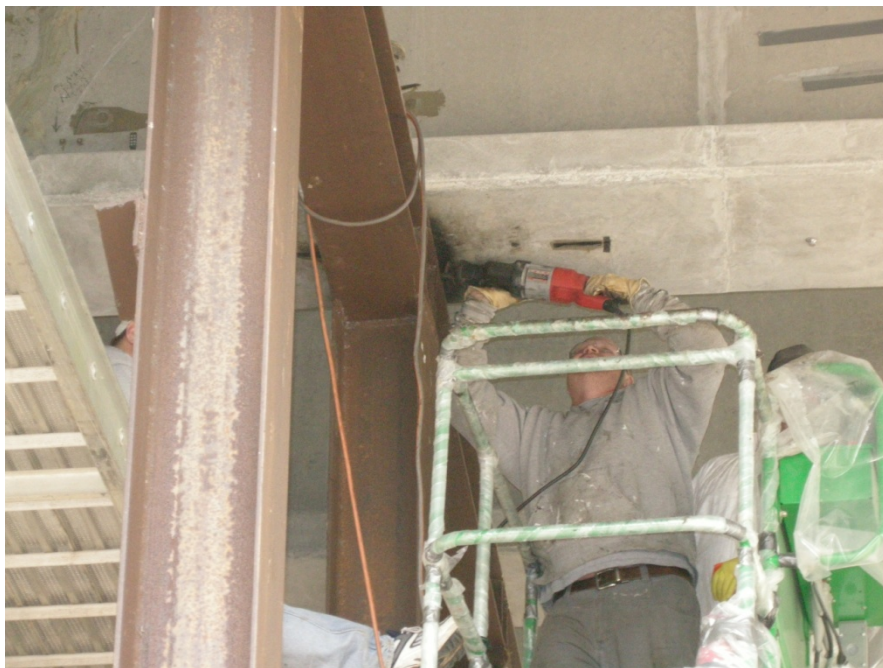
**Figure K.6: Use of reciprocating saw during bearing pad removal**

The installation of the FRP reinforcement required that all bearing pads be removed. These bearing pads inhibited FRP installation to the bottom of the girder at false-support locations. The bearing pads under Span 11 were, in general, more difficult to remove than the bearing pads under Span 10. Initially, the contractor attempted to remove each bearing pad by punching it out of place using a chisel and hammer. When a bearing pad was under enough pressure to prevent removal, the contractor then used a reciprocating saw on the pad in an attempt to alleviate some of that pressure, as shown in Figure K.6.

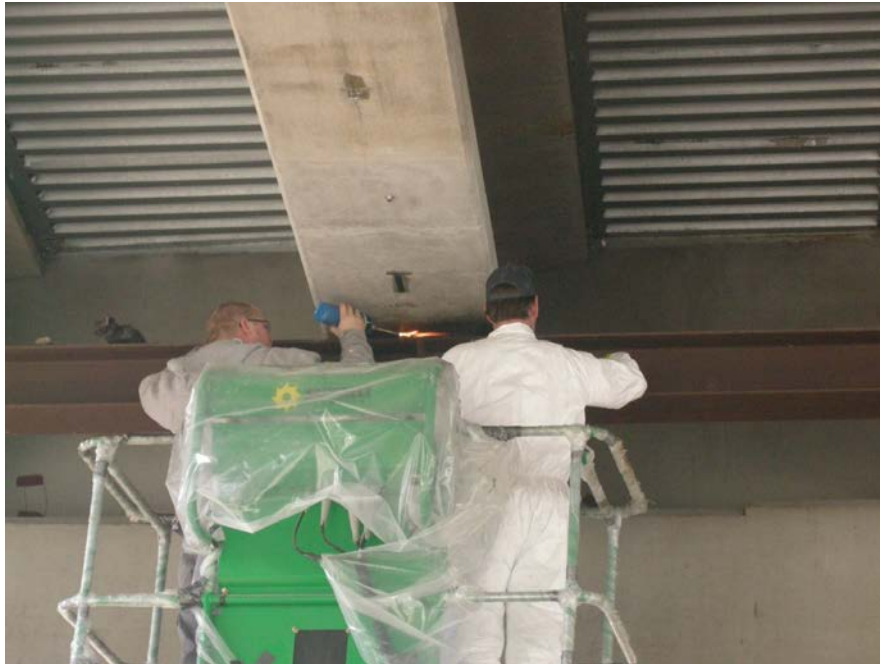
**Figure K.7: Use of propane torch during bearing pad removal**

In some cases, saw cutting alone was not effective at alleviating enough pressure for successful bearing pad removal. In these cases, a propane torch was used to soften the rubber, as shown in Figure K.7, which then allowed for a more effective sawing process.

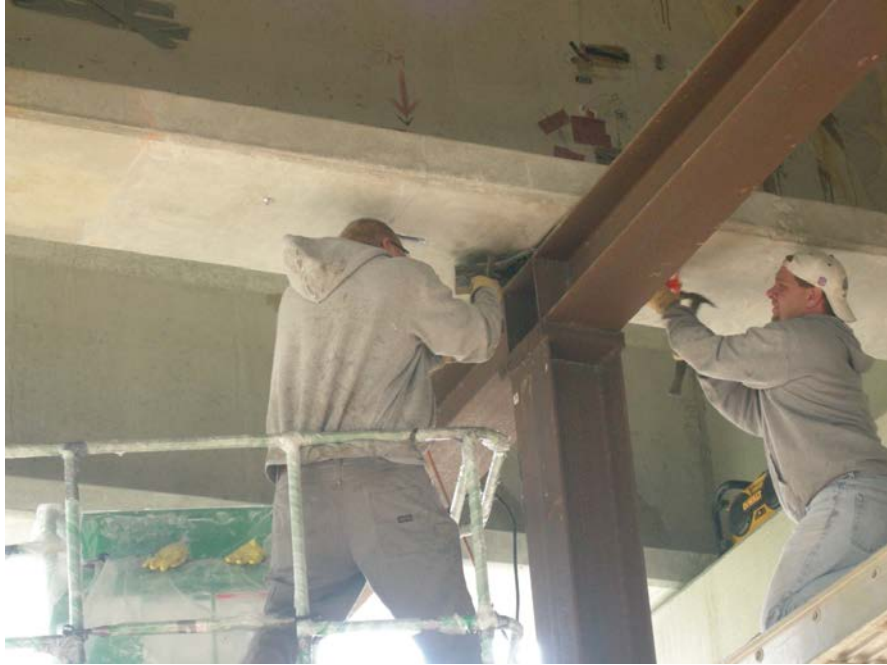
**Figure K.8: Successful removal of bearing pad**

After successful pressure alleviation, the bearing pad was removed using the initial chisel-and-hammer removal method, as shown in Figure K.8. An example of a bearing pad that required forceful removal is shown in Figure K.9. Bearing pads were *not* replaced following the installation of the FRP reinforcement.

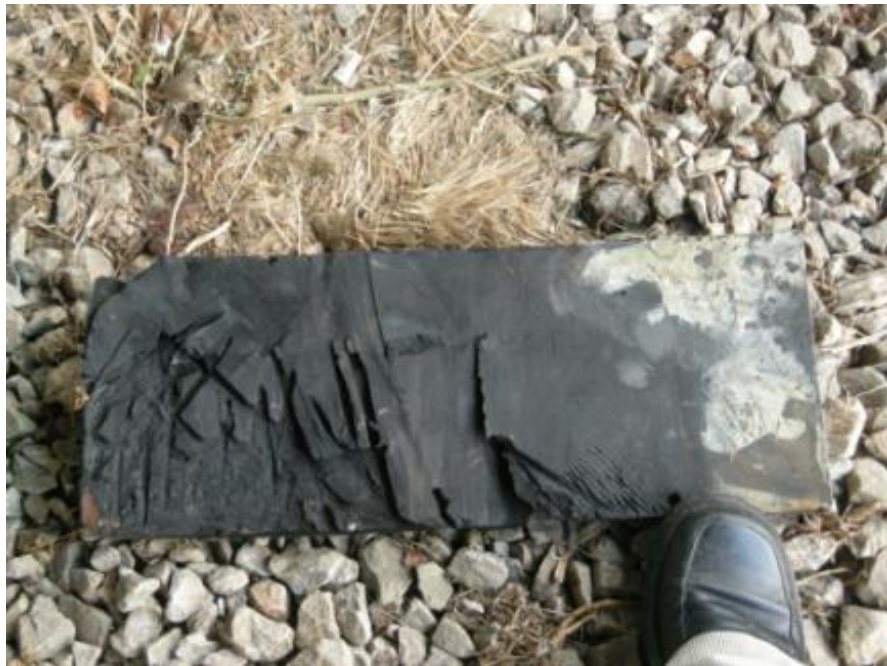
**Figure K.9: Bearing pad after forceful removal**

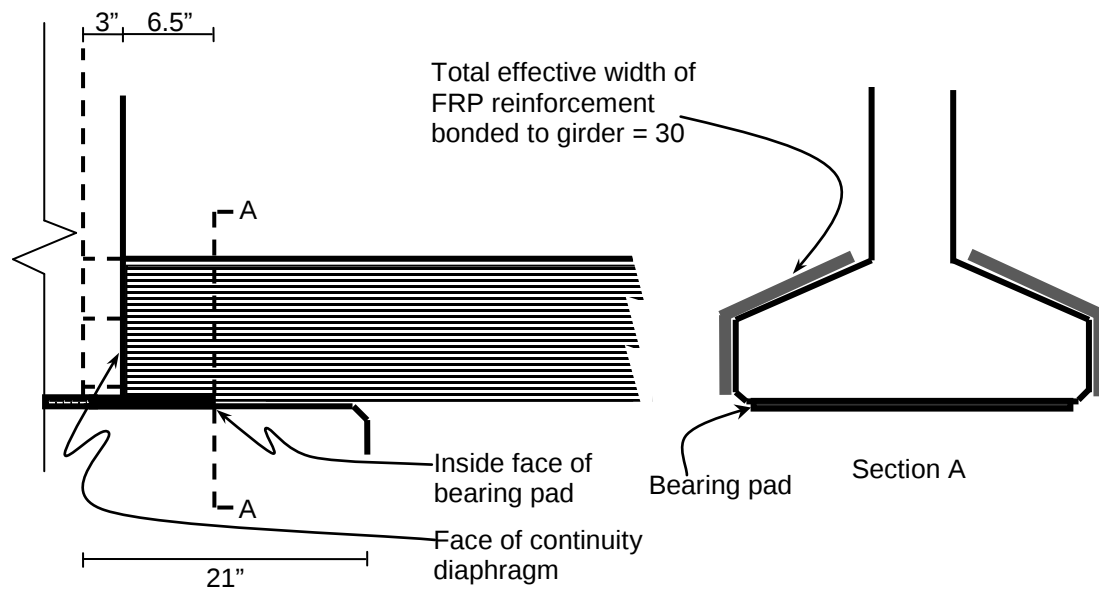
**Figure N.3: Cross-sectional configuration of FRP—near diaphragm (Swenson 2003)**

The end regions of continuous sheets of reinforcement must be cut appropriately to account for support conditions. At the interior face of the bearing pad, FRP reinforcement cannot be installed along the bottom face of the girder, as shown in Figure N.3. At the termination of the continuity reinforcement, the FRP reinforcement can be installed to wrap around the entire perimeter of the tension flange, as shown in Figure N.4.

The cross section at the interior face of the bearing pad at the continuity diaphragm is located roughly 6.5 in. from the face of the diaphragm. This location is considered critical because it is a support condition and the bearing pad obstructs the ability to install FRP reinforcement around the entire tension flange, which also represents a reinforcement transition location. This is also the point of maximum shear force influence on the bottom flange of the girder.

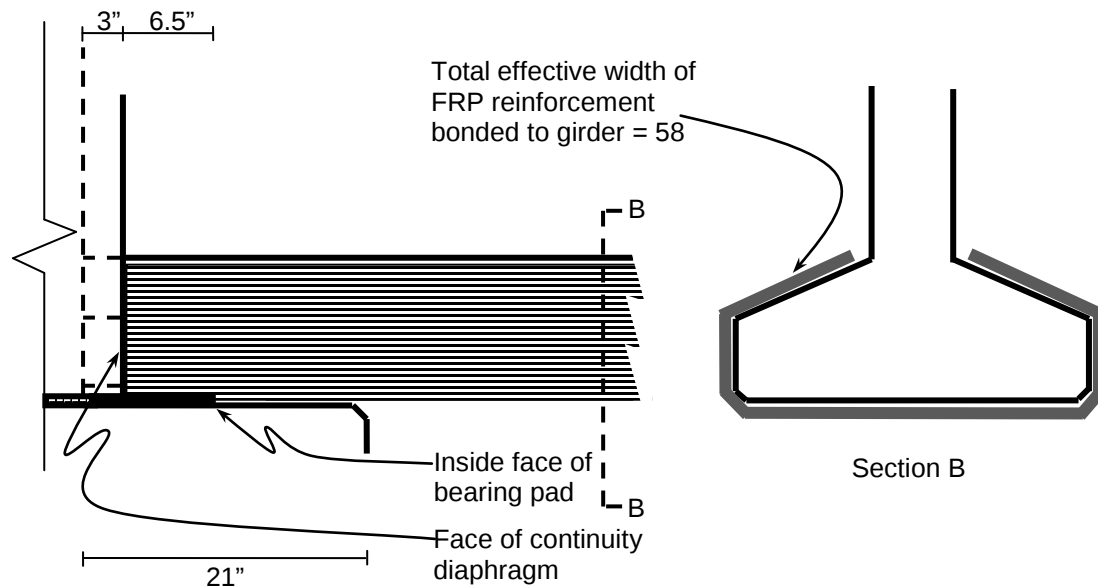
**Figure N.4: Cross-sectional configuration of FRP—typical (Swenson 2003)**

The cross section at the termination of the mild steel continuity reinforcement is located 38 in. from the face of the diaphragm. This location is considered critical because it represents the initiation of a region without longitudinal steel reinforcement that can safely be considered effective for tension resistance in response to shear or positive bending moment demands. Even if cracking is only present between this location and the face of the diaphragm, the short distance

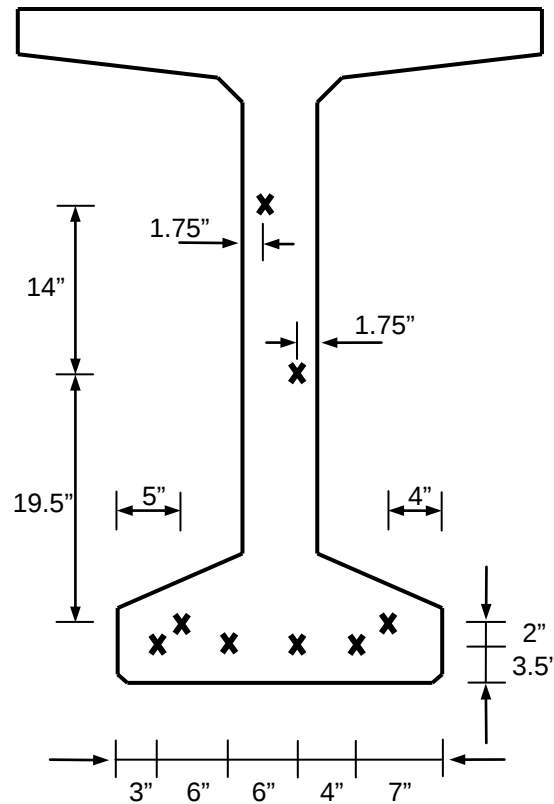
**Figure N.8: Continuity reinforcement—typical BT-54 cross section  
(ALDOT 1988; Swenson 2003)**

The mild steel continuity reinforcement details from original design and construction have been documented by ALDOT (1988). The continuity reinforcement configuration is shown in Figure N.8. The continuity reinforcement of the tension flange is considered to be effective reinforcement for tension capacity. The area ( $A_s$ ) of reinforcement located in the tension flange is

equal to  $2.64 \text{ in.}^2$ , and the centroid ( $y_s$ ) of this reinforcement is located 4.17 in. from the bottom of the girder, which equates to a reinforcement depth ( $d_s$ ) of 59.8 in.

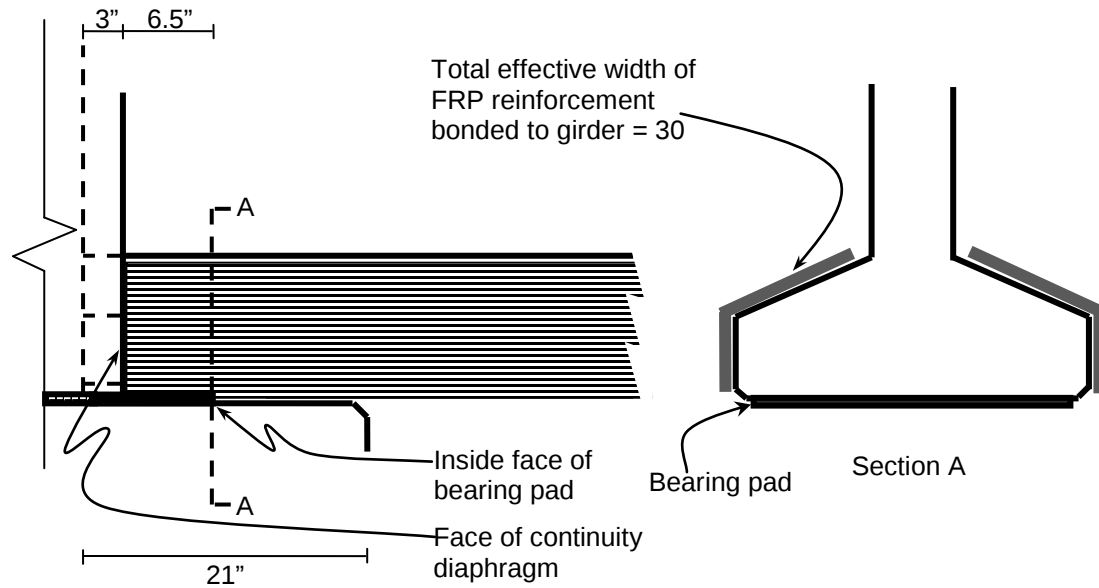
**Figure N.9: Cross-sectional configuration of FRP—near diaphragm (Swenson 2003)**

The effective widths of FRP reinforcement ( $b_f$ ) are representative of the repair system designed for Northbound Spans 10 and 11 of I-565 (Swenson 2003). The FRP reinforcement configurations are different for the two critical locations, as shown in Figures N.9 and N.10.

The FRP reinforcement configuration at the interior face of the bearing pad has an available effective width ( $b_f$ ) of 30 in., and the typical configuration that wraps the perimeter of the tension flange has an effective width of 58 in. The centroid of FRP reinforcement ( $y_f$ ) at the interior face of the bearing pad is roughly 6.5 in. from the bottom face of the girder, which equates to a reinforcement depth ( $d_f$ ) of 57.5 in. The bonded length ( $L_b$ ) from the FRP termination at the
