PAINT MARKING DURABILITY

Project Number ST-2019-5

Summary Report

Auburn University

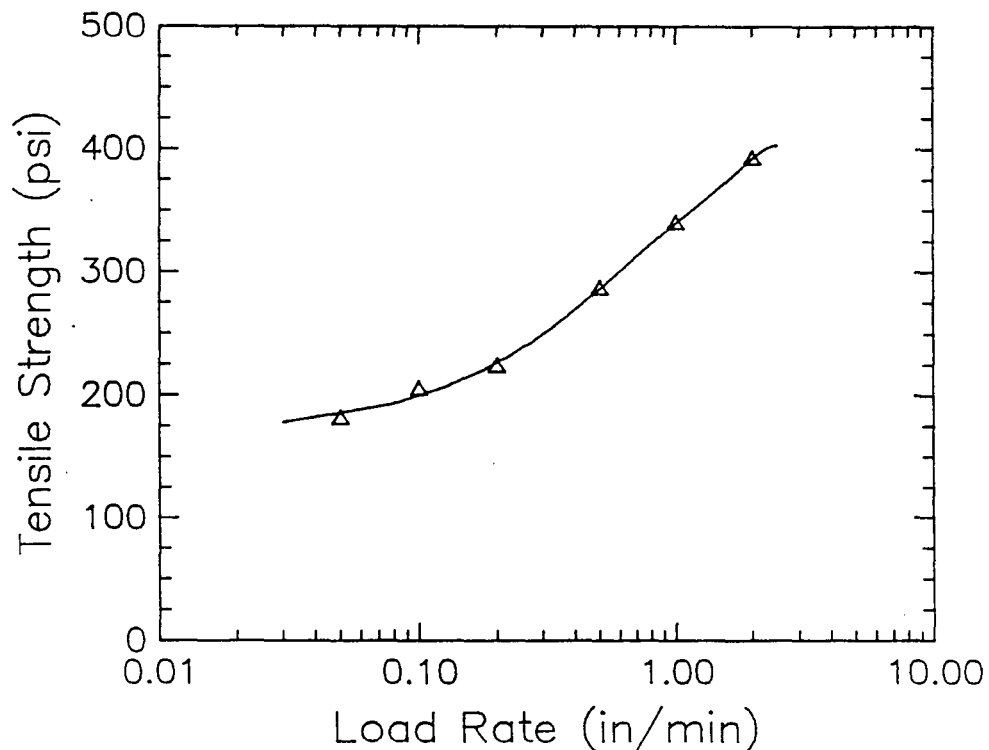
Figure 3.1 Effect of Load Rate on Ultimate Tensile Strength (Water Base)

The load rate tests performed on a typical water base paint demonstrated the visco-elastic nature of the material. Figures 3.1 and 3.2 clearly show the dramatic effect that the load rate has on this type of material. The slower the load rate, the more time the material has to undergo viscous creep. A load rate of 0.5 in/min was selected for subsequent tensile testing as it provided the greatest consistency in the measured data.
